# CULVERT INSPECTION FORM

District Upper Hutt City

Road Pinehaven Road RP 0 km No. of Lanes 2

Culvert No. \_\_\_\_\_ Waterway Name Pinehaven Stream

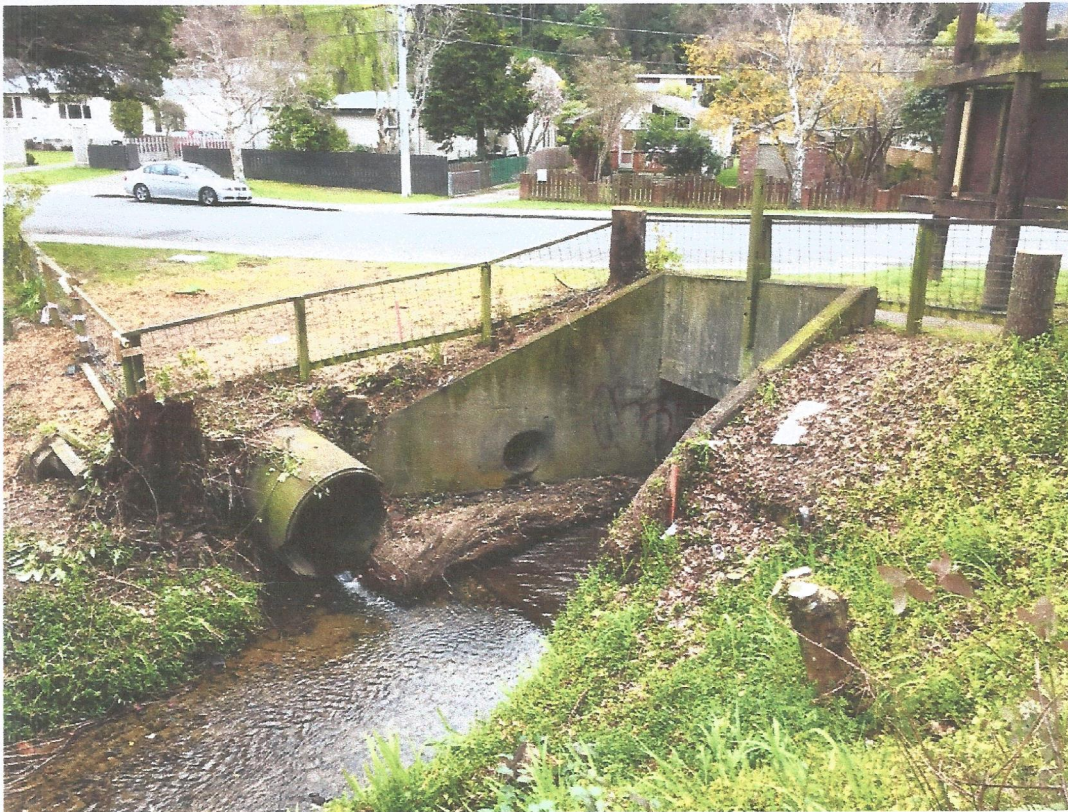
Inlet showing debris build up and scour underneath large pipe

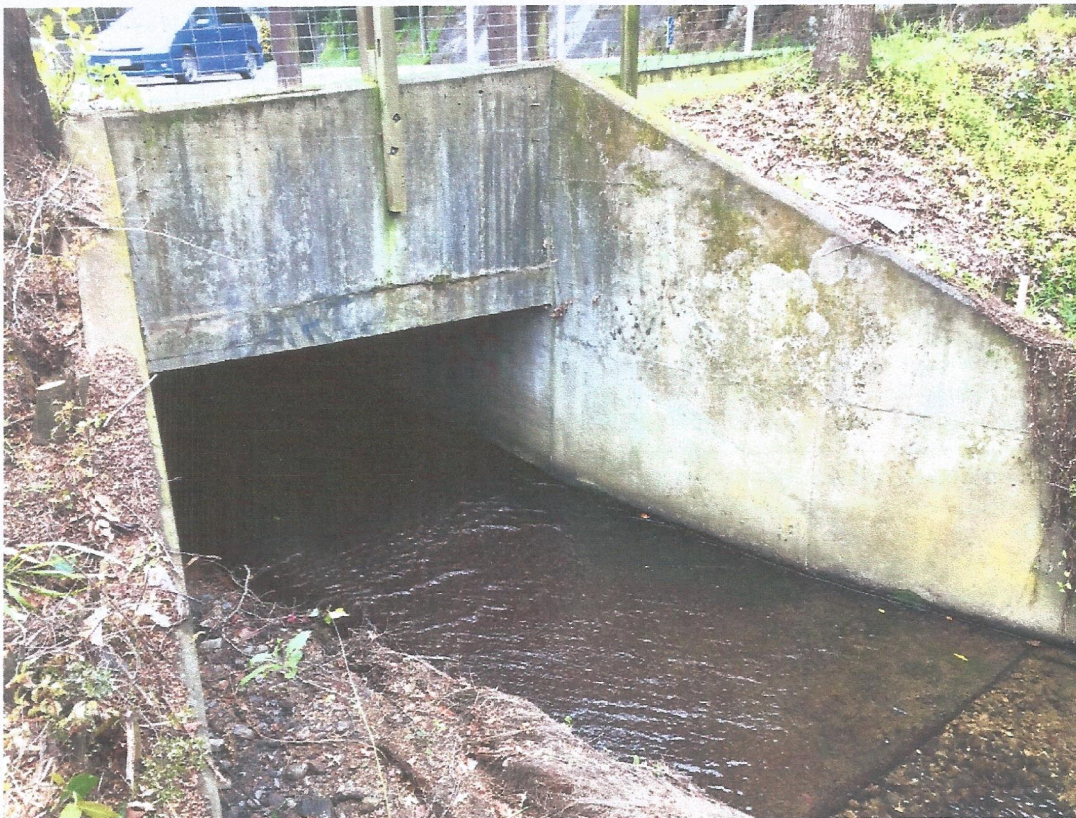
Inlet showing Headwall and wing wall

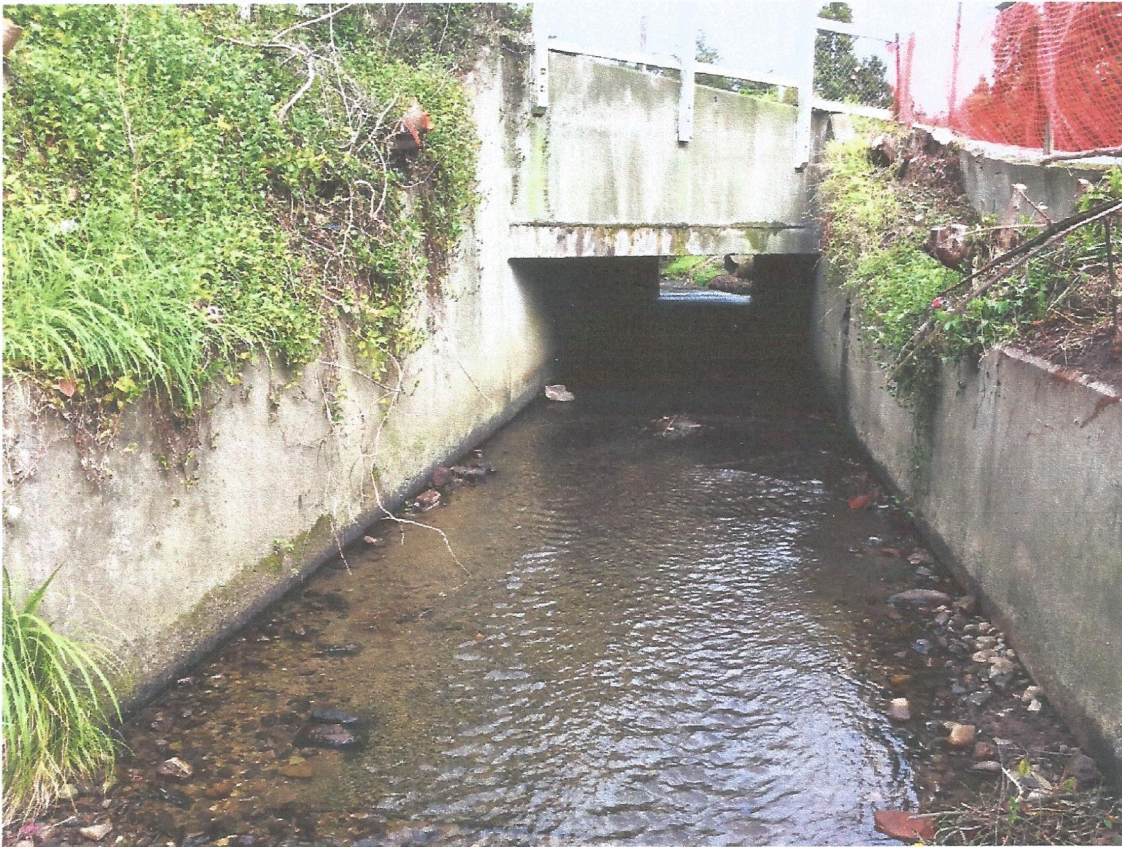
Outlet showing headwall and wing walls

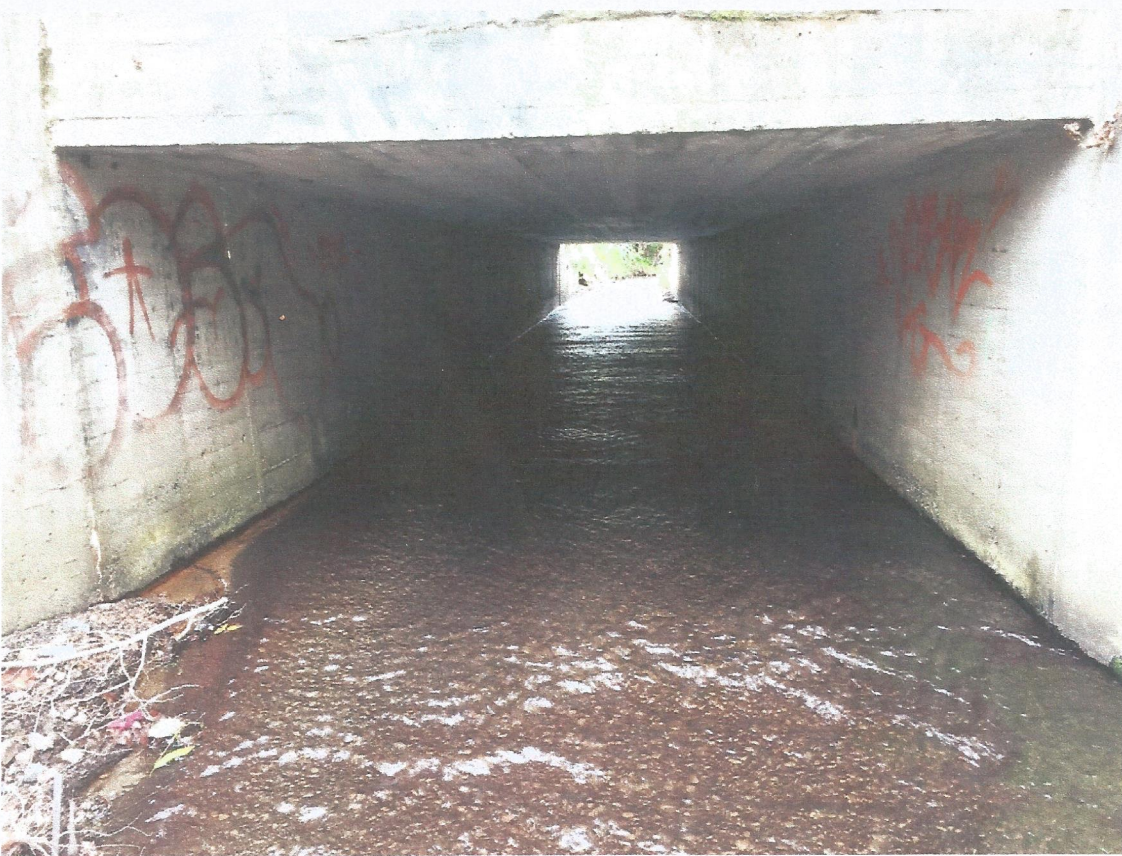
Inlet showing graffiti

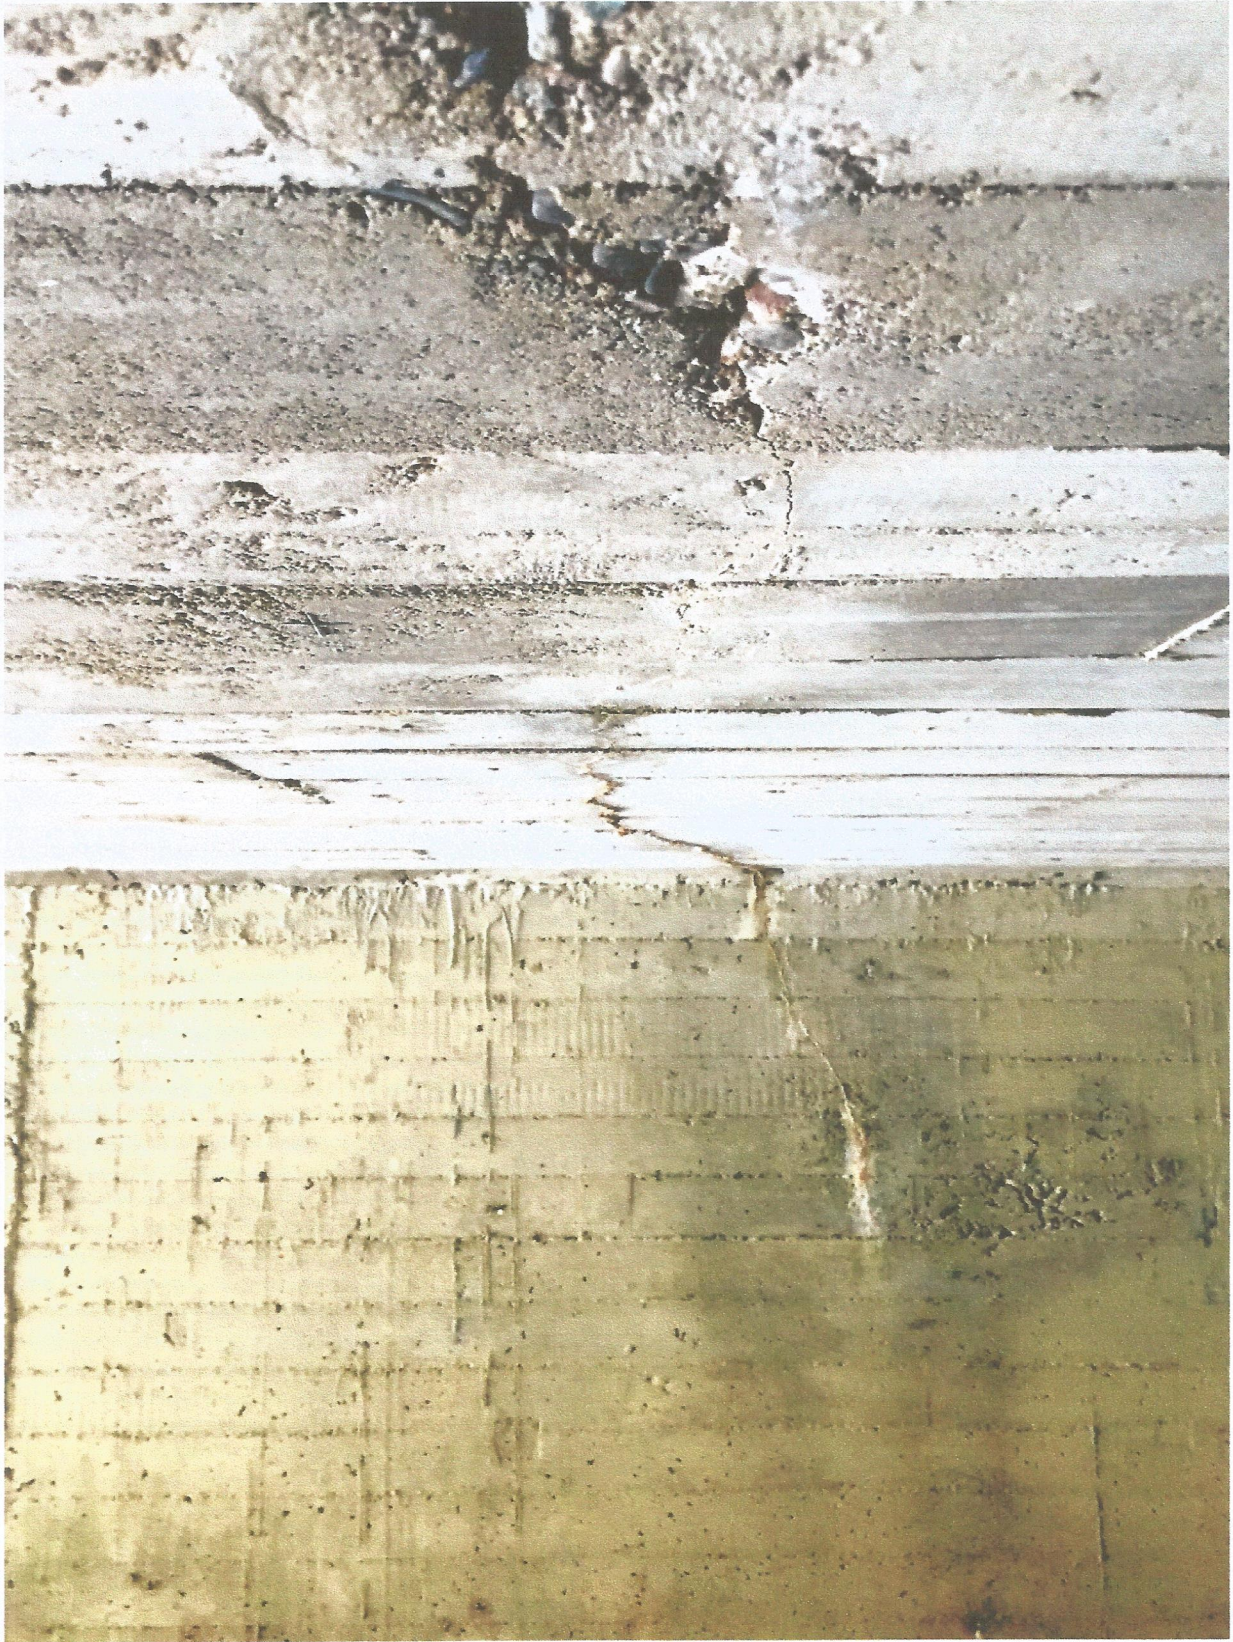
Soffit crack showing honeycomb and efflorescence

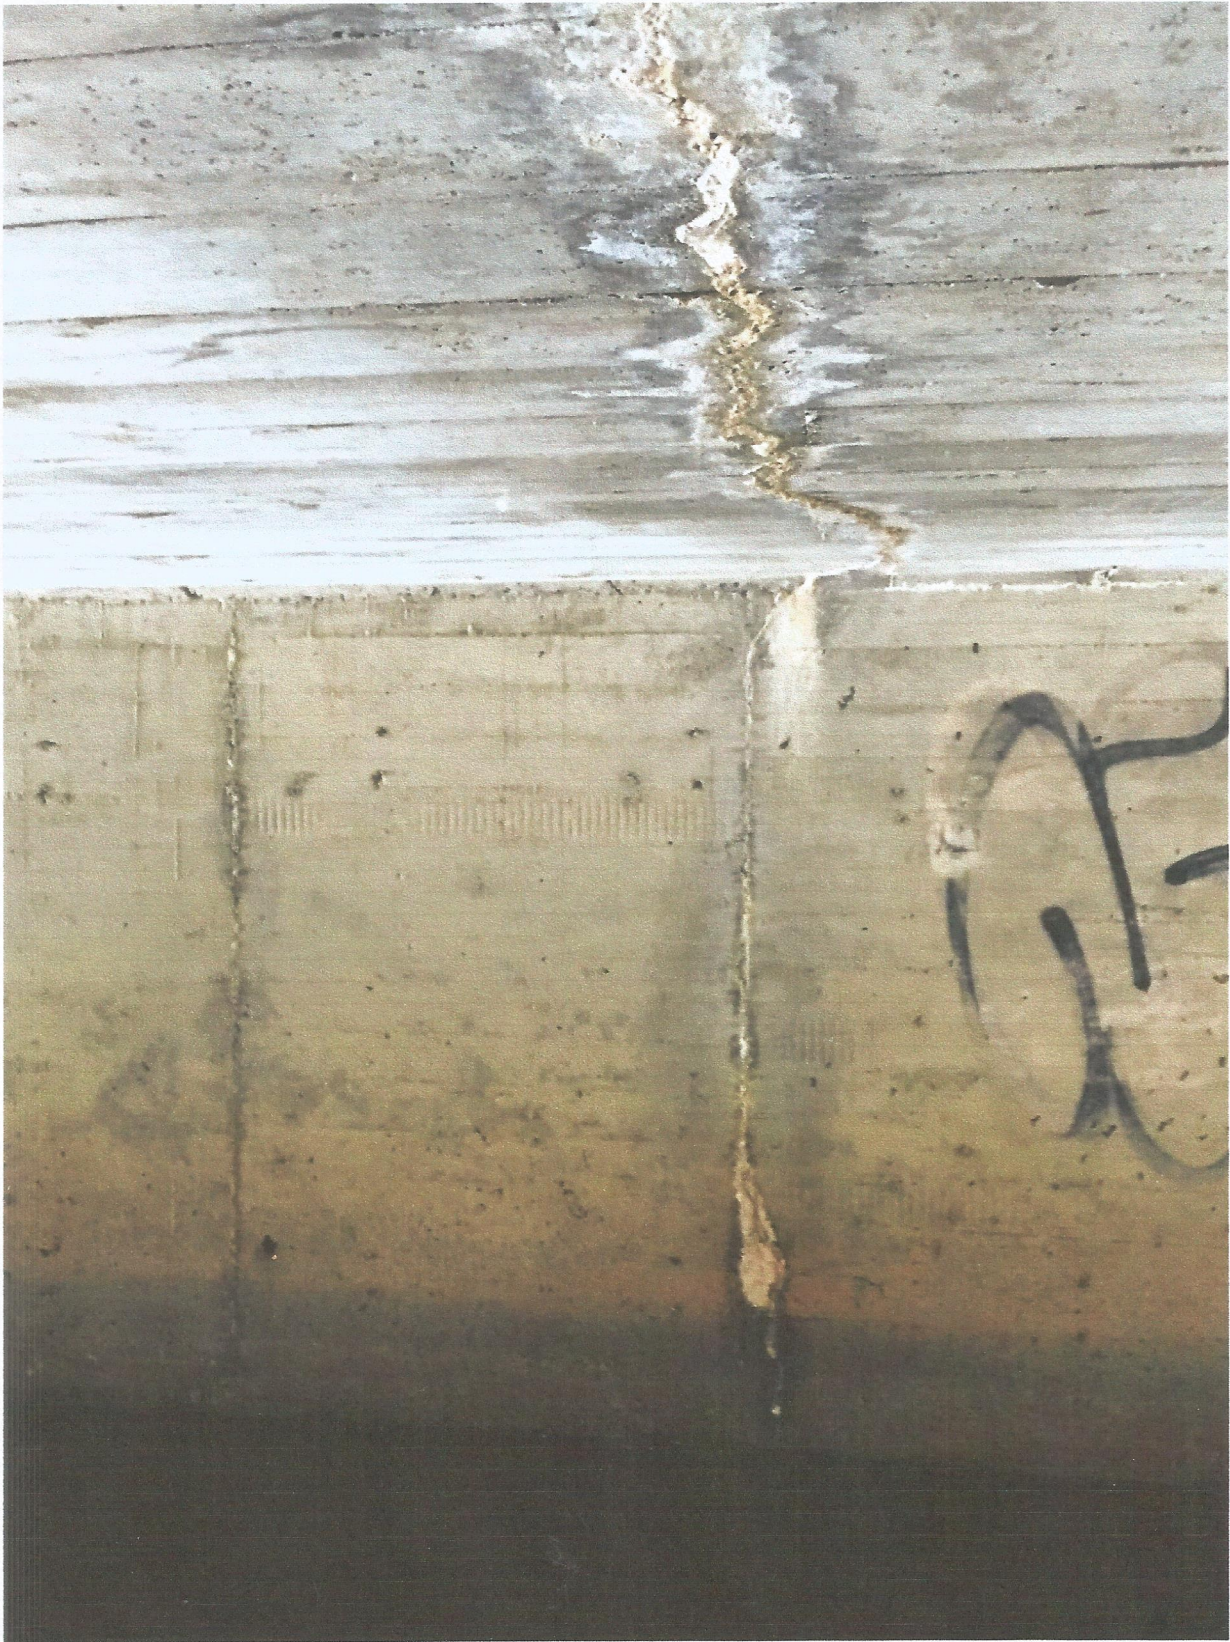
Crack 2 showing efflorescence and graffiti
