UHCC - PC42 Hearing

Flood Maps Must Be Accurate

Save Our Hills (Upper Hutt) Inc.

GWRC & UHCC 1-in-100 year flood for 27 Elmslie Rd:

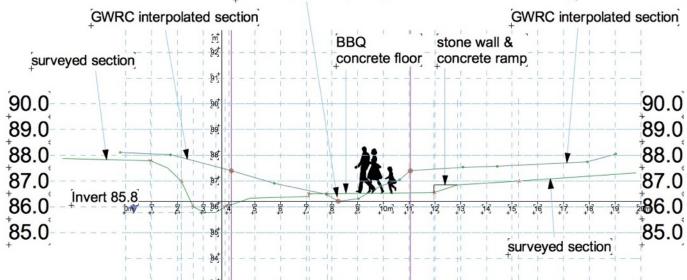
GWRC Topography Wrong for 27 Elmslie Road, Pinehaven – Cross- Section at Chainage 640

assumed location of GWRC's invert (based on GWRC Flood Map showing deepest flood level over BBQ floor)

Channel Section Y-Y (based on Topo. Survey) compared with GWRC Interpolated Section at Chainage 640
