2019-12-08_Pinehaven Stream flood event_CDA Drawings_Rev A

Applications for resource consents, and a Notice of Requirement for a Designation by Wellington Water Limited on behalf of Upper Hutt City Council, for the construction, operation and maintenance of the structural flood mitigation works identified as the Pinehaven Stream Improvements Project

Statement of Evidence of Alexander Keith Ross

Report on Infiltration Tests carried out on the Pinehaven Stream Catchment During July 2019

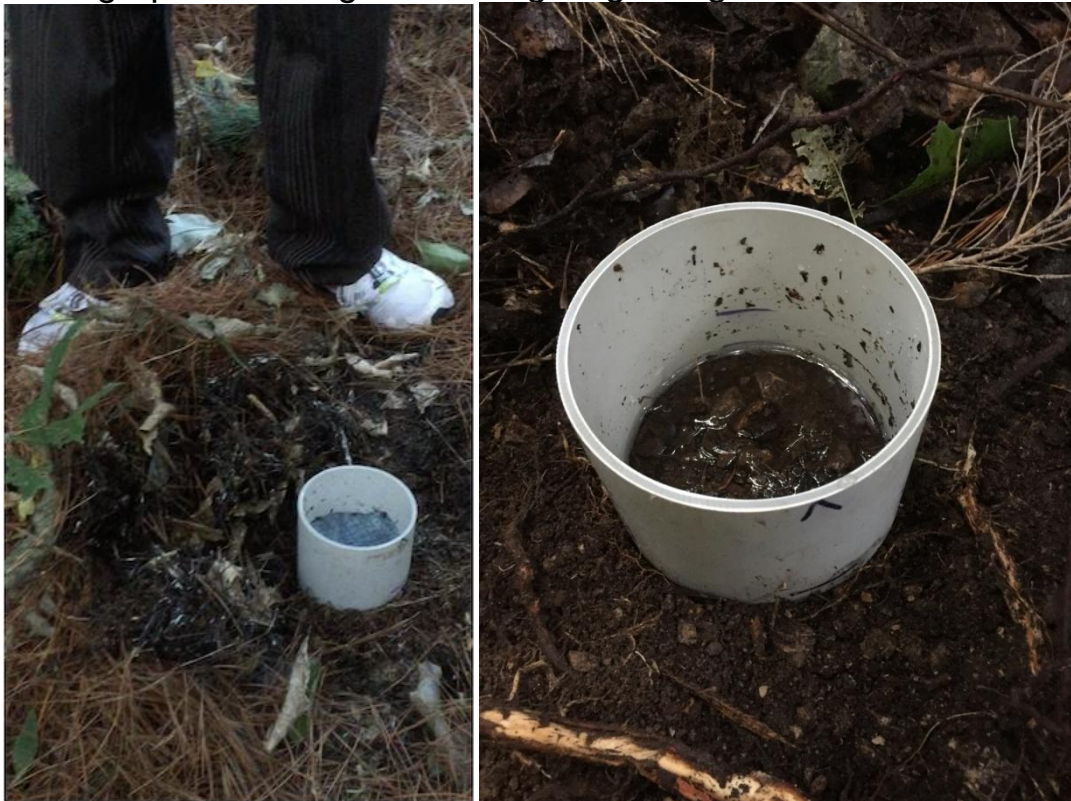
Photographs showing tests using single ring infiltrometer.

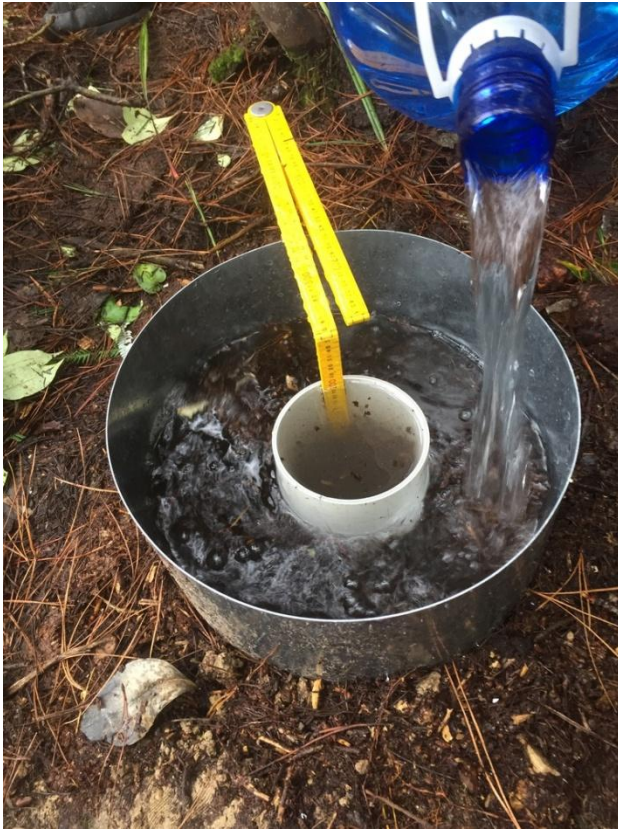
DRI Test 1 Edge of Pines

The photographs below show the various test sites at 27 Elmslie Road, Pinehaven and in the Pinehaven Reserve.

The test results were graphed for tests 1 - 3 of the double Ring Infiltrometer (as shown below), and gave base infiltration rates between 512 - 900 mm/hr for the Bush and forest areas at 27 Elmslie Road.

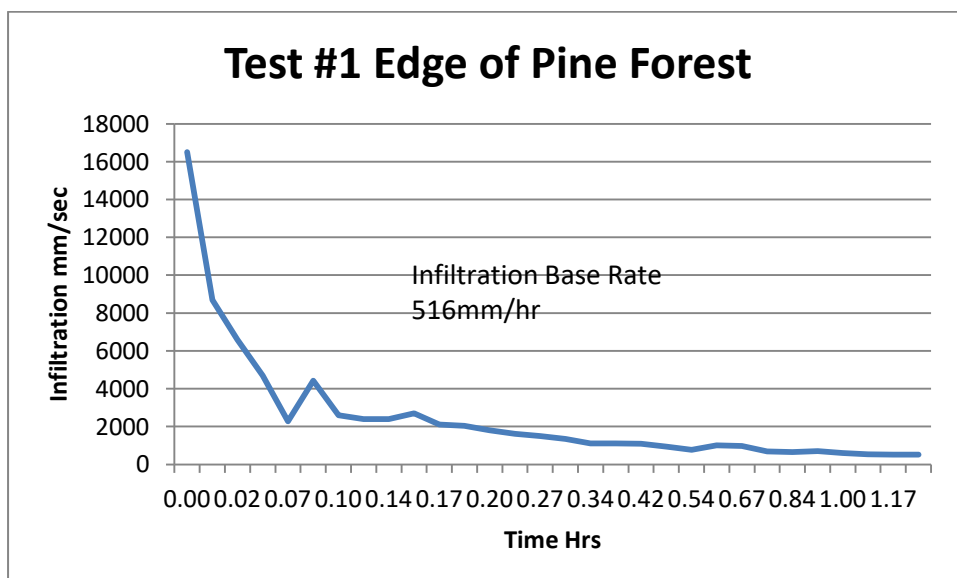
Setting aside the outlier of Test #6 at 7 sec the average time is 119 sec giving an infiltration rate of 603 mm / hr Which is reasonably consistent with the double ring tests.

The tests on the lawn areas and the Pinehaven Reserve gave consistent results of 1 - 2 mm/hr for the infiltration rate on this type of land cover.

The results show that the forest and bush areas in the Pinehaven catchment have much higher infiltration rates than what was proposed in the flood model calculations by WRC and as such the peak flood calculations, volumes, and extent of flooding shown on the maps based on the catchment as presented in 2019 are grossly exaggerated.

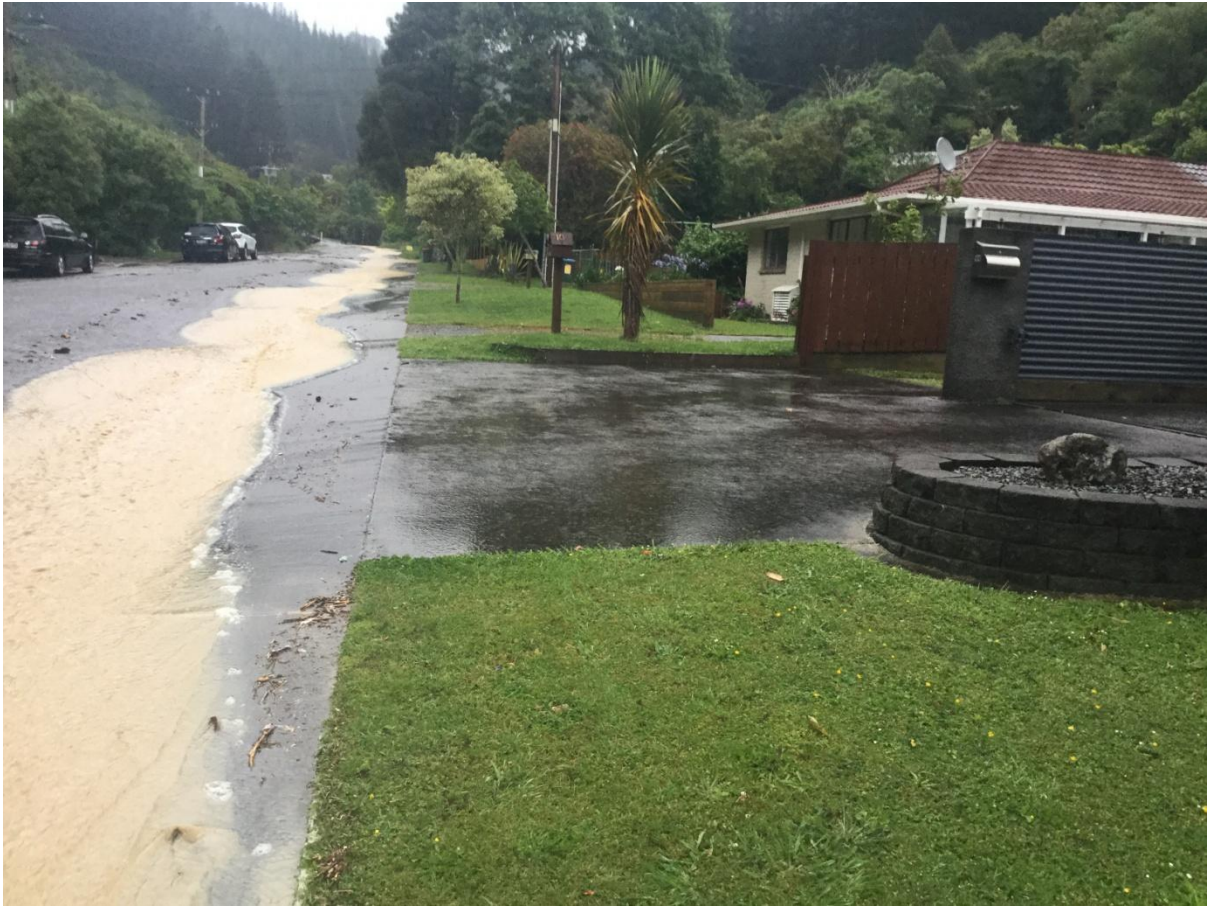
Photograph of secondary flow path caused by undersized culvert and vegetation blocking the channel below the culvert at 122 Pinehaven Road.

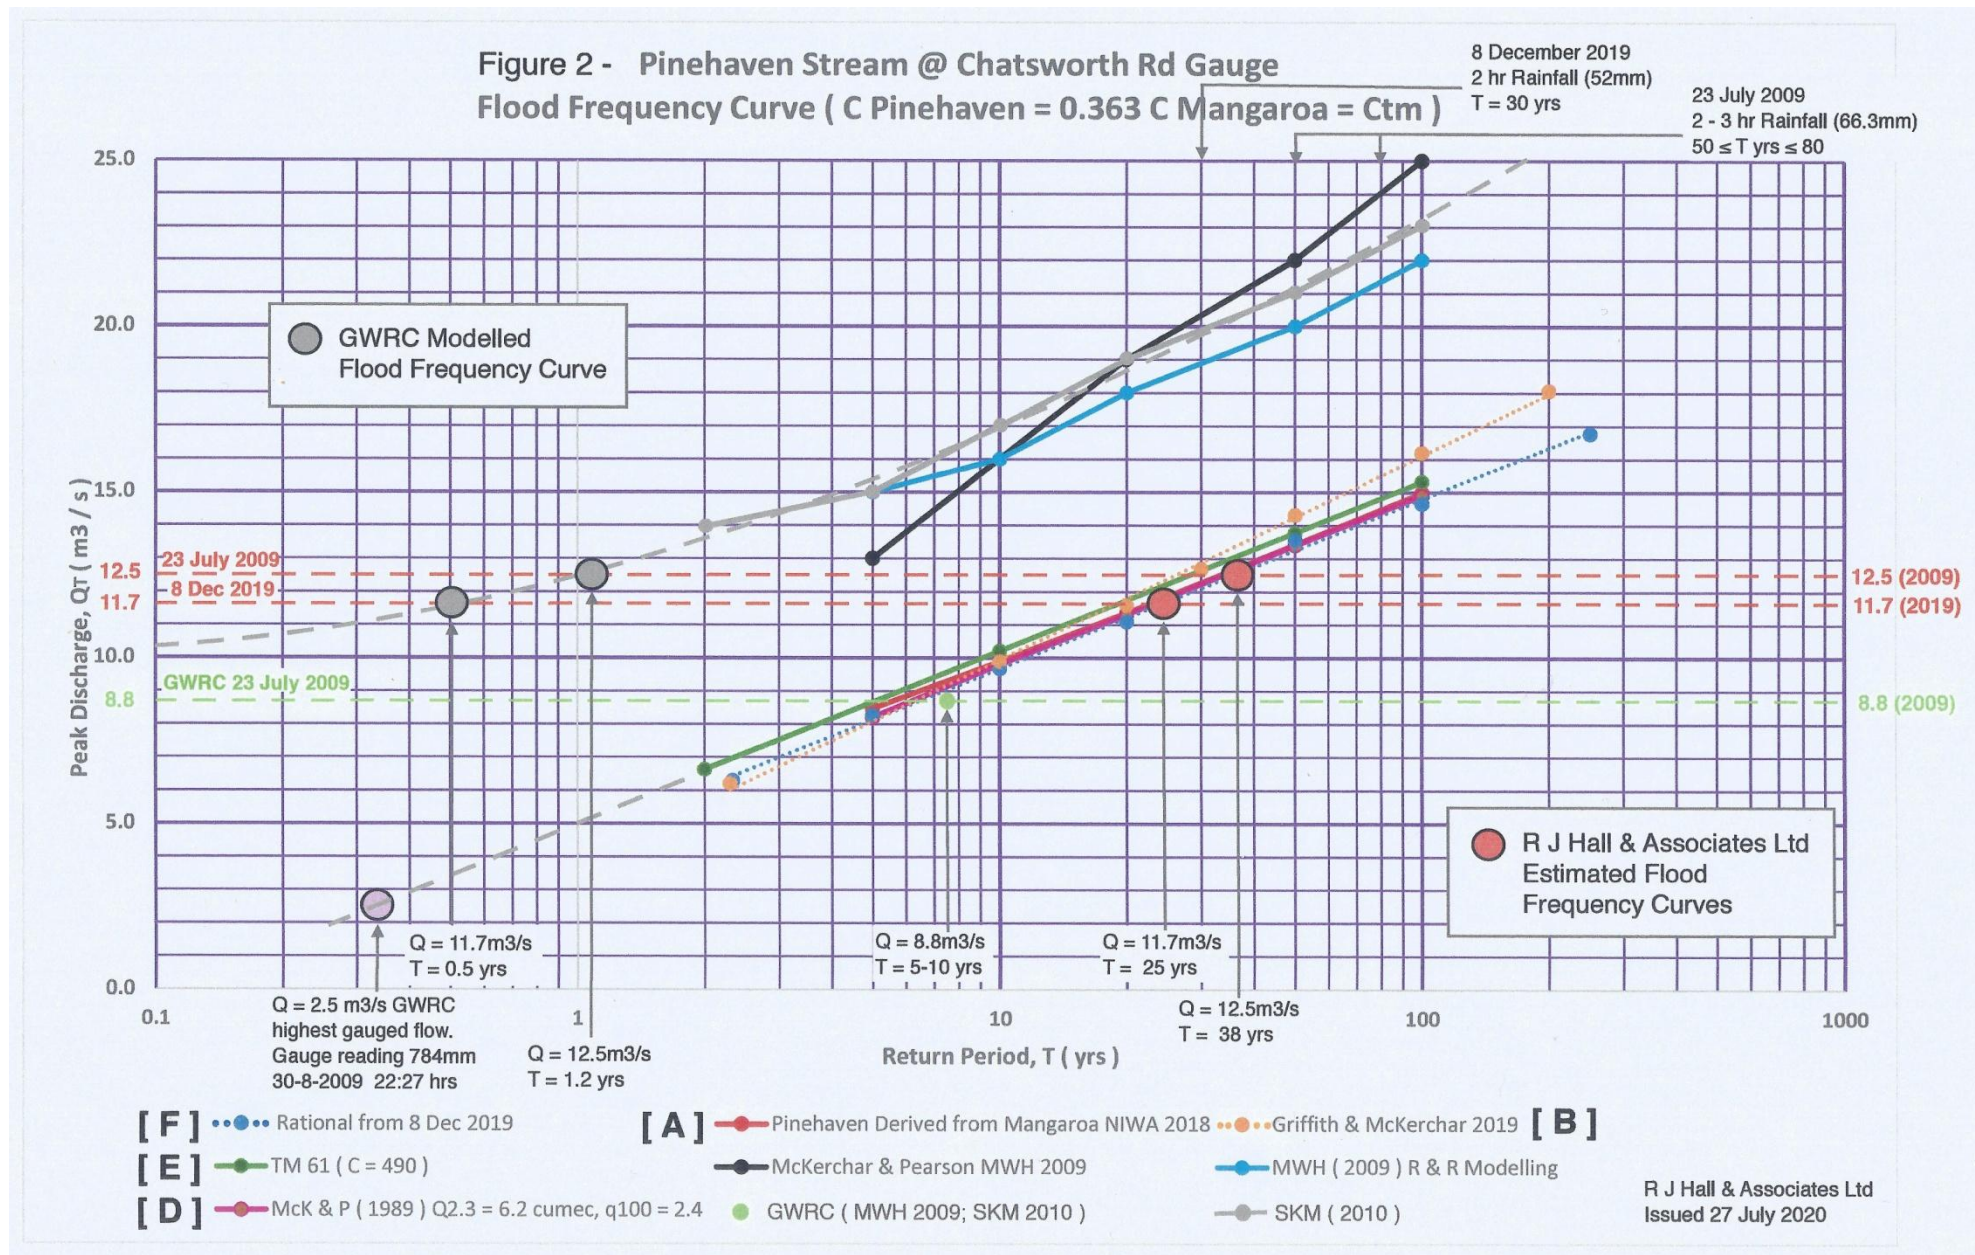
Rating Curve from RJ Hall showing Peak Discharge vs Return Period and Highlighting the error in GWRC flood estimates.

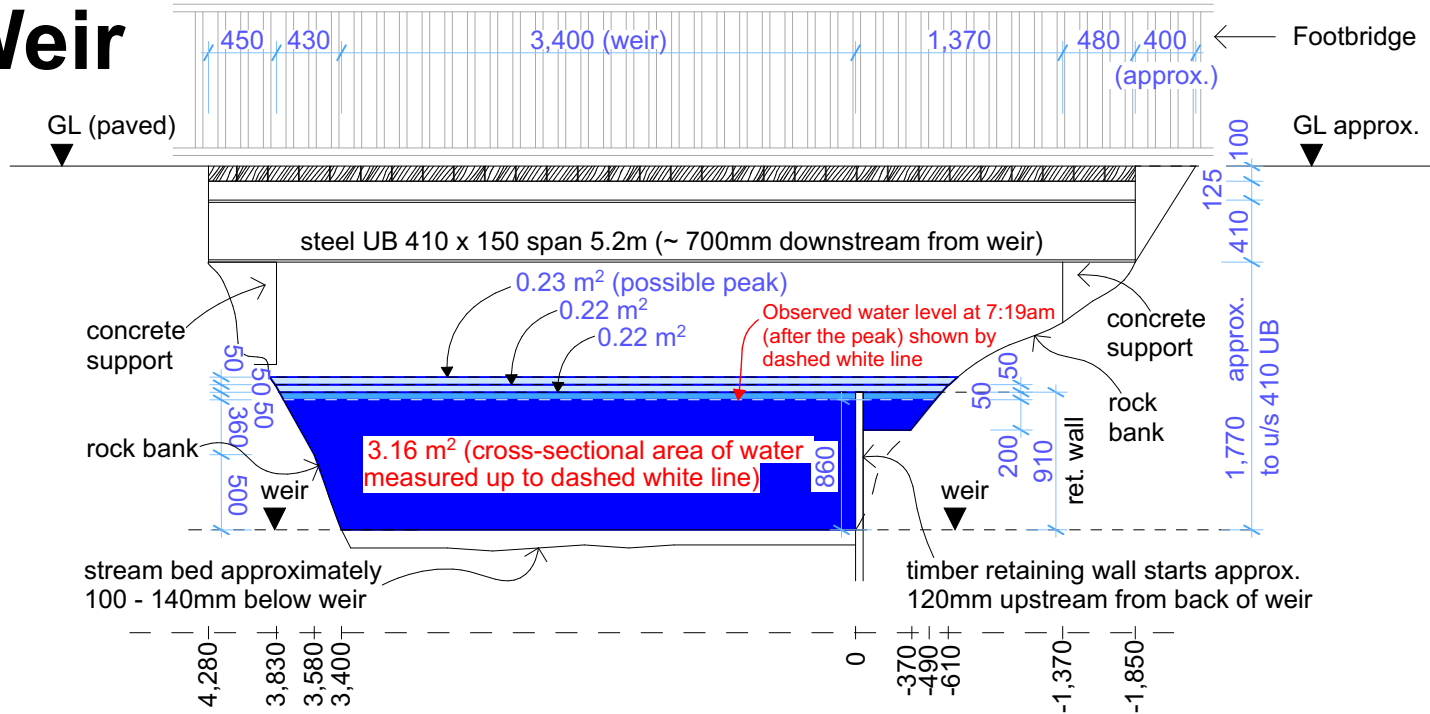
Weir under Footbridge - Channel Section 1:50

Cross-Section of Pinehaven Stream channel at Weir Under Footbridge (looking downstream)
 22.9.18 - Measurements taken on site by Steve Pattinson (SOH)
0.81m approx. depth of flow over weir observed 8th Dec 2019 at 7:19am

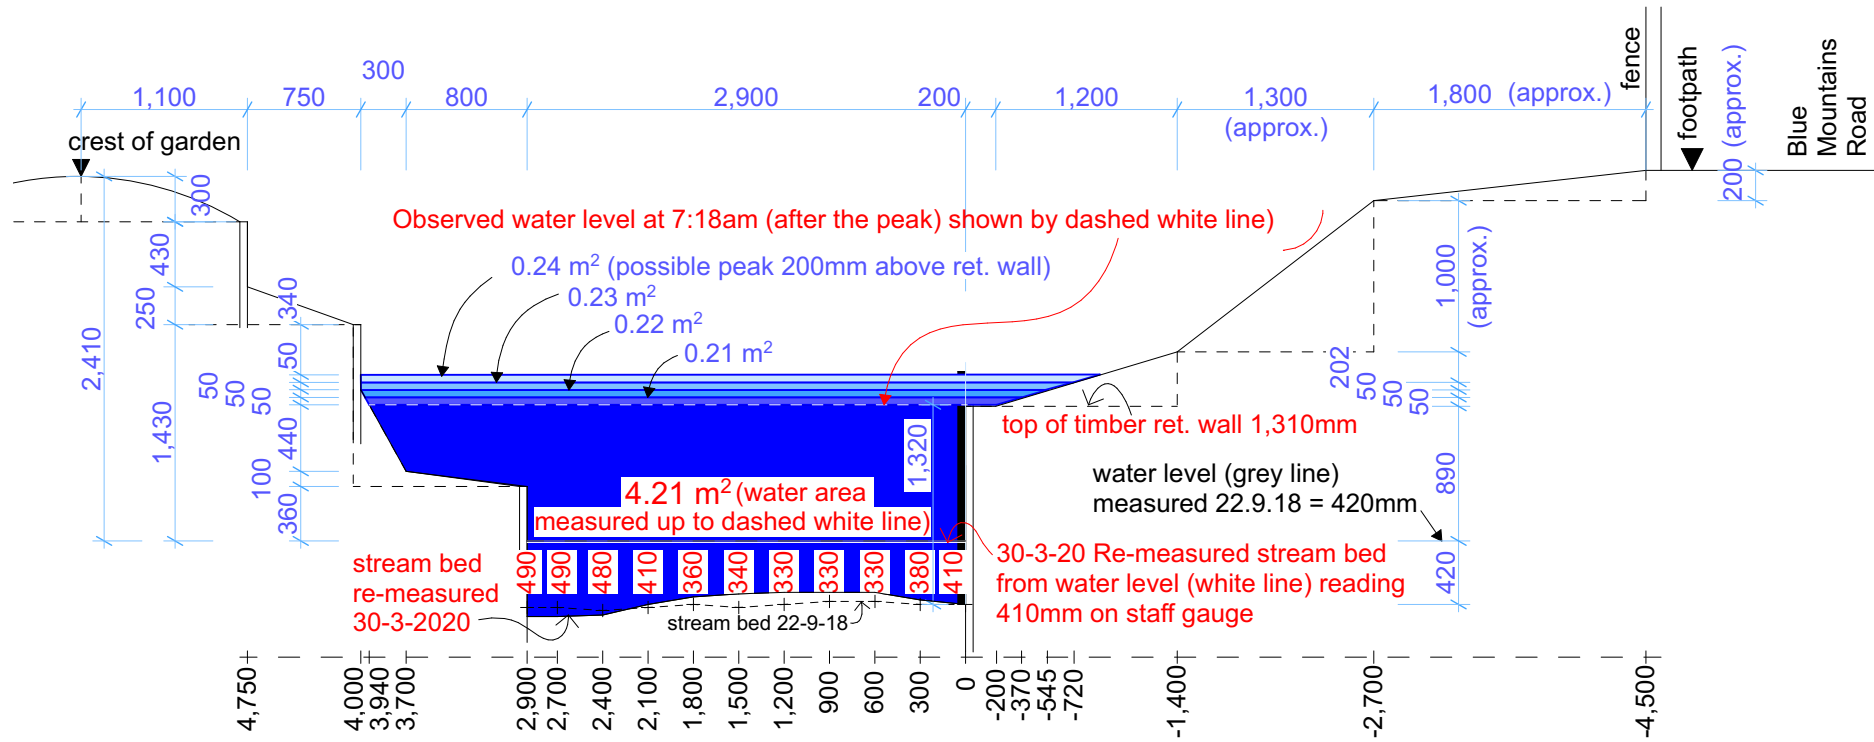
Staff Gauge Location - Channel Section 1:50

Cross-Section of Pinehaven Stream channel at staff gauge (looking downstream)
 (Staff gauge location approximately 3.4m upstream of footbridge weir)
 22.9.18 - Measurements taken on site by Steve Pattinson (SOH)
1.32m approx. depth of flow observed 8th Dec 2019 at 7:18am

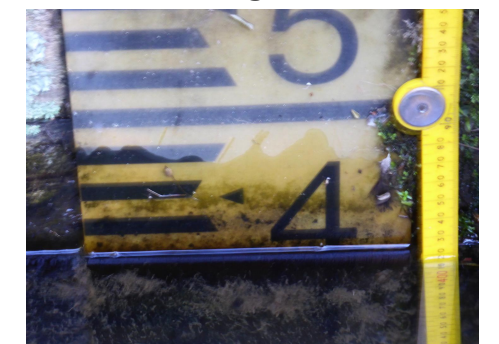
7 - Water Depth 420mm (Date 22/9/18)

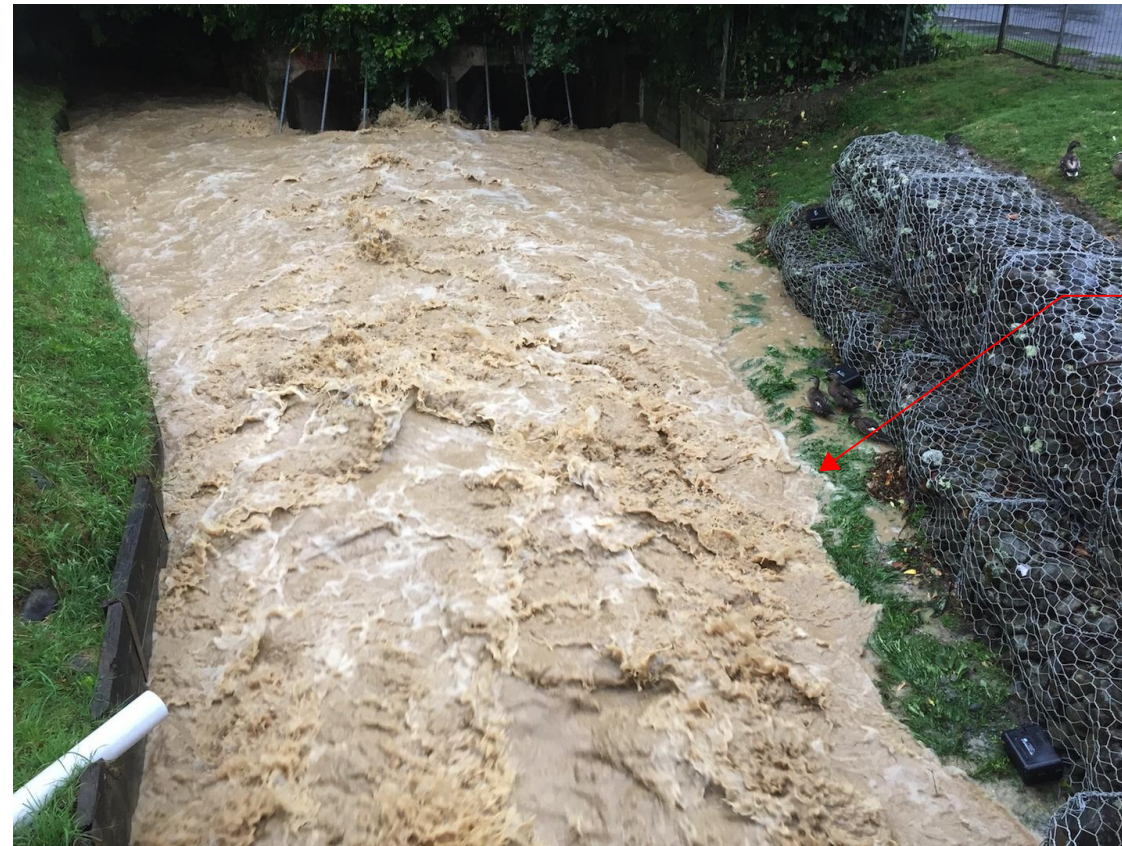
2 - View downstream from footbridge 8 Dec 2019 at 7:17am

On 8 Dec 2019 at 7:17am, water level appears to be about level with grass ledge (a little lower than at 6:14am - see Photo 1 opposite).

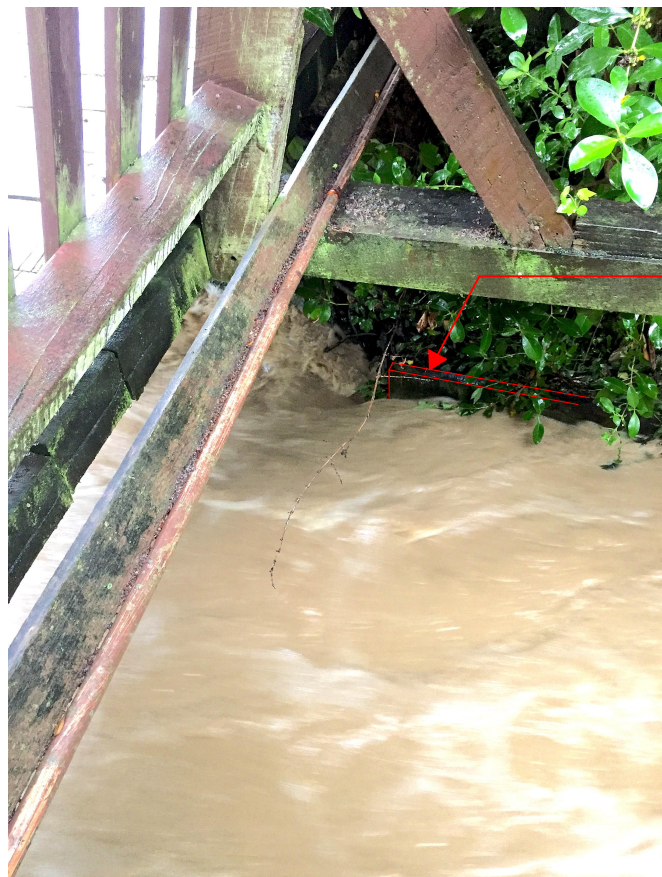
3 - Right Bank at Weir on 8 Dec 2019 at 7:19am

On 8 Dec 2019 at 7:19am, water level appears to be about 50-150mm below top of timber retaining wall (top of timber retaining wall is 910mm above the weir).

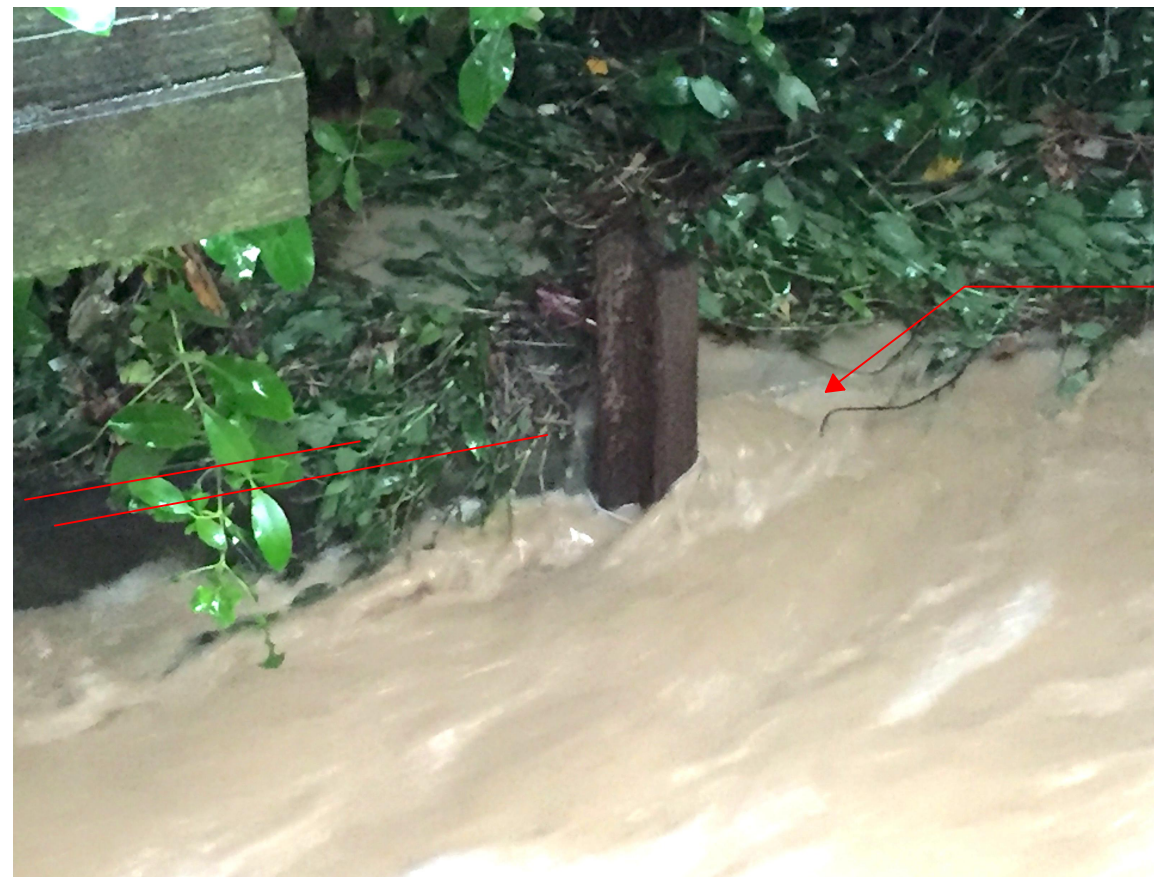
4 - Right Bank at Retaining Wall post (about 1.8m upstream of weir) 7:18am

On 8 Dec 2019 at 7:18am, the water level appears to be just overtopping the 1,310mm high timber retaining wall (on the upstream side of the steel post, which is about 1.8m upstream of the weir) and just below the top of the timber retaining wall on the downstream side of the steel post. Note: the staff gauge is about 1.6m further upstream from the steel post in this photo).

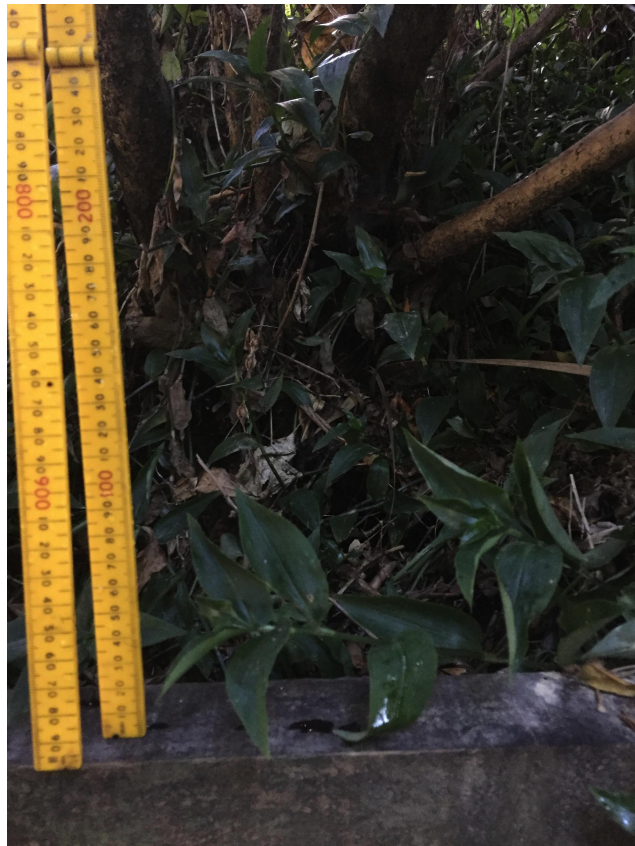
1 - Debris 100mm to 150mm above top of retaining wall.

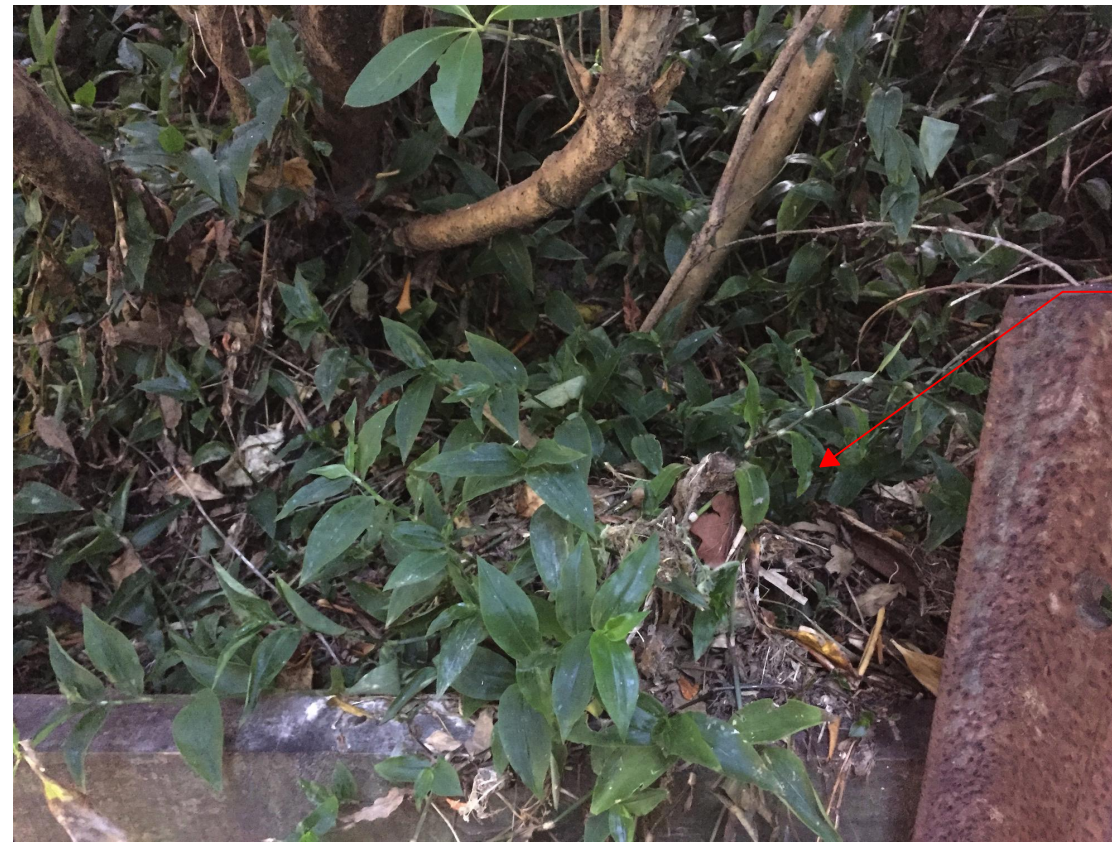
2 - Debris still evident 16/3/20 above retaining wall and at base of tree.

On 16/3/20 there is still debris evidently washed up against the base of the tree above the retaining wall, possibly 100mm to 150mm above the retaining wall. - see Photo 1 opposite and see Photo 4 below.

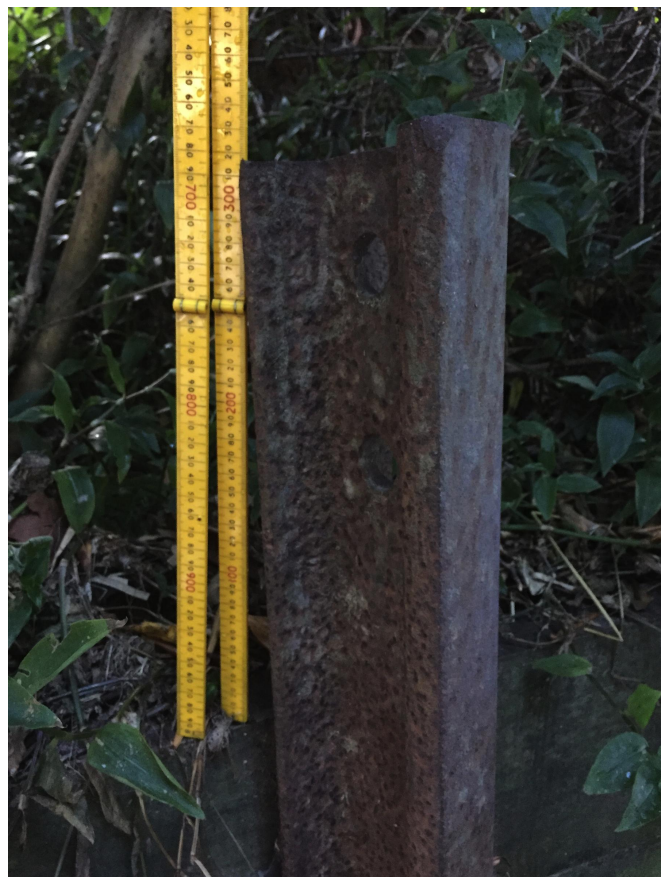
3 - Top of steel post is 317mm above top of retaining wall

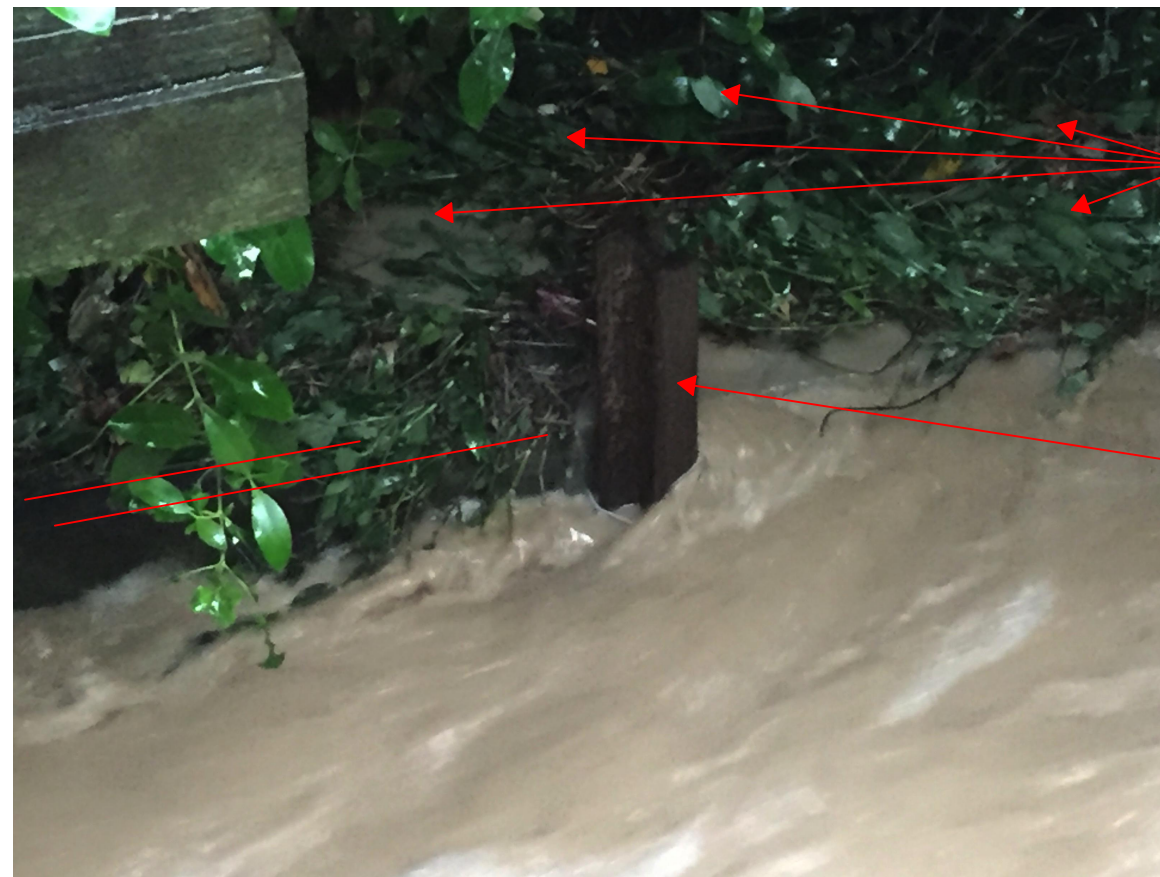
4 - Right Bank at Retaining Wall post (about 1.8m upstream of weir) 7:18am

On 8 Dec 2019 at 7:18am, there is evidence of dirty floodwater above the level of the timber retaining wall. This suggests the peak flow, which occurred before 7:18am, went above the retaining wall, which is 1,310mm at the staff gauge. (Note: the top of the steel post is 315mm above the top of the retaining wall - see Photo 3 opposite).

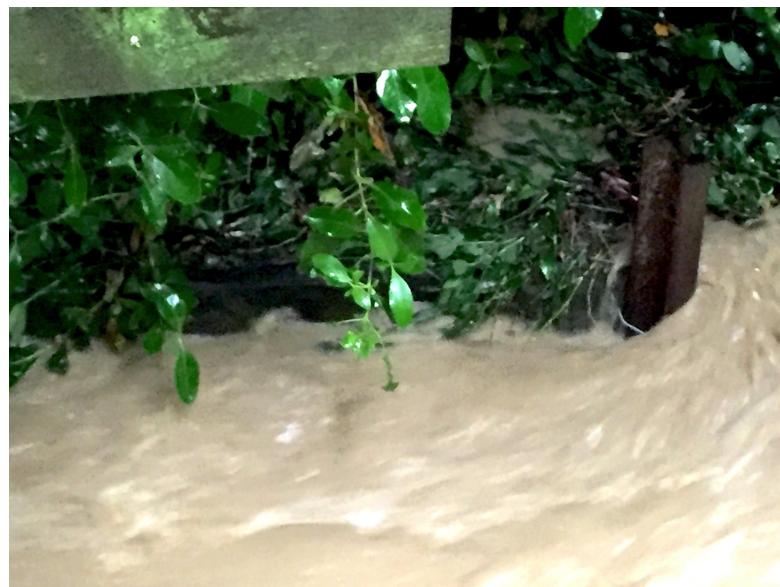
2 2019-12-08 07.18.08_

The distance from the top of the timber retaining wall down to the water in this photograph (on the downstream side of the railway iron) is 135mm (approx.) - See Drawing Sheet 110.1

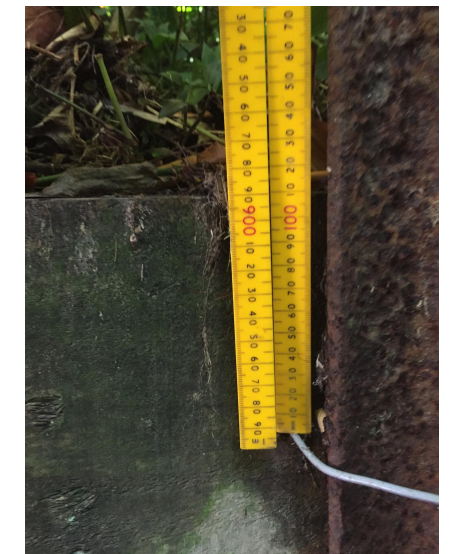
5 - 108mm to No.8 wire from top of ret. wall

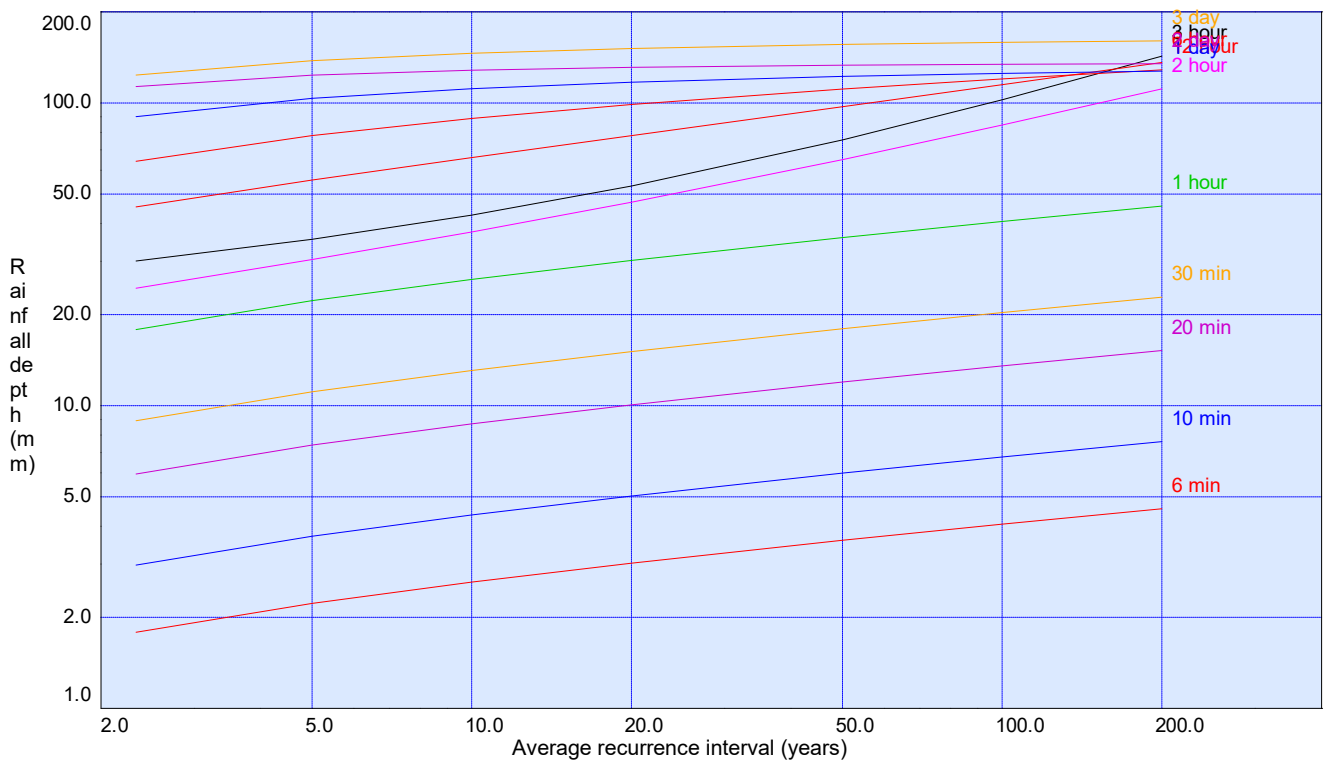
Rainfall [Rainfall] versus ARI at Pinehaven Reservoir - GWRCweb from 1-Jan-2011 00:00:00 to 1-Jan-2020 00:00:00 GEV distribution

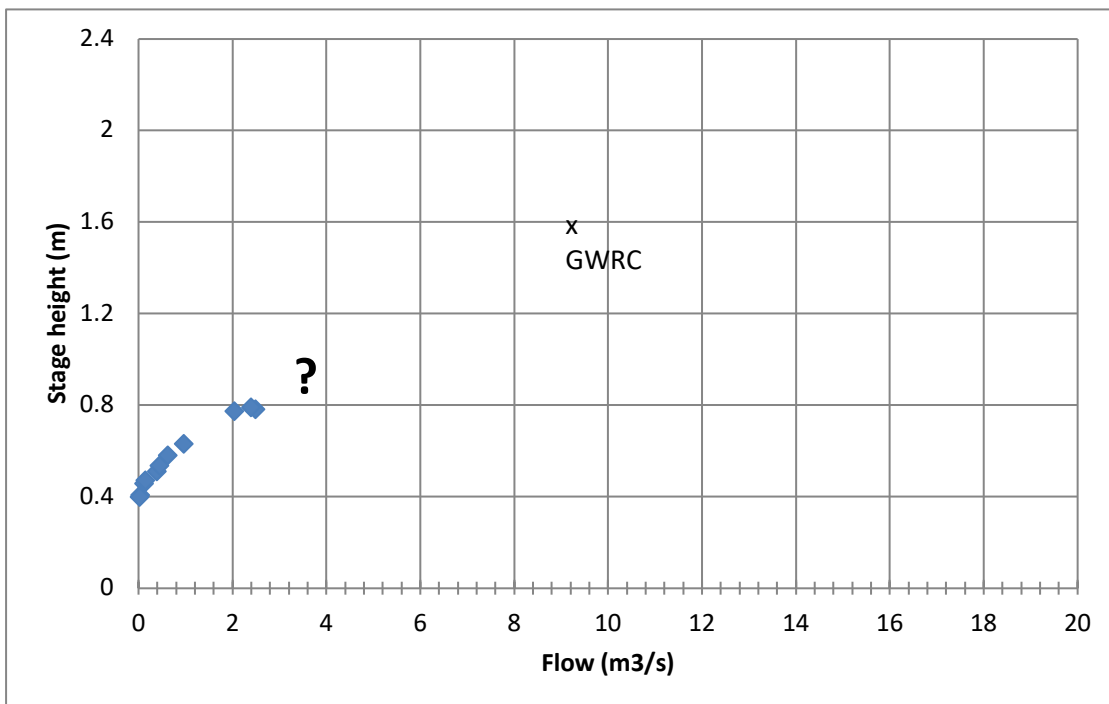
Figure 1: Flow gaugings available and the problem with extending the rating curve without high flow gaugings.

The problem for the GWRC hydrology team was how to extend the rating curve from 0.8 m to 1.6 m Figure 1, due to the lack of high flow measurements. The lack of any flood measurements or mapped flood marks during the peak of the 23 July 2009 is disappointing as the capture of flood measurements for flood design purposes is the main reason for the flow recorder site on Pinehaven Stream opposite Chatsworth Road.

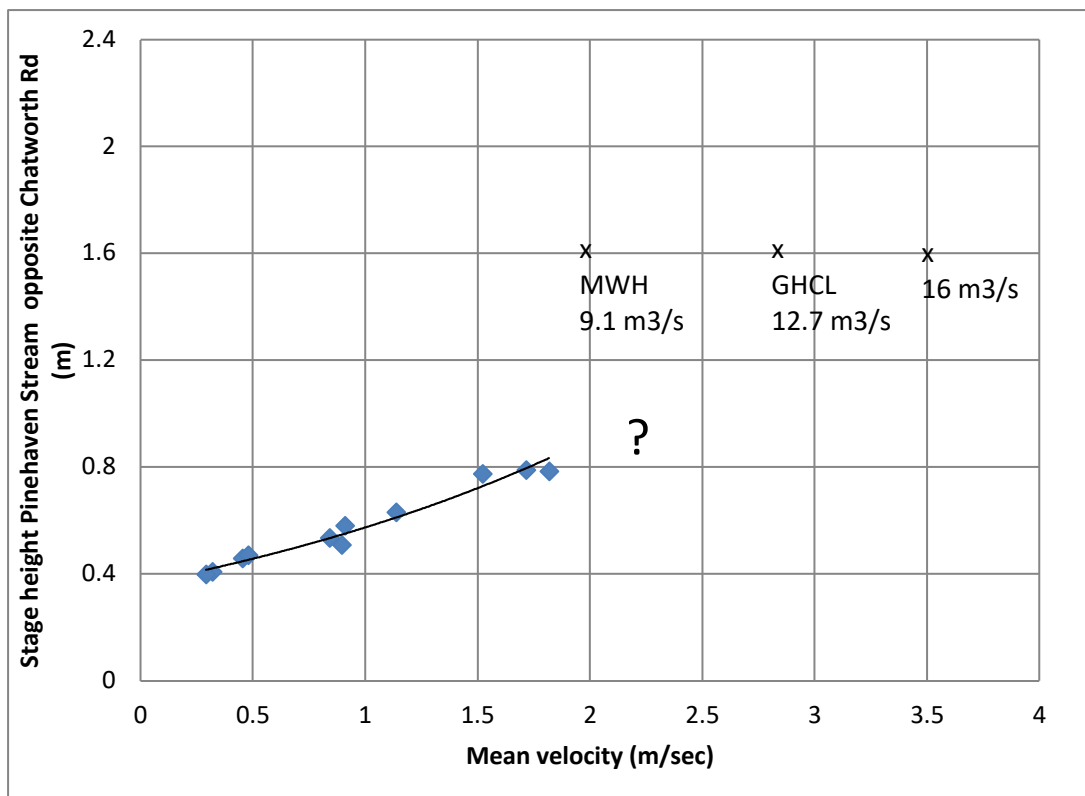
Figure 4: Pinehaven Stream at Chatsworth road stage height versus mean velocity curve

Figure 4 displays the problem with extending the stage/velocity curve between 0.8 m and 1.6 m. The MWH approach was to adopt 2 m/sec at stage 1.6 m. However this is only a 10 % increase in mean velocity from the stage of 0.8 m. This is not plausible in such a smooth bedded and smooth walled channel. My estimate is 2.8 m/sec which would result in a 12.7 m³/sec flow at 1.6 m, however for a flow of 16 m³/s a mean velocity of 3.51 m/sec would be required.

With the lack of higher flow gaugings, extending the velocity curve is difficult, see Figure 4 below.
