Project Name: Pinehaven Stream Improvements
Project Number: IZ089000

Subject: Response to section 92 requests for further information - submissions

Subject	Response to Jan 23 2020 Section 92 Request - Mapping 8 December 2019 flood event	Project Name	Pinehaven Stream Improvements Project
		Project No.	IZ089000
Author	Damian Debski		
Date	February 26, 2020

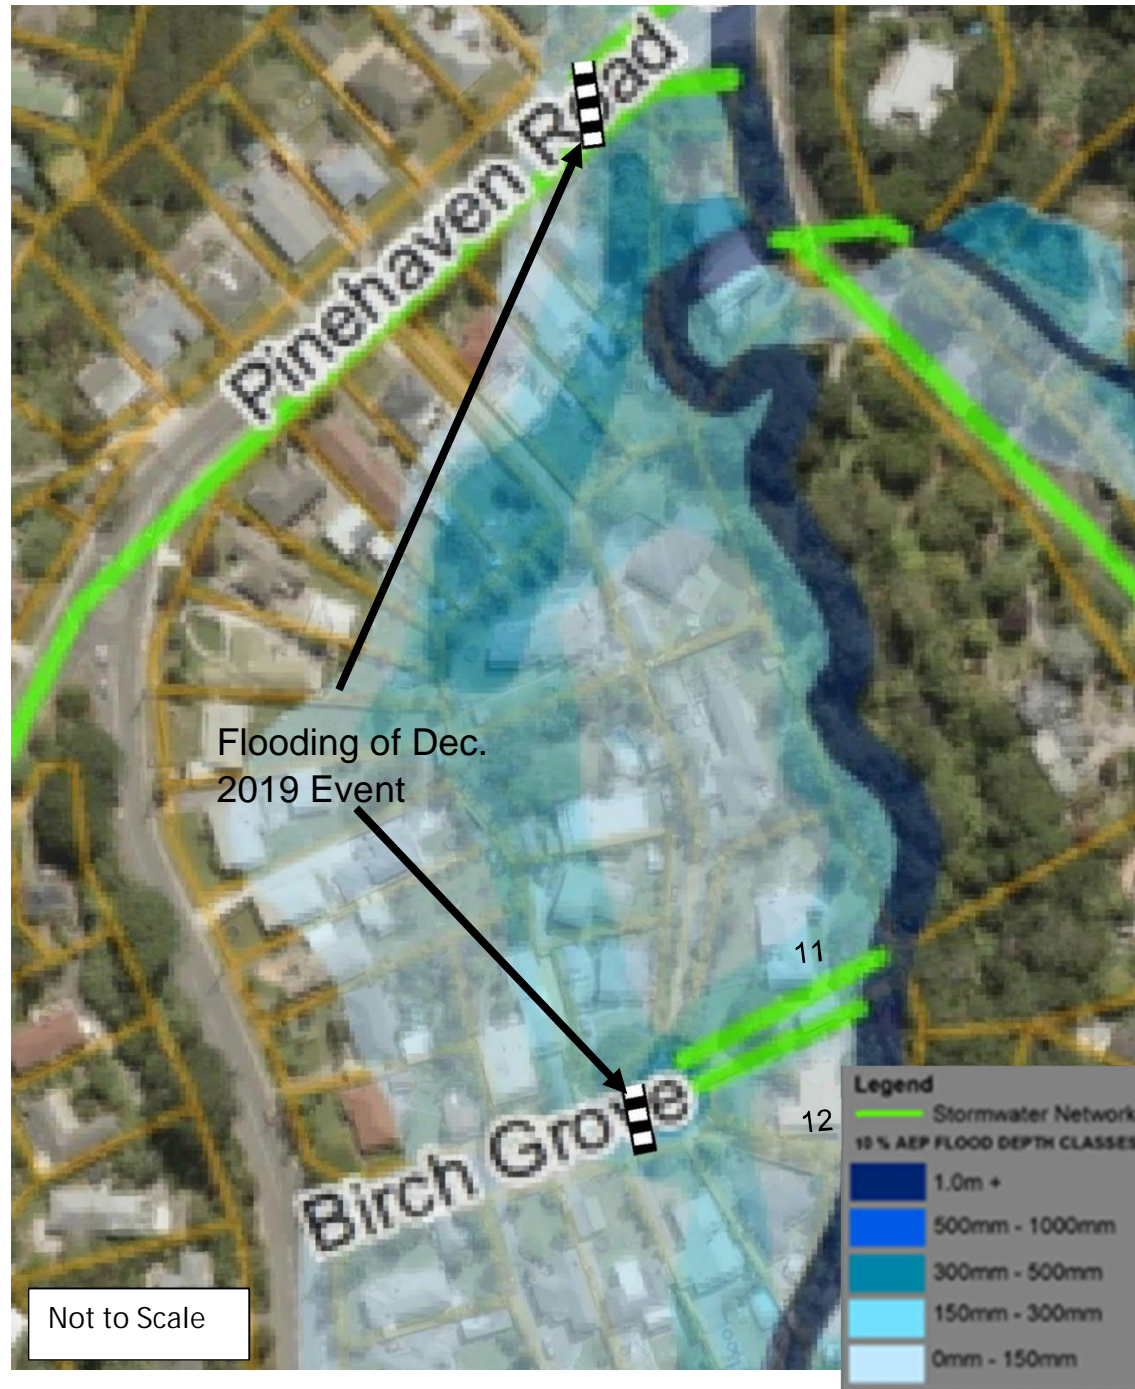
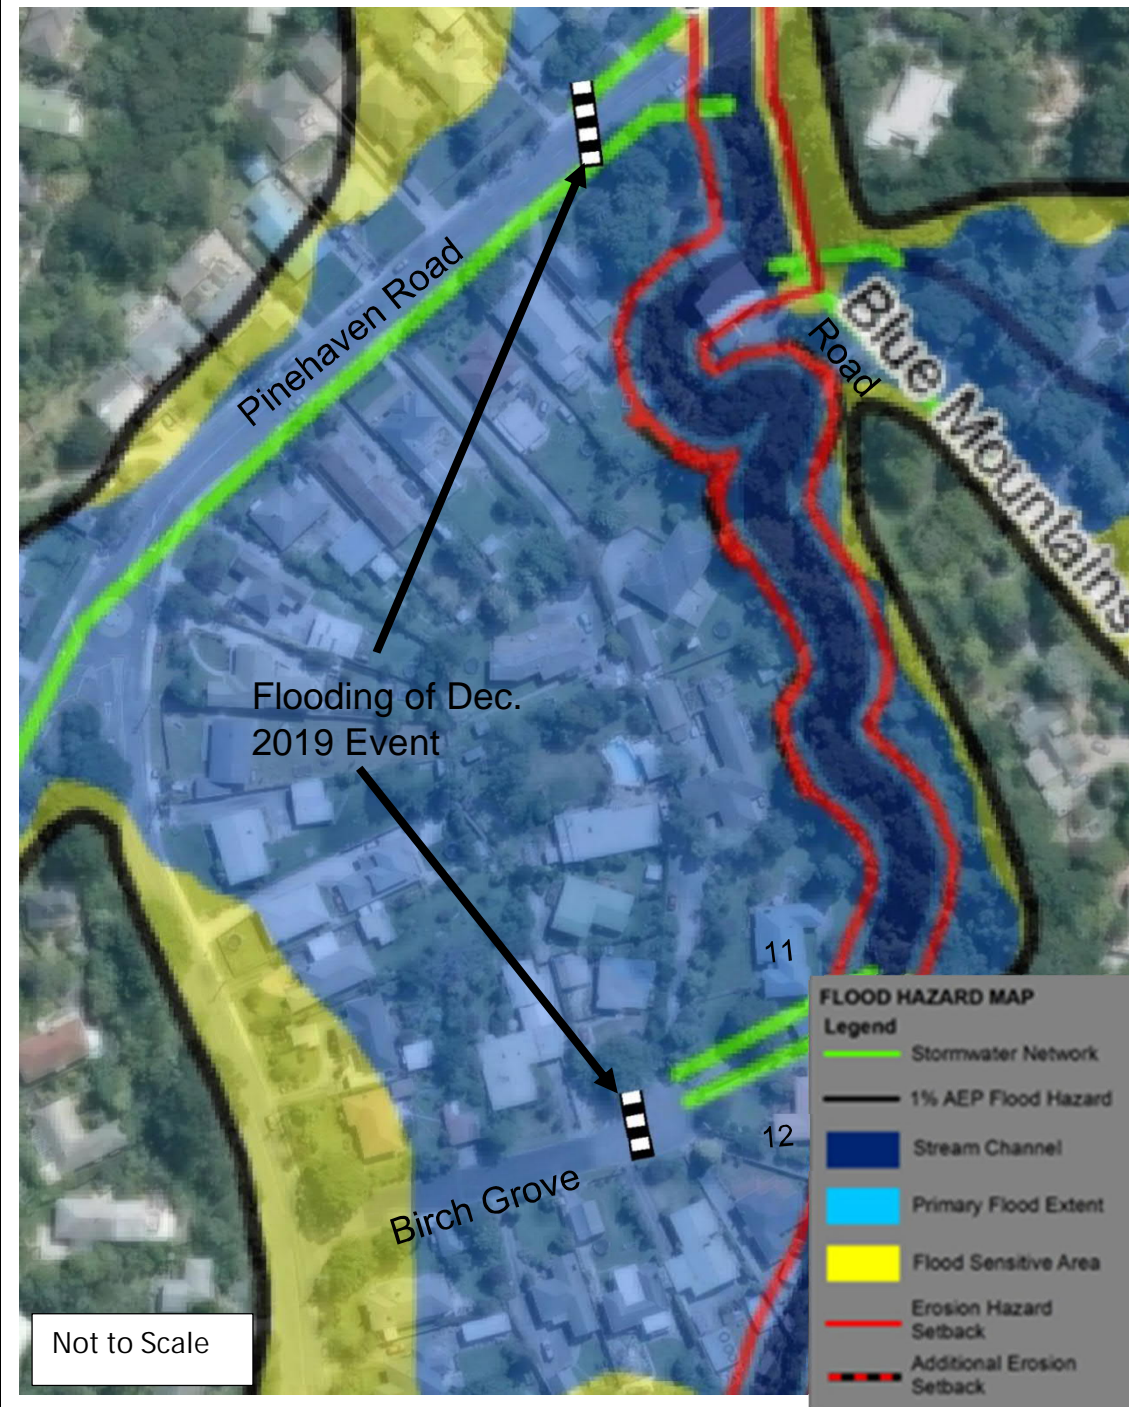
Between Birch Grove and Pinehaven Road:

The flooding photographed at 11 and 12 Birch Grove is predicted in both the 10-year and 100-year model flood extent. The photographs do not show how far along Birch Grove the flooding extended. Debris photographed at Pinehaven Road on the true left bank of the Stream is approximately at the 10-year model flood extent.

In this section of the Stream the observations indicate flooding was at least as extensive as the model 10-year flood extent.

Comparison of December 2019 Event Flooding with 10% AEP Event

Comparison of December 2019 Event Flooding with 1% AEP Event

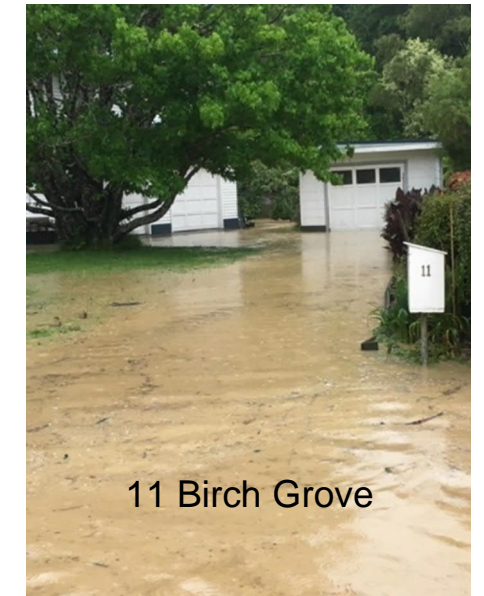
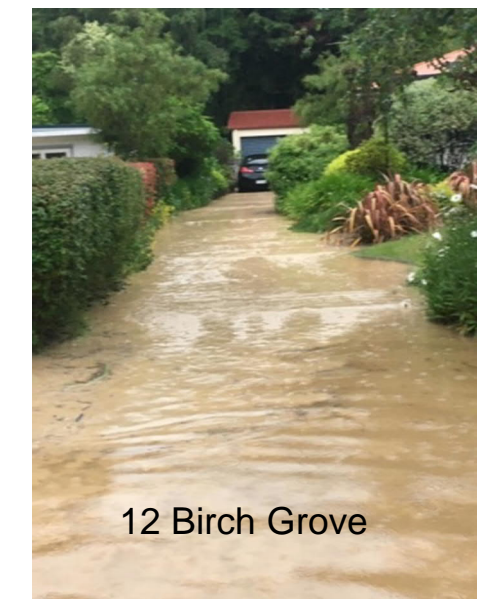
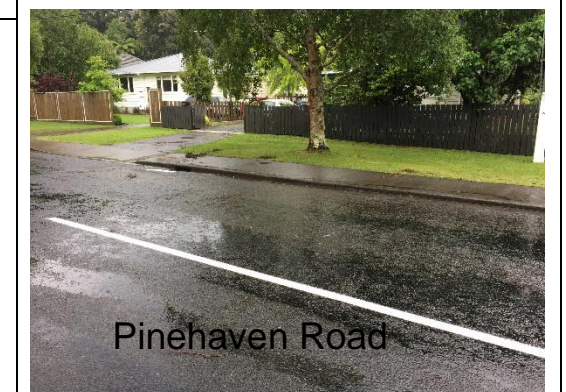
Flooding at 11 and 12 Birch Grove during December 2019 event:

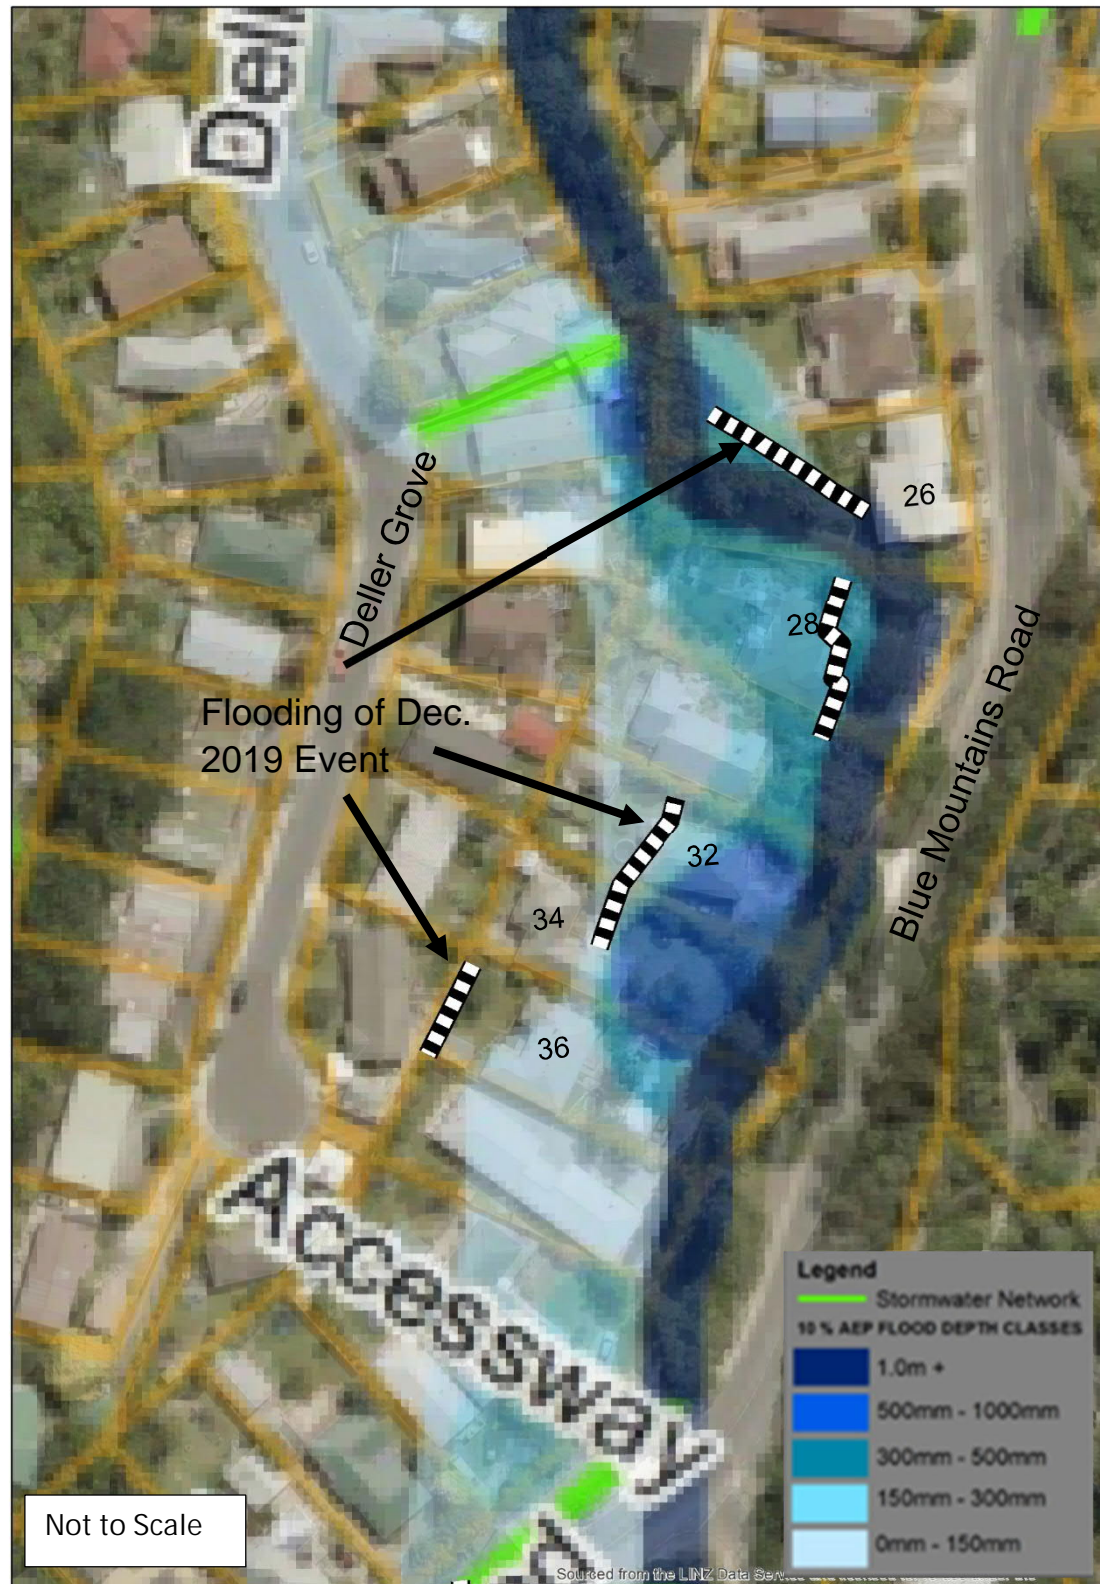
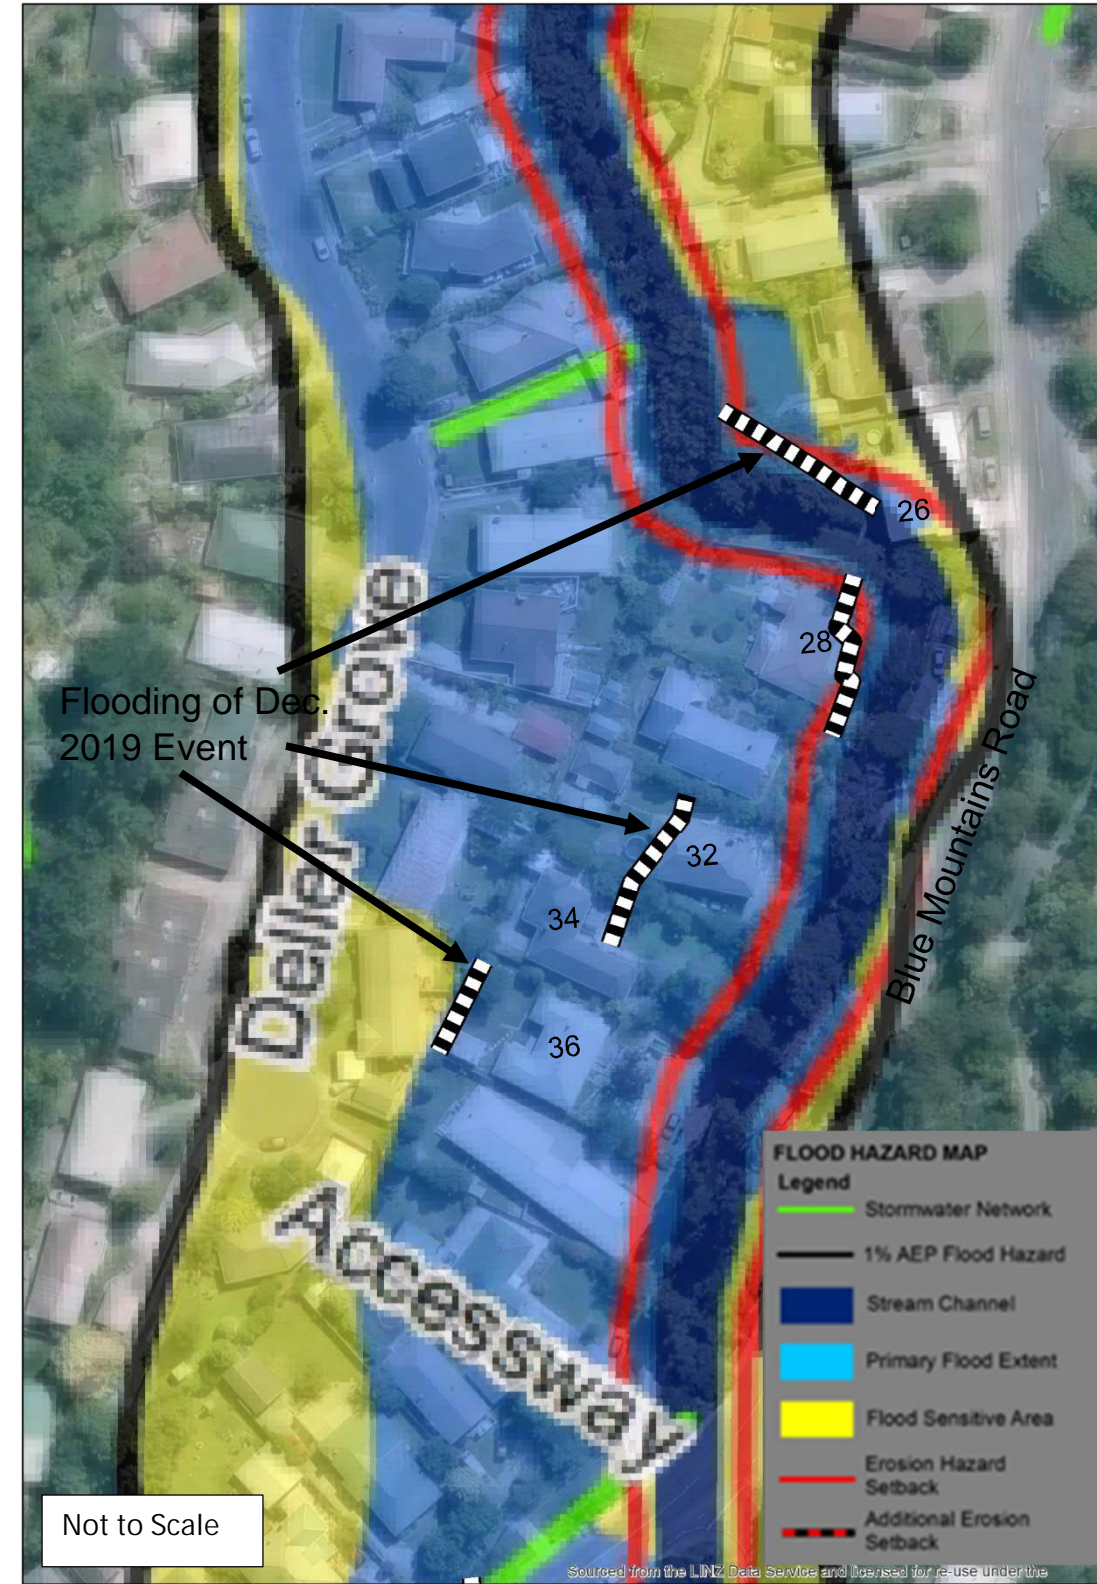
Between 26 and 36 Blue Mountains Road:

The flooding and debris recorded at No. 36 Blue Mountains Road appears to be consistent with the model 100-year flood extent. At Nos. 26, 32 and 34 Blue Mountains Road the records appear to be consistent with the model 10-year flood extent. At No. 28 the extent of flooding to the rear of the property cannot be established from the photographs – evidence of flooding to the front of the property is within the model 10-year and 100-year flood extent.

In this section of the Stream the observations suggest the flooding lies between the model 10-year and 100-year flood extent.

Comparison of December 2019 Event Flooding with 10% AEP Event

Comparison of December 2019 Event Flooding with 1% AEP Event

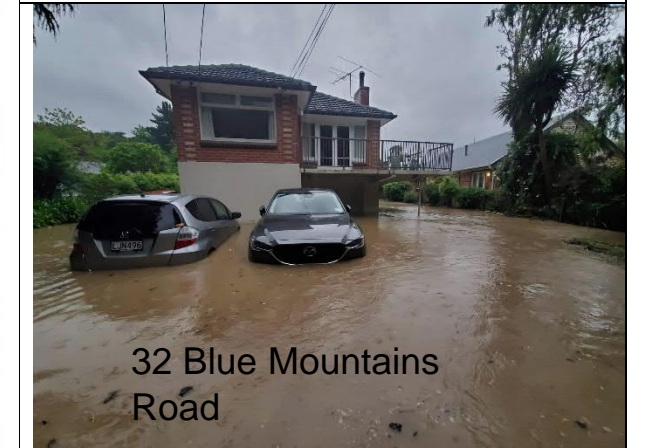
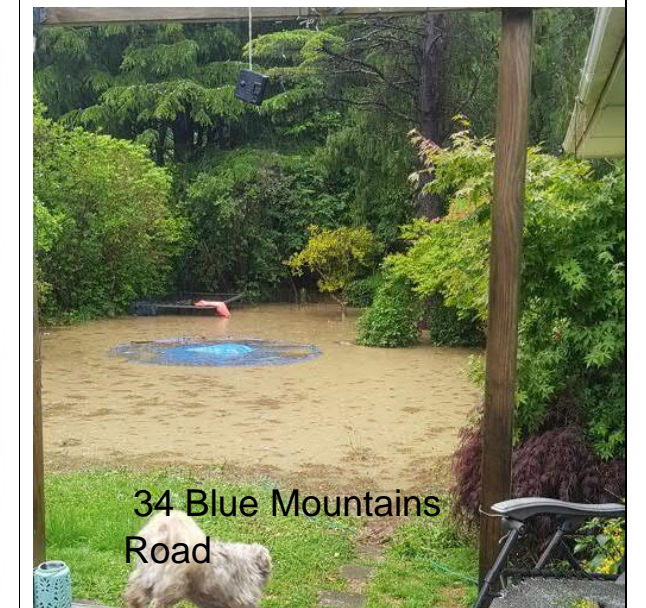
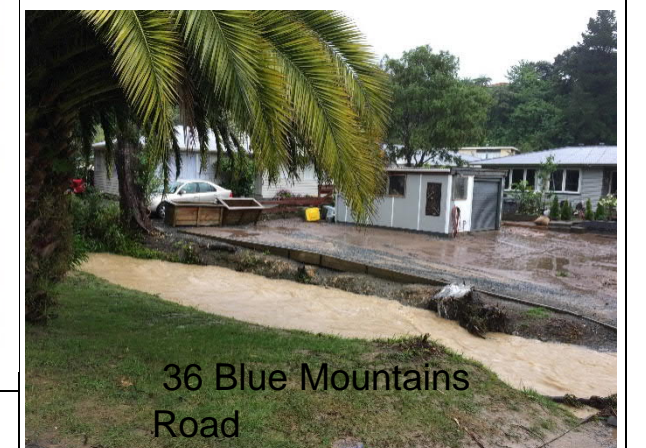
Flooding at 32, 34 and 36 Blue Mountains Road during December 2019 event:

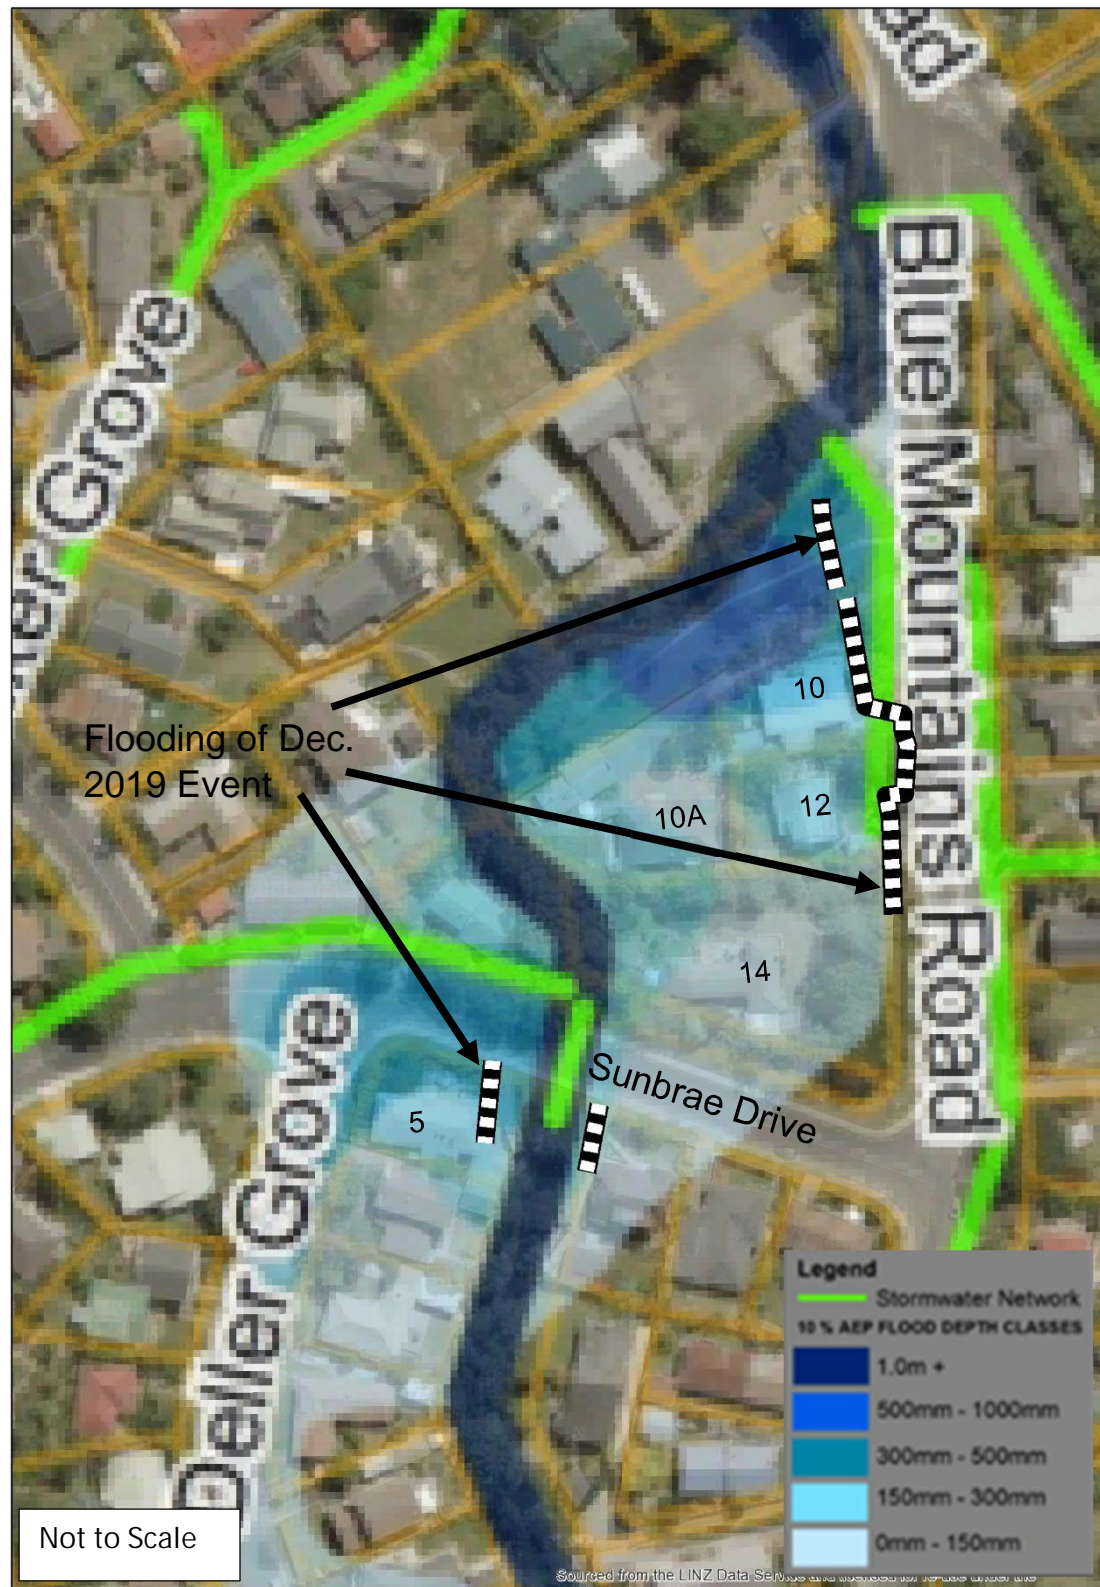
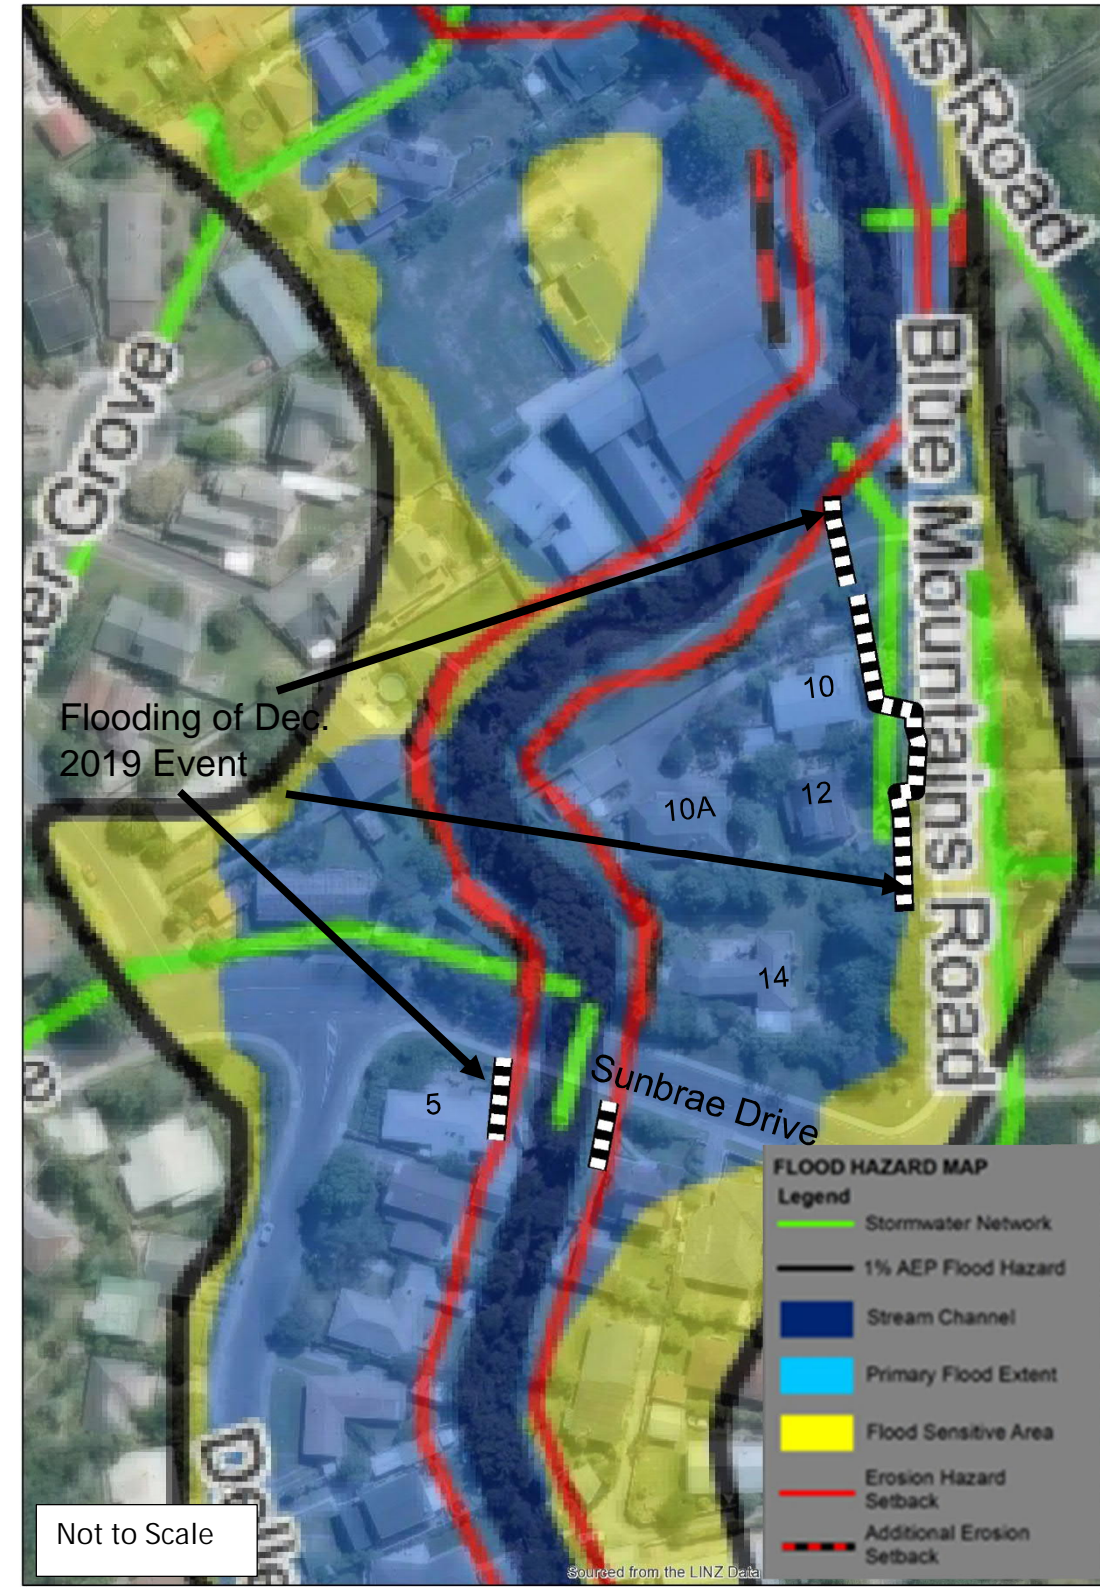
Between Sunbrae Drive and Willow Park:

Debris recorded on the south side of Sunbrae Drive appears to be consistent with the model 10-year results for deeper flooding. However, the extent of flooding along the road is not clear from the photographs. Recorded flooding at Nos. 10, 12 and 14 Blue Mountains Road appears similar to both the model 10-year and model 100-year flood extents. Flooding is contained at this location by the rise in ground level along Blue Mountains Road. In Willow Park, the debris recorded appears to be consistent with the model 10-year extent.

In this section of the Stream the observations suggest the flooding lies between the model 10-year and 100-year flood extent.

Comparison of December 2019 Event Flooding with 10% AEP Event

Comparison of December 2019 Event Flooding with 1% AEP Event

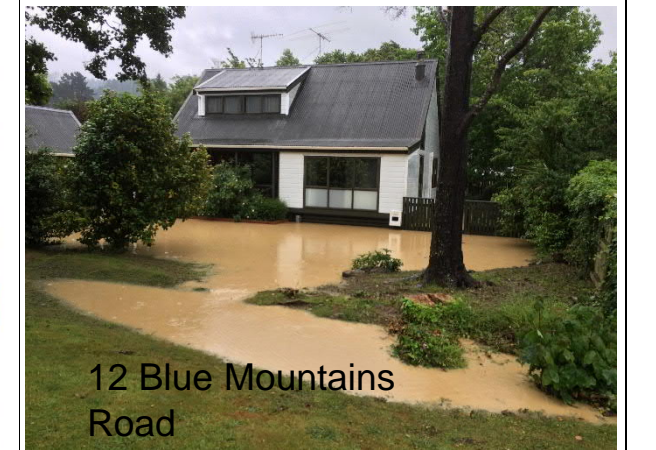
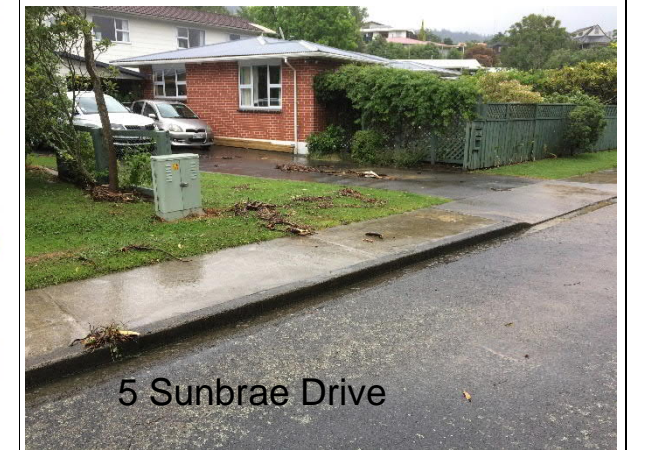
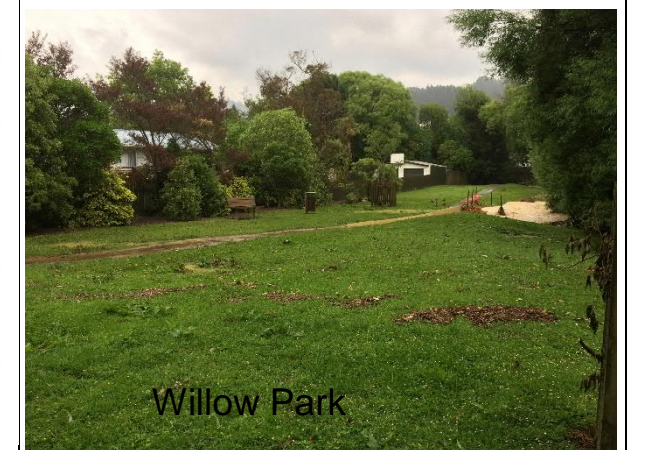
Flooding at 12 Blue Mountains Rd, 5 Sunbrae Dr and Willow Park during December 2019 event:
