Our ref: 773-WLGGE225406AE-RevB

Mangaroa Peatlands Extent - Mapping Update

Upper Hutt City Council (UHCC) requested Tetra Tech Coffey (NZ) Ltd refine the southern extent of the Mangaroa Peatlands in the area around Katherine Mansfield Drive, Upper Hutt as outlined in Tetra Tech Coffey's proposal "Mangaroa Peatlands Extent – KMD" dated 18 November 2021.

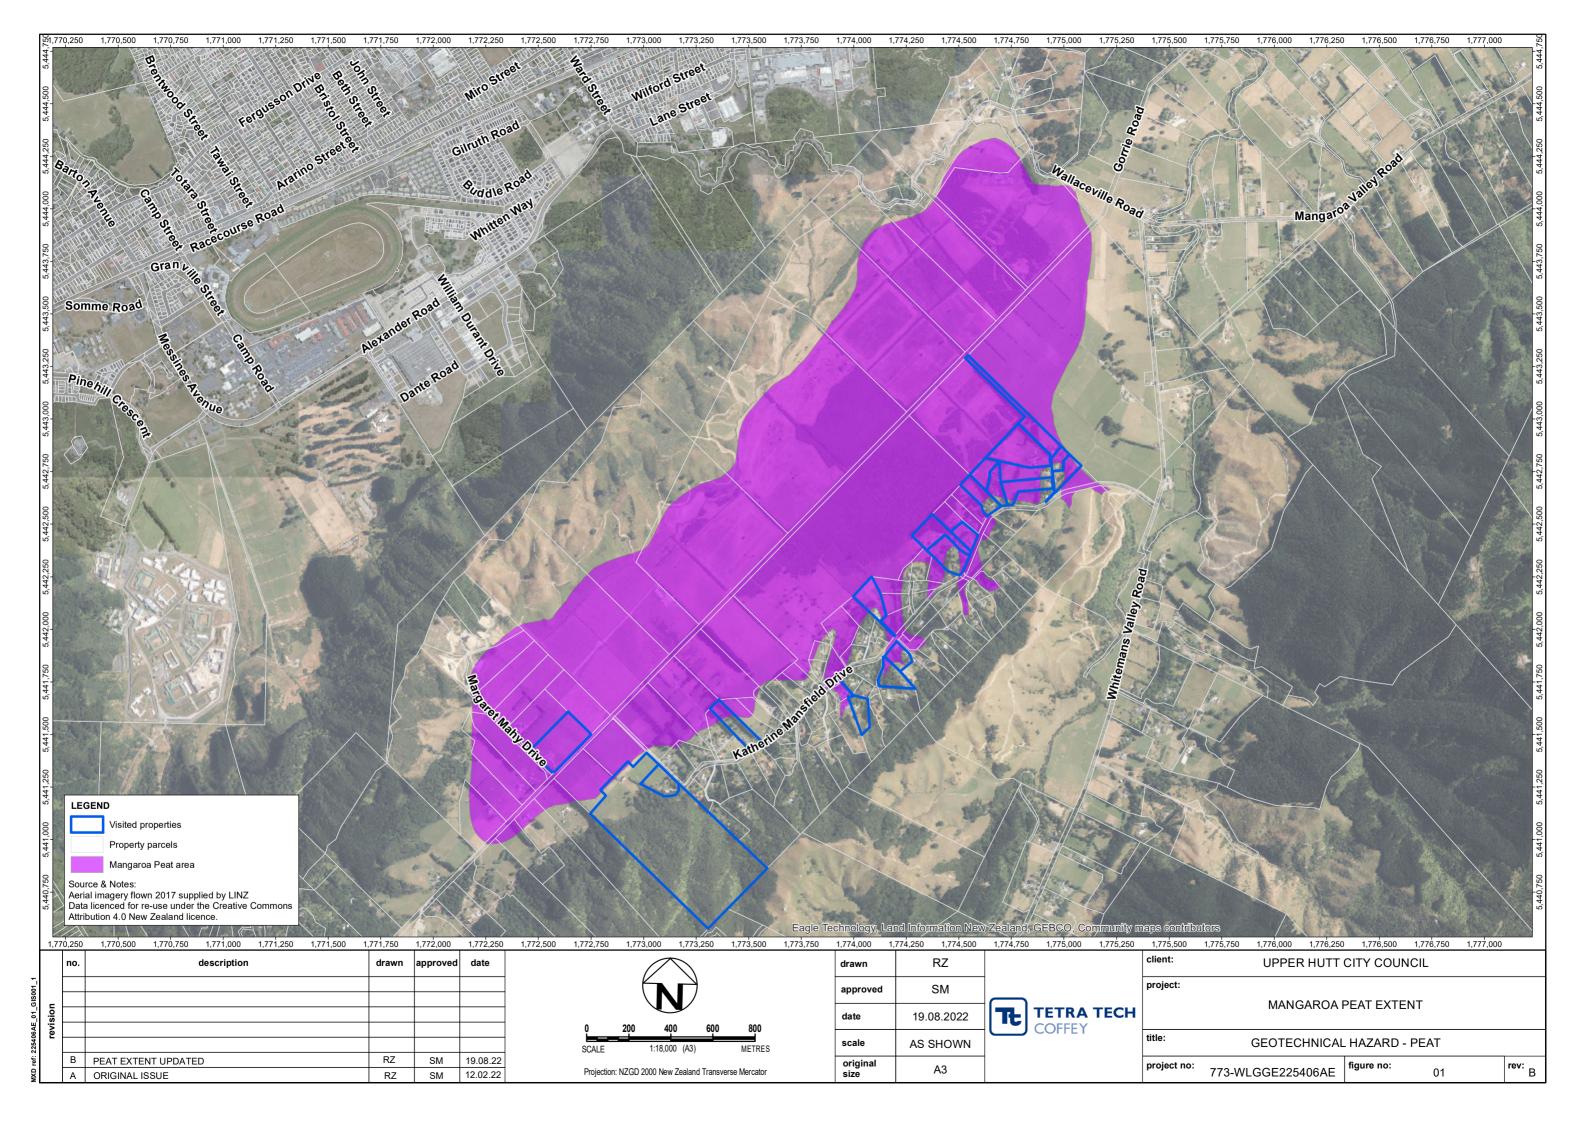
Figure 1 – Geotechnical Hazard – Peat (pdf and GIS file)

The extent of this peat hazard overlay has been determined based on the area mapped as peat in the Geology of Wellington 1:50 000 Map¹. Katherine Mansfield Drive runs near the south-eastern boundary of this peat overlay, crossing some mapped peat areas. Some of the rural-lifestyle properties in the area overlap the peat overlay area. During the consultation process, some residents have provided submissions relating to the location of the Mangaroa Peat Overlay on their property. Discussions with Upper Hutt City Council (UHCC) have determined that a site walkover with access to relevant properties be undertaken to refine the southern boundary of the peatland extent.

We assess that the revised peatland extent map is sufficient for an area-wide assessment. Site specific intrusive investigation could be undertaken for proposed dwellings within the mapped peatland area to confirm the presence and/or extent of peat and determine the geotechnical hazard and mitigation measures on a case-by-case basis.

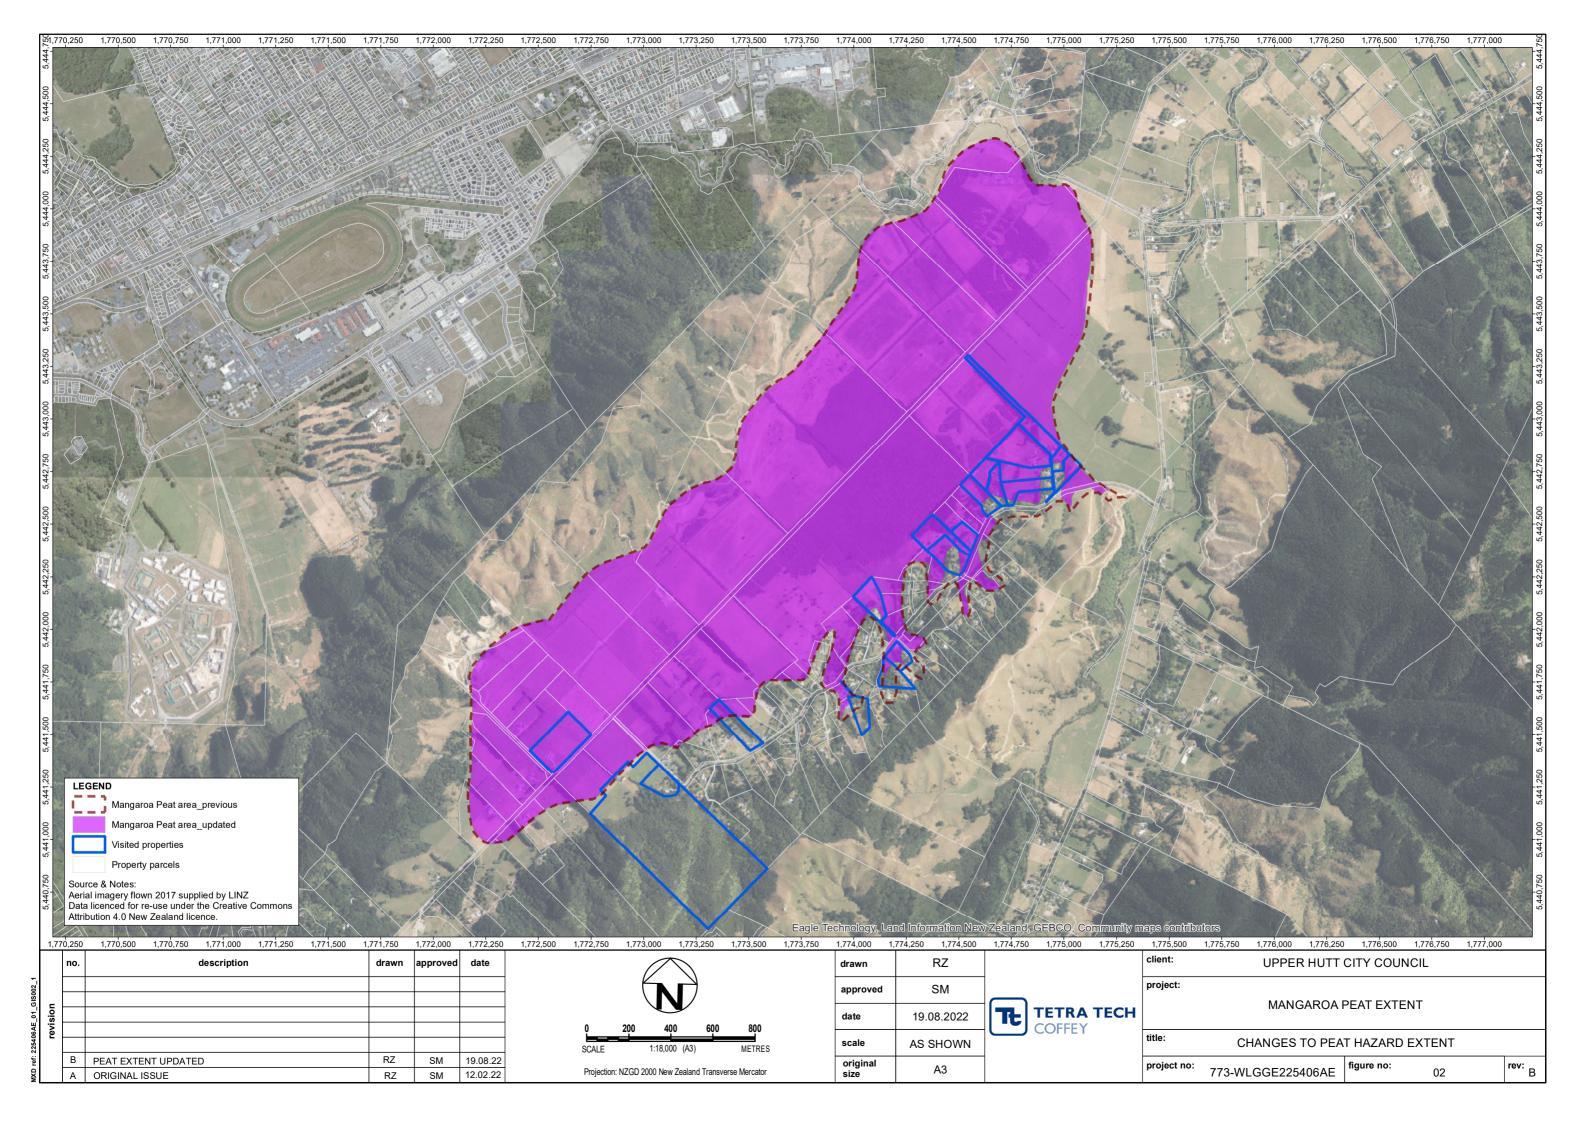
Figure 2 – Changes to peat extent

The peatland boundary was only adjusted where there was clear evidence that areas currently mapped as peat were likely not peat. The following key criteria was the basis of the adjustment of the peat extent:

The following table summarises the properties where the peat boundary has been adjusted.
