1980s Significant Drainage Upgrade

Save Our Hills (Upper Hutt) Inc.

Current 1-in-100 year flood maps don't show any benefit from “significant work” in the 1980s (after 1-in-100+ year flood in 1976) to improve stormwater drainage in Pinehaven and Silverstream; this work doubled the capacity of the drainage network and should result in less flooding in future.

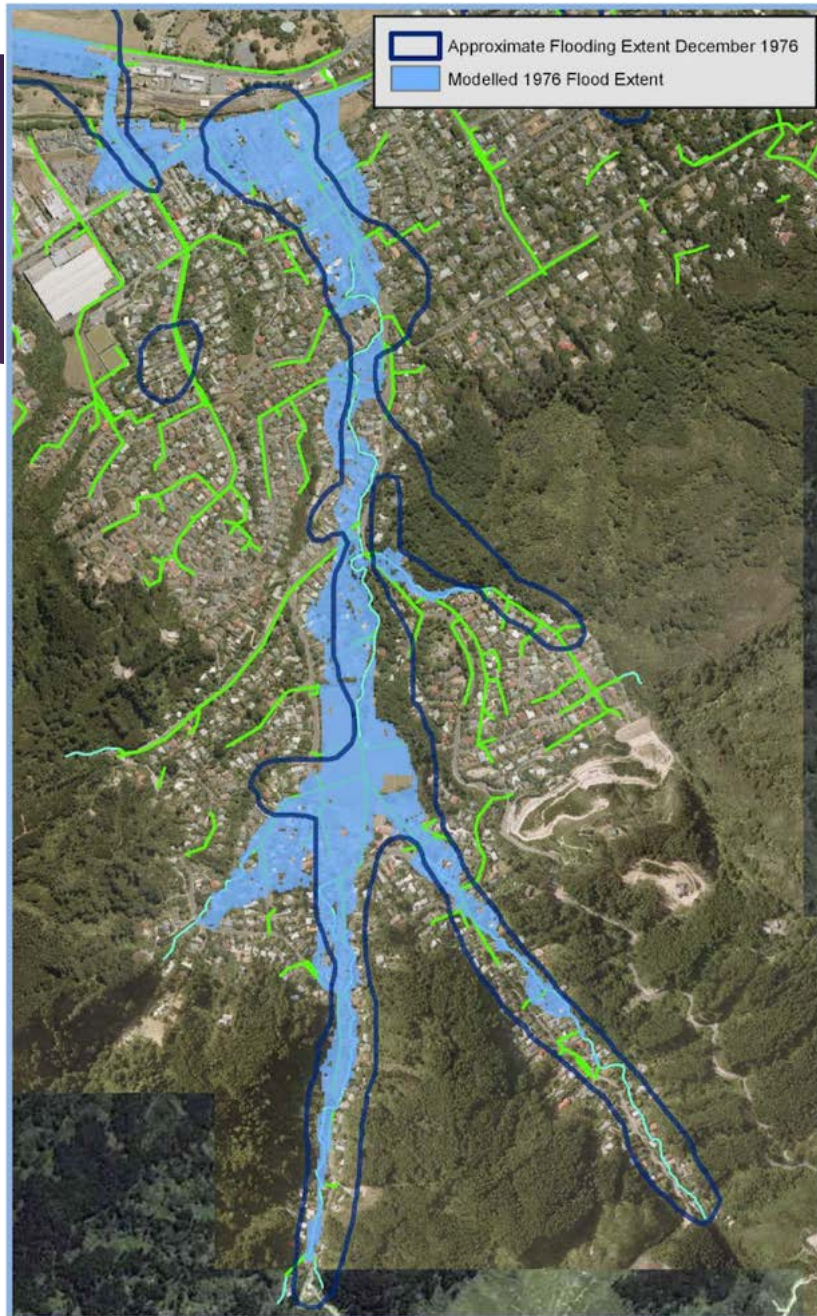
Pinehaven Stream Flood Hazard Assessment_May 2010
Rev E_Vol 1_Figure 14, p24

The public have only seen this Figure 14 (opp.) comparing a reduced version of GWRC 2010 map with a slightly enlarged version of the 1976 map.

Eg. Fig. 14 shows less blue around Silverstream and around Jocelyn Cres than in the previous slide, and no blue to Chichester Dr or up Wyndham Rd.

The public is misled by Fig. 14 to believe that GWRC's 2010 1-in-100 year flood modelling is correct because it roughly matches the 1976 flood. In actual fact, it exceeds the 1976 flood extent.

■ Figure 14 Comparison of 1976 and Modelled Flood Extents

If Figure 14 was drawn correctly, it would be less convincing that GWRC's flood modelling matches the 1976 flood extent

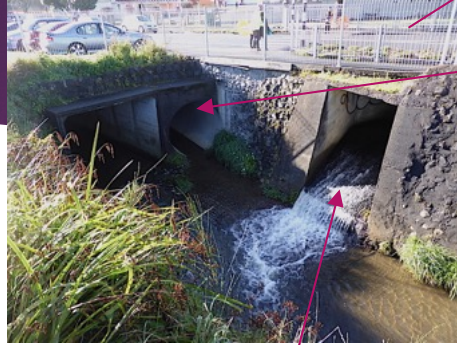
Pinehaven Stream
discharging into
Hulls Creek

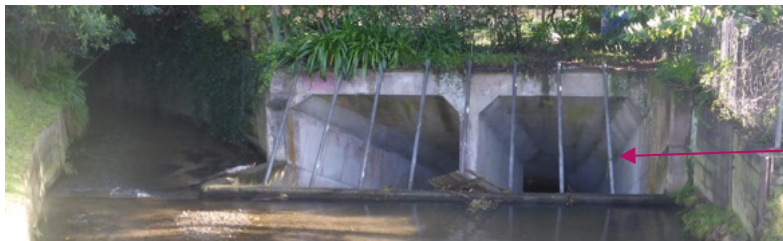
Overflow bypass
built in 1980s

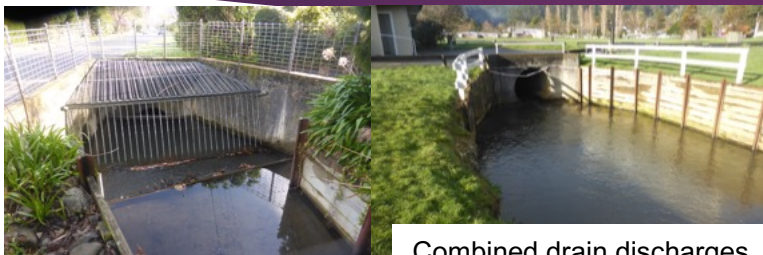
Open stream feeds holding pond on lower field

Overflow bypass built in 1980s at 105 Pinehaven Road

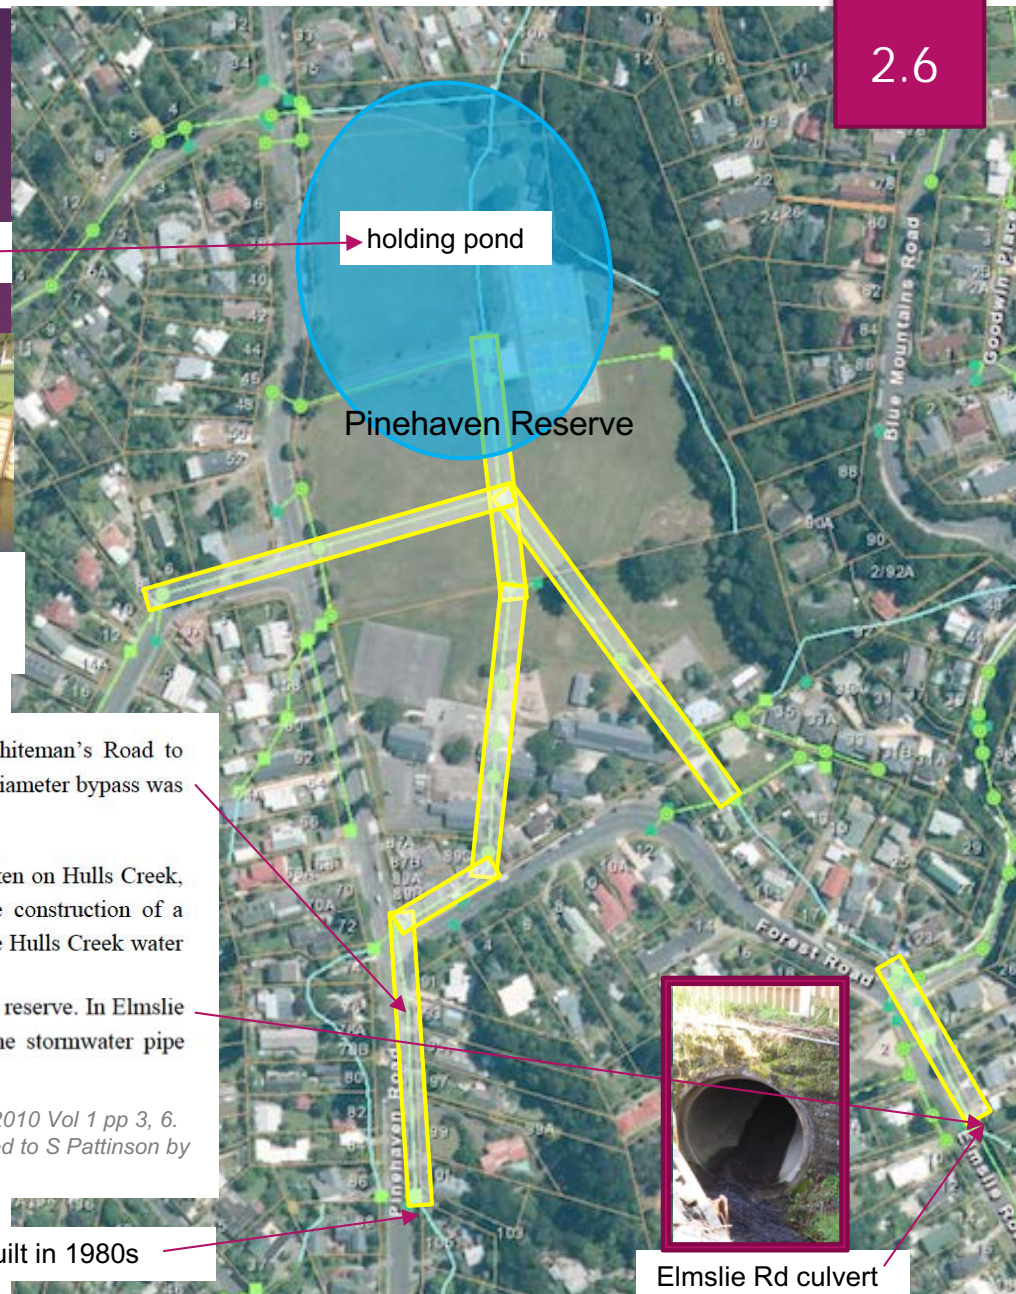
Combined drain discharges to open stream & ponding area in Pinehaven Reserve

This event led to the construction of a 2100mm diameter bypass under Whiteman's Road to provide protection against a 50 year event (UHCC, 1983). A smaller 1200mm diameter bypass was also constructed in Pinehaven Road upstream of Pinehaven Reserve.

An overflow bypass in Pinehaven Road also drains into the pipe network in the reserve. In Elmslie Road the stream passes beneath Forest Road in a culvert before entering the stormwater pipe network in Pinehaven Reserve.

Overflow bypass at 105 Pinehaven Road built in 1980s

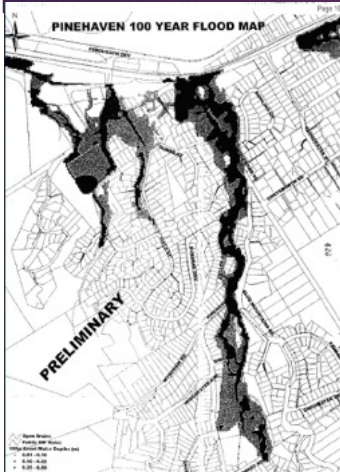
UHCC flood map (2005)

UHCC 100 year flood map 2005 (above) shows flooding only as far as Pinehaven Reserve, and as might be expected following improvements to drainage in the 1980s.
