Prepared for Maymorn Developments Ltd

Gabites Block: Archaeological Assessment

Gabites Block, Maymorn Road, Upper Hutt

October 2021

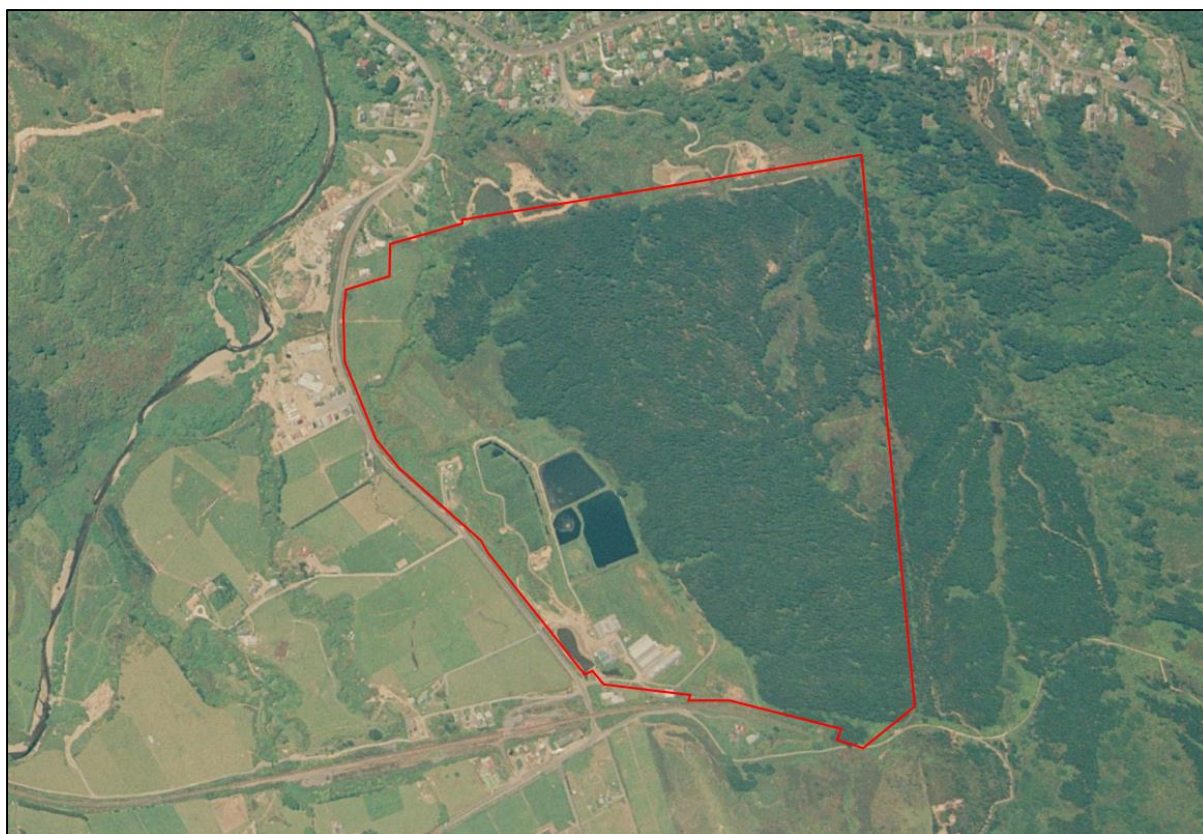
Figure 4: Aerial image of the property taken in 2000, showing the change in use of the flat terrace, and the modification of the terrain. Image from Retrolens.

During the latter half of the 20th century the property has undergone significant modifications to the terrain, particularly on the flat terrace area adjacent to Maymorn Road. This terrace area on the western side of the study area originally had a stream running through the middle of it via a substantial gully (see Figure 3). During the 1960s and 70s the terrace and gully was infilled with material possibly taken from the hillsides to the north and east and three holding ponds were formed (see Figure 4). The stream was routed in a straight line across the terrace. The land was allegedly used for pig farming during this period.

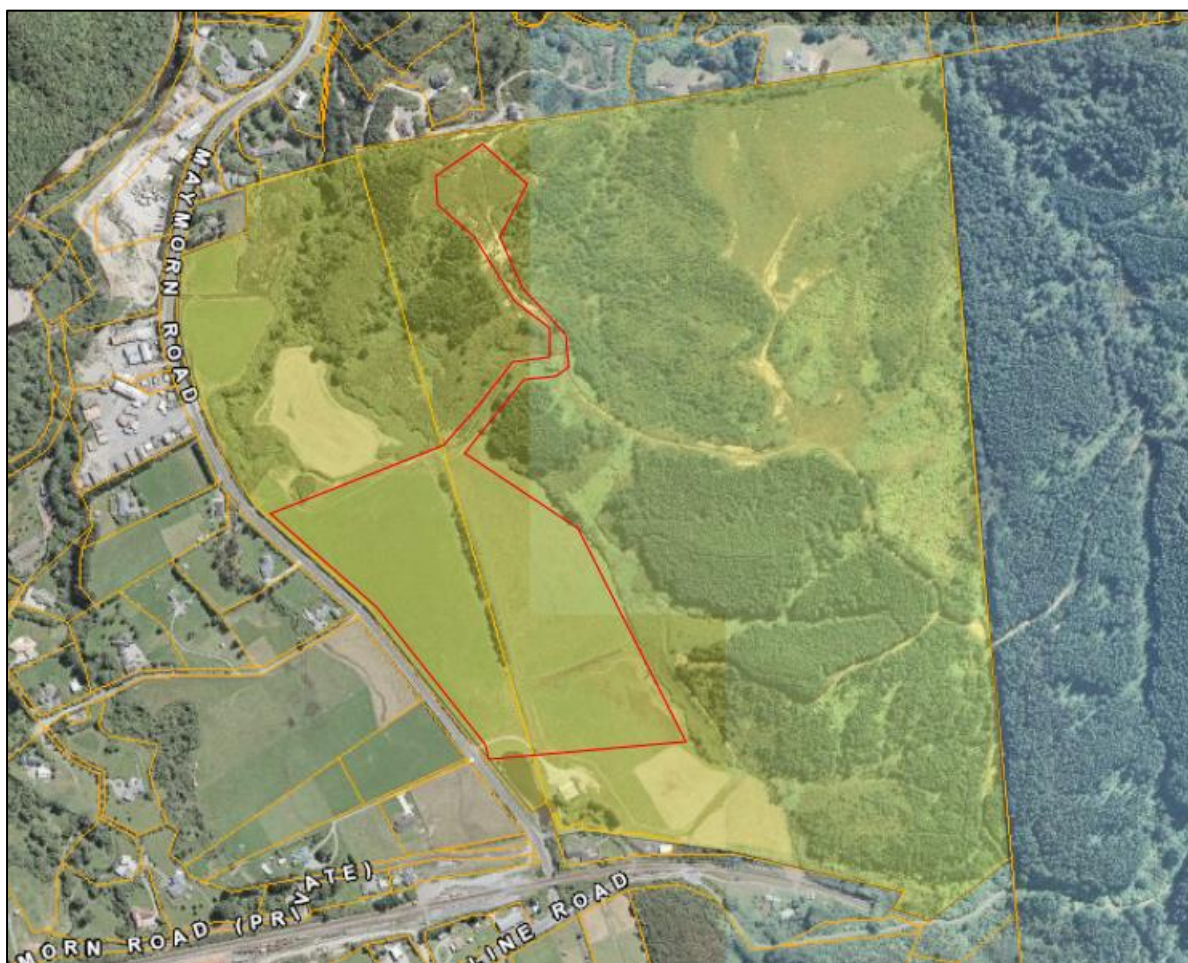
The site was visited by the author Emily Howitt and Jamie Gillies of Gillies Group Management Trust on 4 October 2021. The site was accessed via four-wheel drive. The northern point on the ridge closest to the recorded archaeological site was visited and inspected, as was the lower terrace (Figure 6). The hilly area in the eastern half of the property was not visited.

Figure 6: The area inspected during the field survey (shown in red).

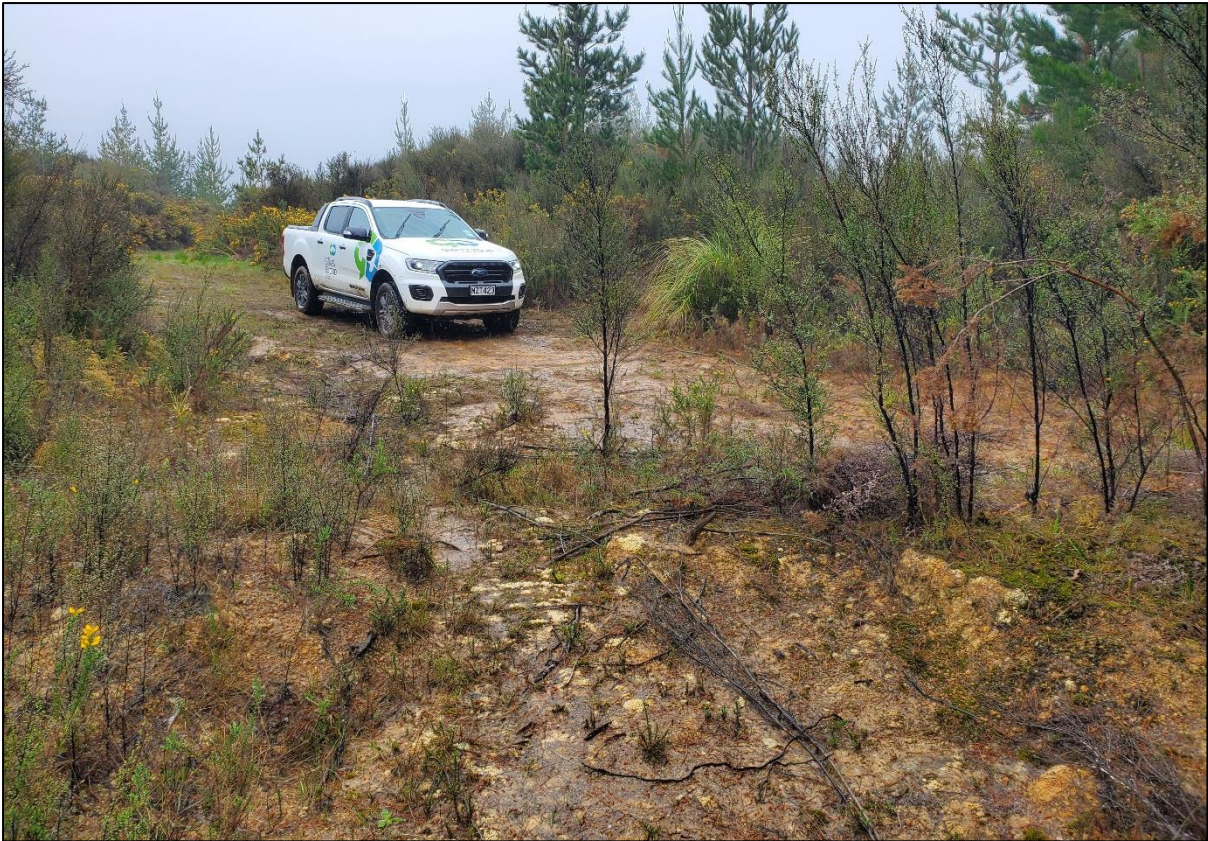
The ridge showed visible evidence of having undergone significant ground reduction. The ridge appears to have been artificially levelled (Figure 7). The exposed soil observed on the ridge was natural yellow clay indicating the topsoil had been removed. At the edge of the ridge a cut bank approximately 1.5m high shows the extent of the ground lowering (Figure 8). It is probable that material removed from the ridge was used to level and infill the flat terrace adjacent to Maymorn Road, including filling and rerouting the stream and forming the holding ponds for the pig farming operation from the 1960s onwards (Figure 9).

There was clear evidence of significant modern ground disturbance on both the ridge and the terrace. The use of the terrace for farming pigs is also likely to have destroyed any archaeological features that may have been present on the terrace. It is likely that any physical remains of archaeological sites, if they were ever present, were destroyed during earthworks to lower the ridge, fill in the stream gully and flatten the terrace.

Figure 7: The northern end of the ridge, closest to the recorded archaeological site, looking south. Note the lack of topsoil.

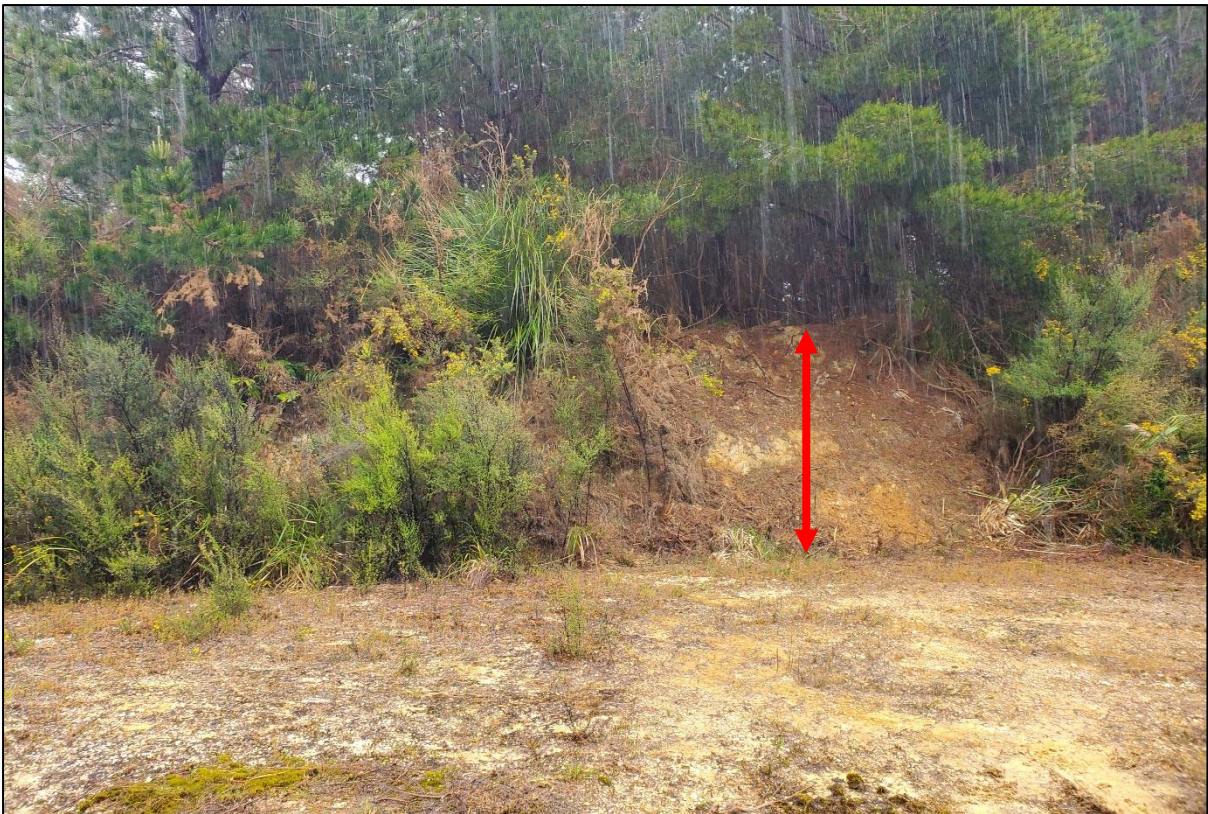
Figure 8: The western edge of the ridge showing the extent of the cut that has occurred to lower the ground level and presumably remove material for deposition on the terrace.

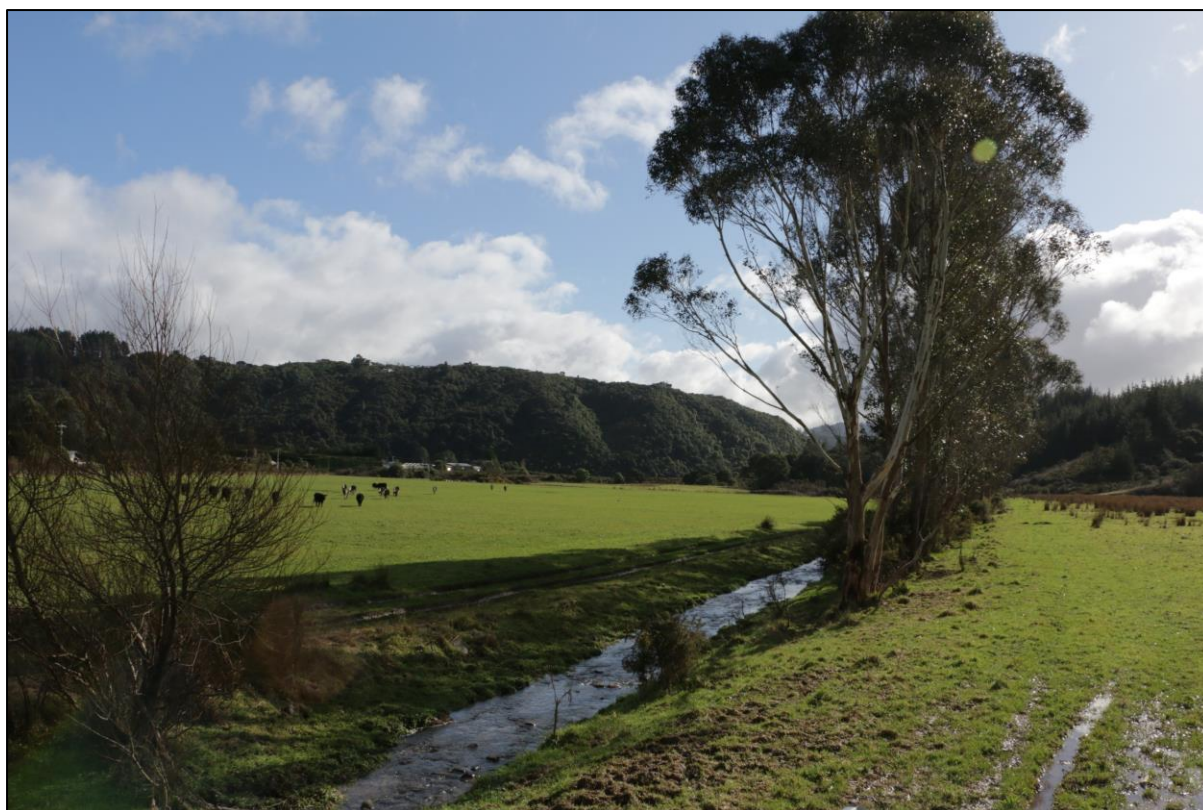
Figure 9: The southern end of the flat terrace showing the stream through the middle of the area. Image supplied by client.
