# **Attachment 5: Geotechnical Assessment**

**Project Number #19071.000.001**

## **Geotechnical Investigation**

Gabites Block, Upper Hutt

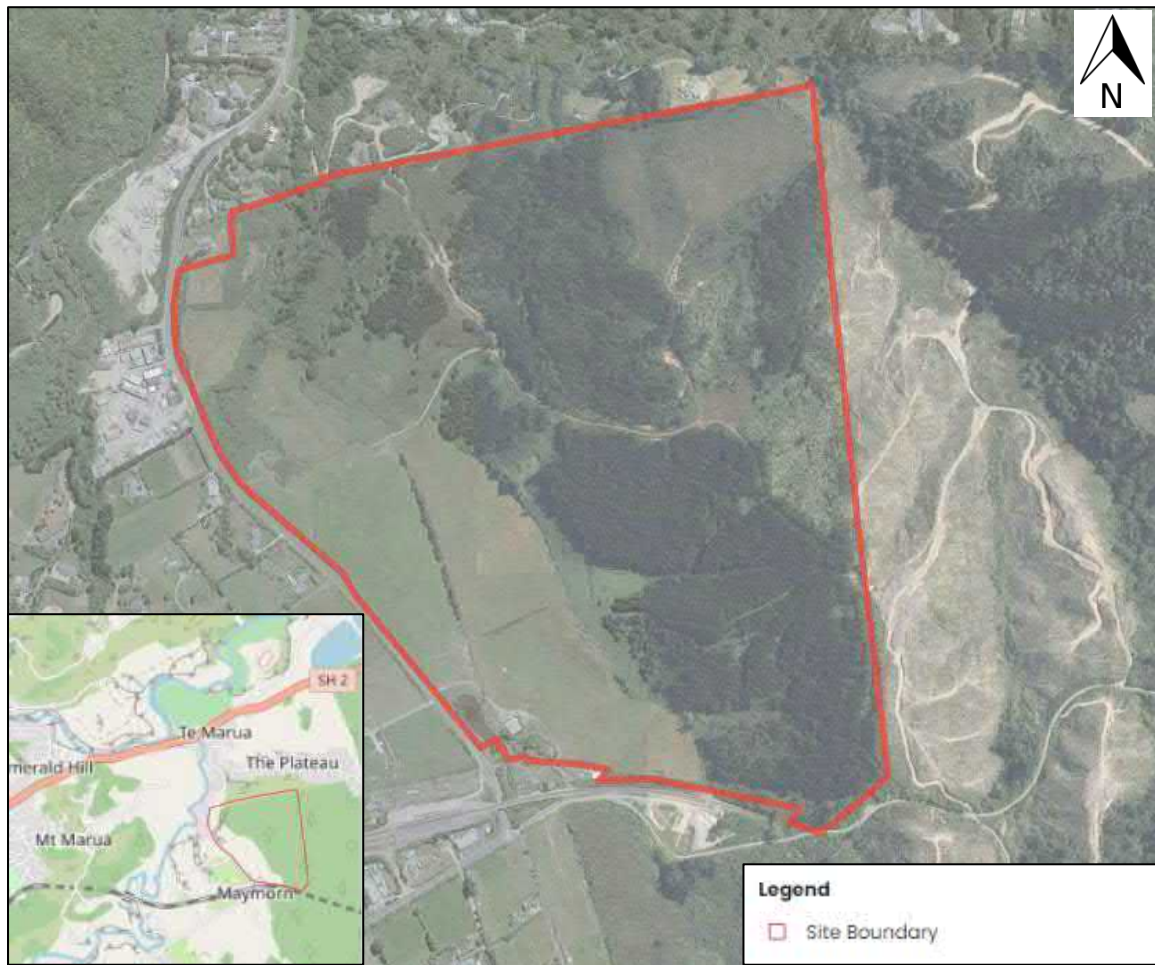
**Figure 1: Site Location Plan**

The proposed development site is located within Maymorn, Upper Hutt and covers an area of 74 ha (Upper Hutt City Council, Xplorer (Public), Property Boundaries & Labels; retrieved October 2021). It is bound by Maymorn Road to the west, the Wairarapa Rail Line and Rimutaka Tunnel to the south, forestry land to the east and residential properties to the north. A site location plan is presented in Figure 1.

Site location plan created using datanest, with aerial photograph from Land Information New Zealand (photography date not specified).

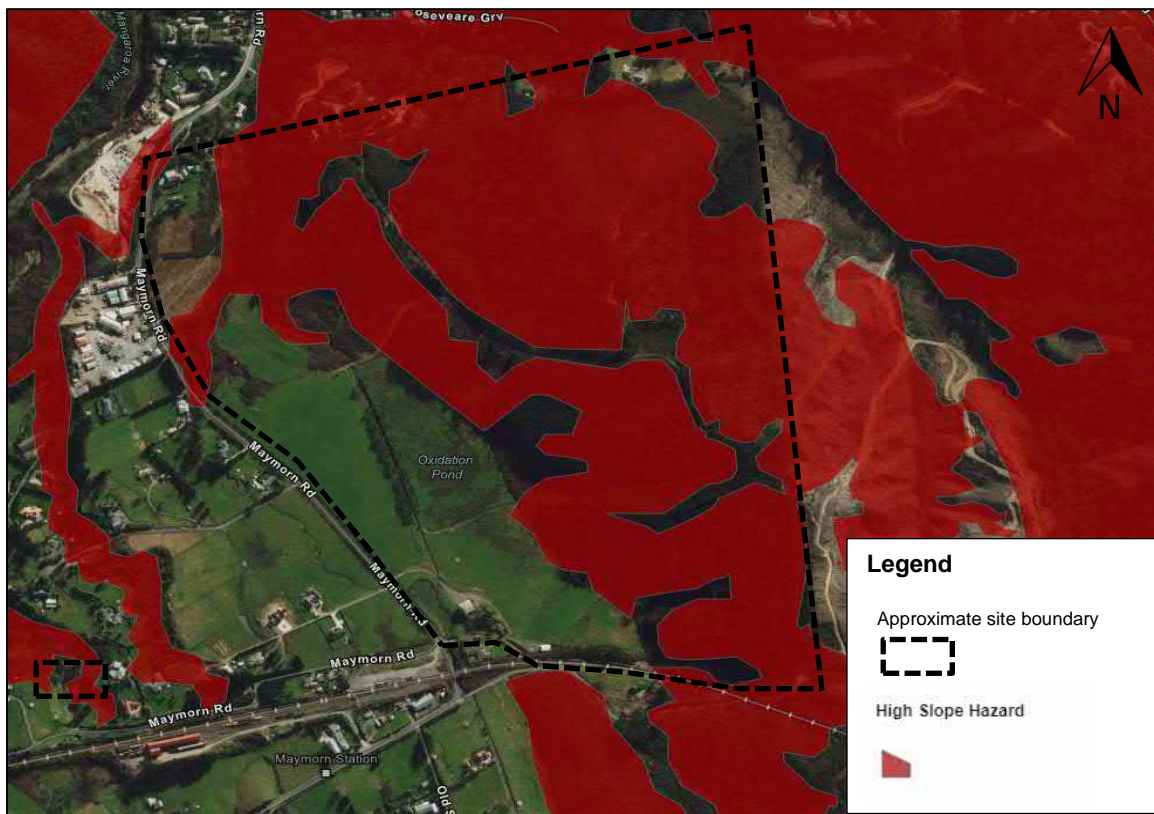
**Figure 4: UHCC Proposed District Plan High Slope Hazard Mapping**

Upper Hutt City Council are in the process of updating the district plan, to address the risk from natural hazards. Plan Change 47 includes a map of areas subject to high slope hazards. Figure 4 shows an excerpt from this mapping, which indicates that the majority of the hill areas of the site (including the banks of the stream channel) are considered to be within the high slope hazard area. Within these hazard areas, Upper Hutt City Council note that “new building platforms in this area have the potential to impact the stability of the hillside”. Plan Change 47 indicates that specific geotechnical assessment and design will be required in conjunction with development of these areas.

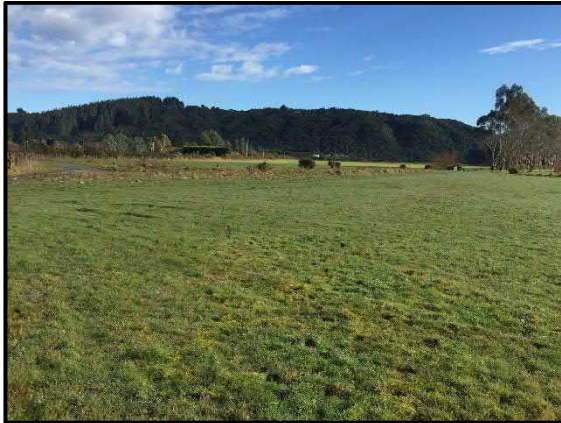
Photo 1: Broadly flat paddocks across the western side of the site used for cattle grazing. Photograph taken facing northwest.

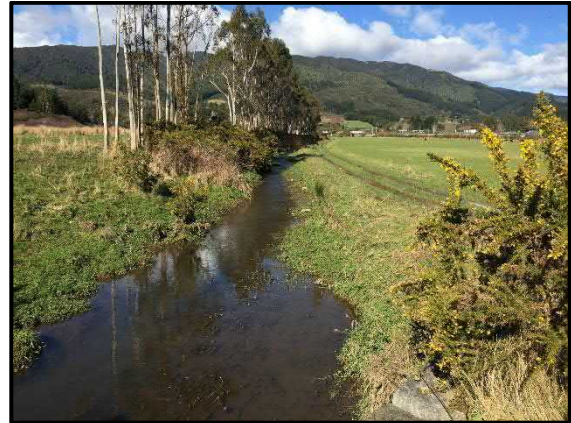
- Standing water and poor drainage with the growth of rushes was observed across much of the flat areas. Generally drier ground conditions were encountered to the west and north, moving away from the base of the hills.

Photo 2: Drainage feature on western side of site. Photograph taken facing south.

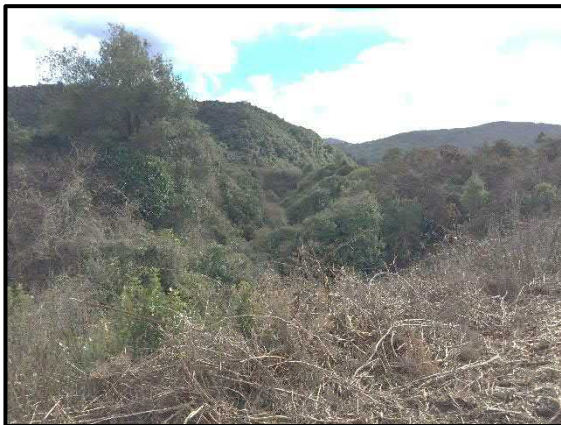
Photo 3: Western branch of the meandering river channel.

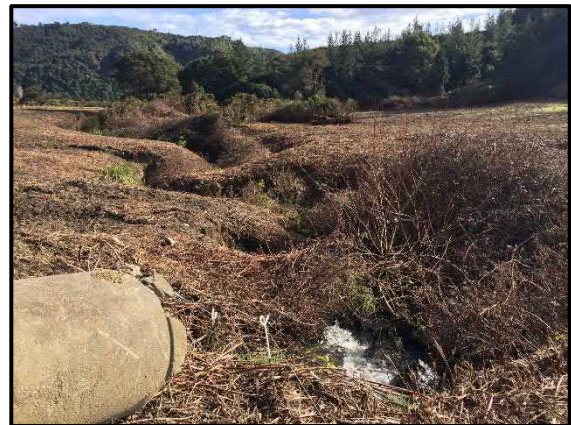
Photo 4: Eastern branch of the meandering river channel.

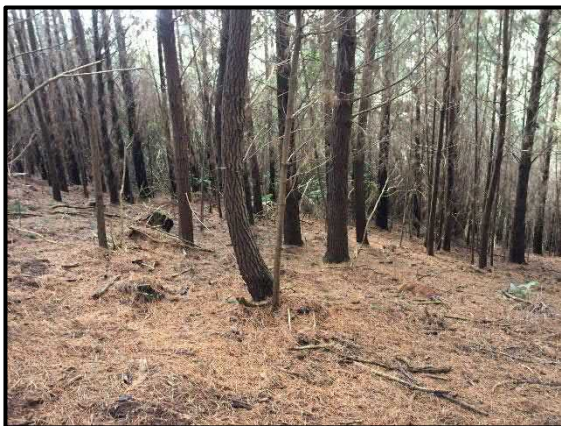
- Evidence of local instability is present in some areas as indicated by the bowing shape of isolated tree trunks (Figure 5 – Photo 5).
  - An area of recent instability was observed at the base of the hills (Figure 5 – Photo 6). The toe of the slope appears to have been previously cut and over-steepened. The cut-slope has recently failed with a headscarp located approximately 8 m above the adjacent paddocks, measuring approximately 4 m wide. The debris lobe at the toe of the slope extended approximately 12 m wide.

Photo 5: Local instability indicated by bowed tree trunks.

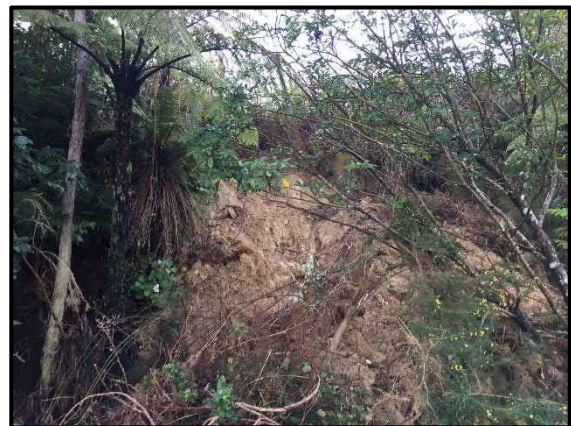
Photo 6: Recent instability on a previously cut slope at the toe of the hills.

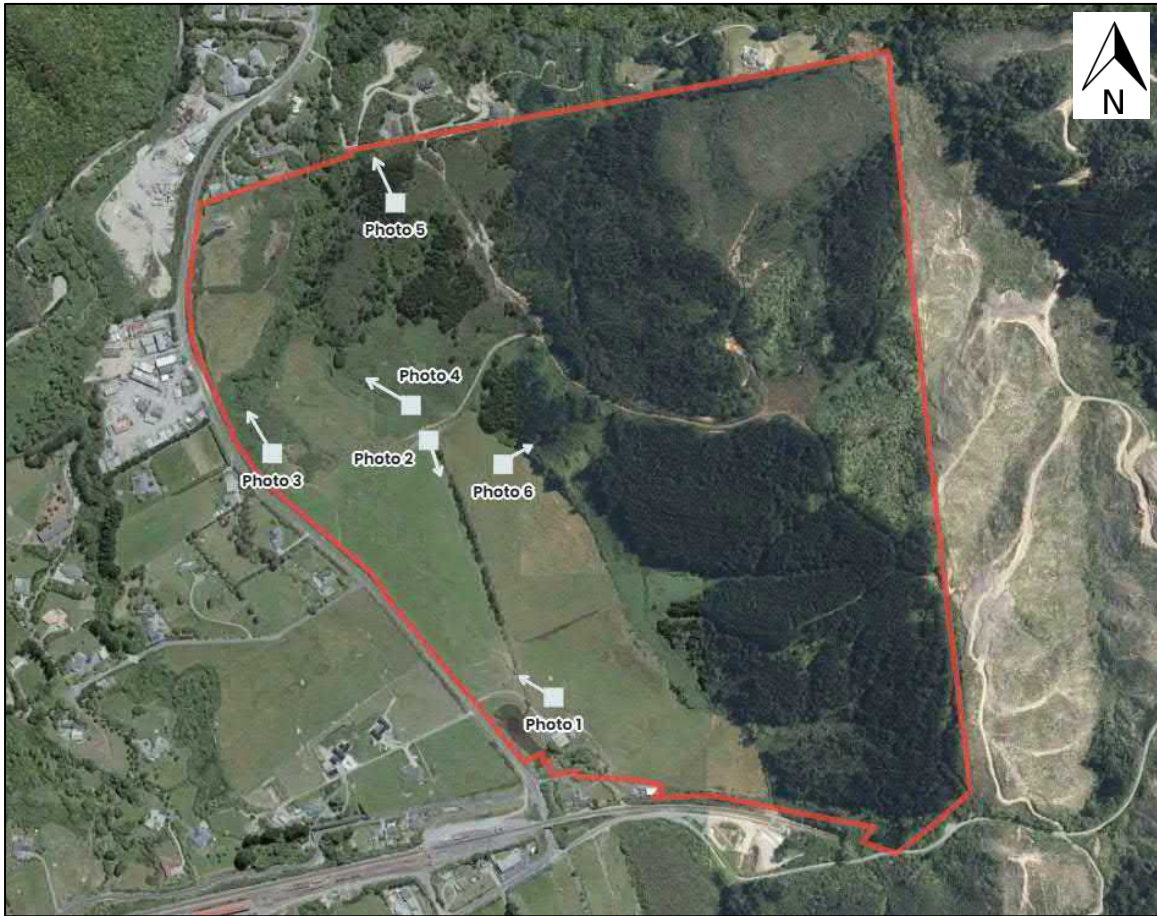
**Figure 6: Location and Orientation of Site Photographs**

Site photographs are presented in Figure 5, with the locations where they were taken and their orientation presented in Figure 6. We note that due to dense vegetation cover (specifically gorse and blackberry) our sloping ground observations were largely limited to that of the recently cleared ground and forestry tracks.

Site plan created using datanest, with aerial photograph from Land Information New Zealand (photography date not specified).

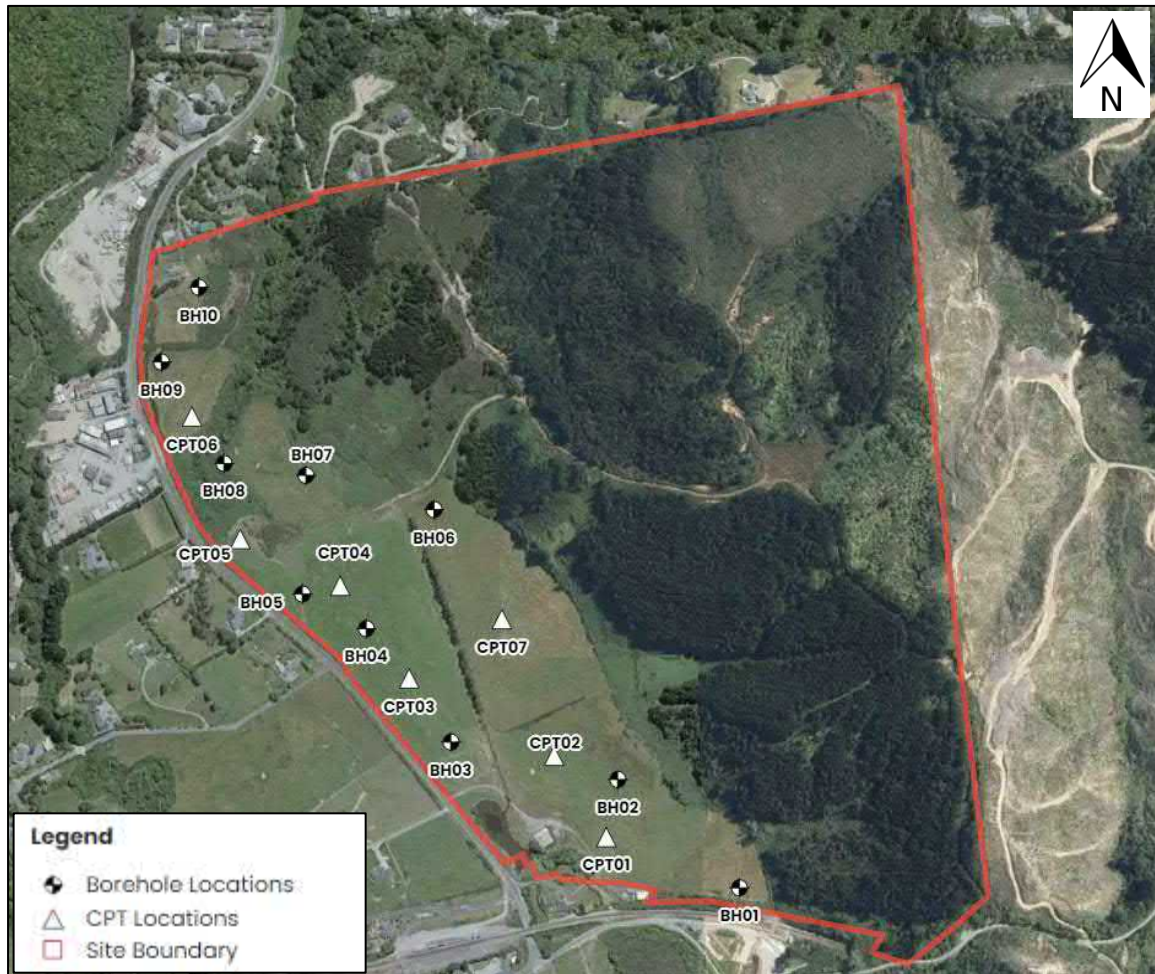
**Figure 7: Subsurface Investigation Locations**

We understand that the MBIE / NZGS Guidance Module 2 Table 2.1 indicates that rural land is to have one deep investigation location per Lot, however, the density of the testing is considered to be adequate to characterise the subsurface conditions for the purposes of identifying the main hazards and constraints which could affect the proposed future residential development. Further subsurface investigations will be required to inform detailed design and building consent works on a lot by lot basis.
