# Pinehaven Stream Improvements Erosion and Sediment Control Plan – Main Works

## Pinehaven Stream Improvements

Project No: IZ089000  
 Document Title: Preliminary Erosion and Sedimentation Control Plan - Main Works  
 Document No.: IZ089000-300-NW-RPT-0001  
 Revision: Rev 2  
 Date: 13 September 2019  
 Client Name: Wellington Water  
 Client No:  
 Project Manager: Eric Skowron  
 Author: Jerry Spinks (of Jacobs) / Michelle Flawn (of Downers)  
 File Name: J:\IE\Projects\02\_New Zealand\IZ089000\21 Deliverables (Live)\01 NoR and RC\Appendices\ESCP\IZ089000 Pinehaven Stream Improvements - ESCP Main Works - Rev2.clean.docx

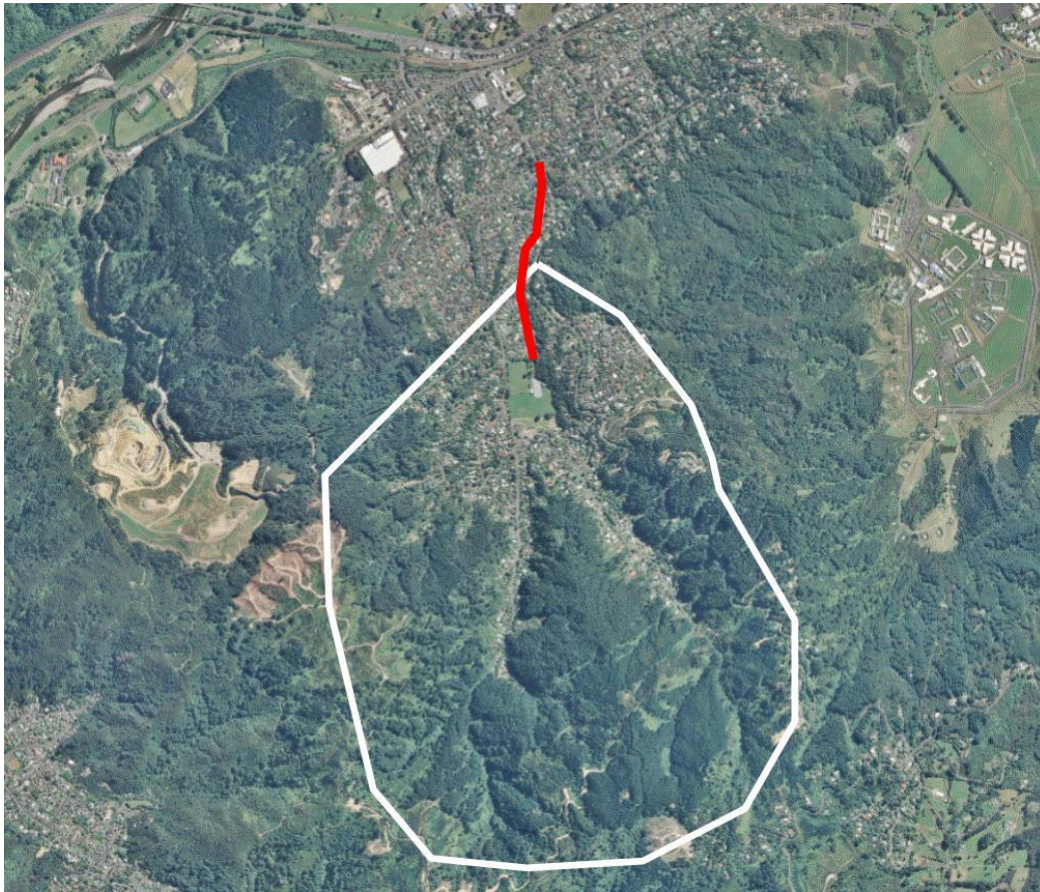
**Figure 1: Pinehaven catchment (shown white polyline) and extent of stream upgrade (shown in red line).**

The catchment is comprised of numerous narrow, steep sided valleys which converge and drain northwards out onto the Hutt River floodplain. The land use within the catchment varies between the upper and lower catchment. The upper catchment and the steep sides of the numerous valleys are predominately covered in pine forest, with some residential land use adjacent to stream tributaries. As the lower catchment opens onto the Hutt River floodplain the major land use in the catchment becomes residential. Amongst the residential properties within the Pinehaven stream catchment there are two schools, a church and some community buildings. The location of the Pinehaven catchment is illustrated in Figure 1. The extent of the stream subject to improvement ('the site') is also shown indicatively.

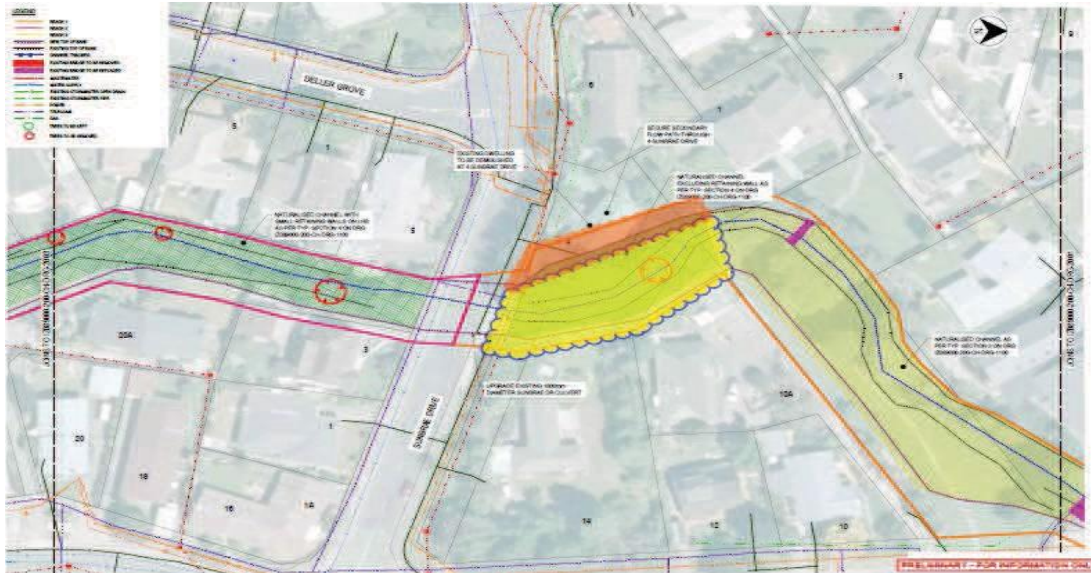
- **Stage 3 (Reach 1):** Will be from the southern extent of Willow Park to the existing culvert under Sunbrae Drive. Access will be via temporary access adjacent to the road and through the property of 4 Sunbrae Drive.

Figure 4: Stage 3 Works adjacent to Sunbrae Drive

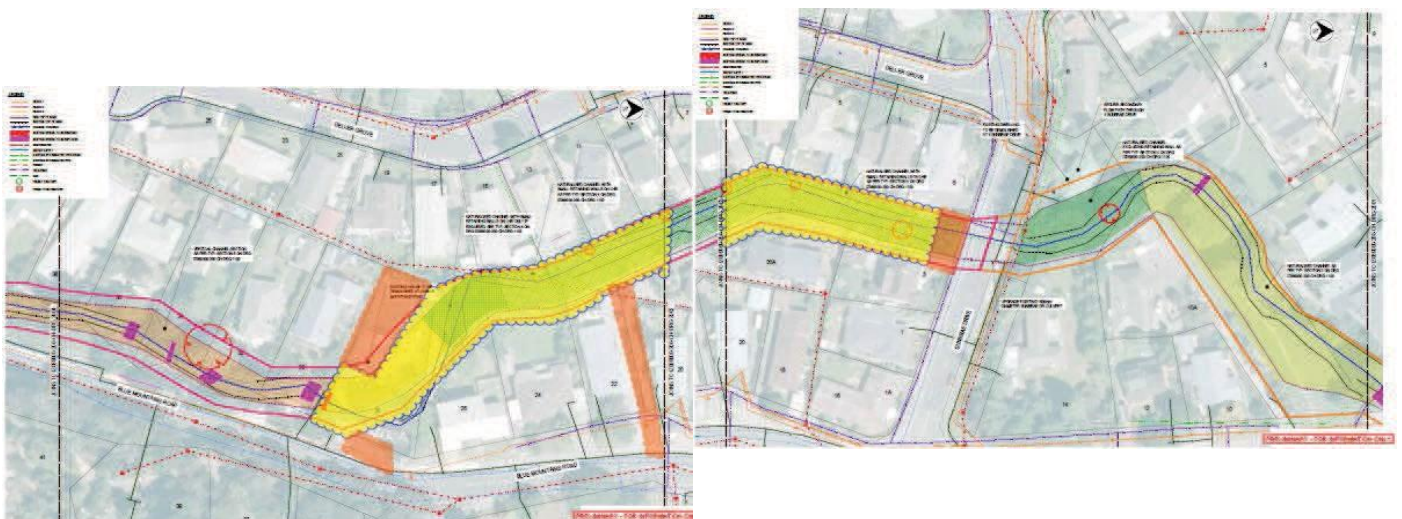
- **Stage 4 (Reach 2):** Will be from the existing culvert under Sunbrae Drive to 28 Blue Mountains Road, which is owned by GWRC. Access will be via temporary access adjacent to Sunbrae Drive and 28 Blue Mountains Road. For site clearance activities, the shared driveway to 20A and 20B Blue Mountains Road will be used.

Figure 5: Stage 4 Works near Blue Mountains Road.

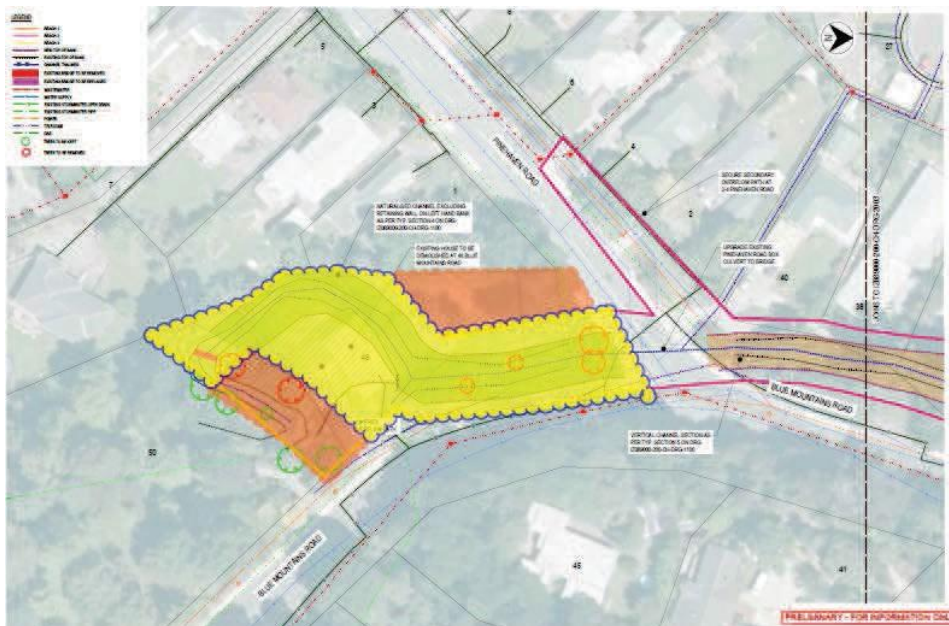
- Stage 6 (Reach 3):** Will be from the existing box culvert under Pinehaven Road to the southern extent at 50 Blue Mountains Road. Construction access will be via temporary access to the west of the stream from Pinehaven Road and 48 Blue Mountains Road.

Figure 7: Stage 6 Works near 48 Blue Mountains Road

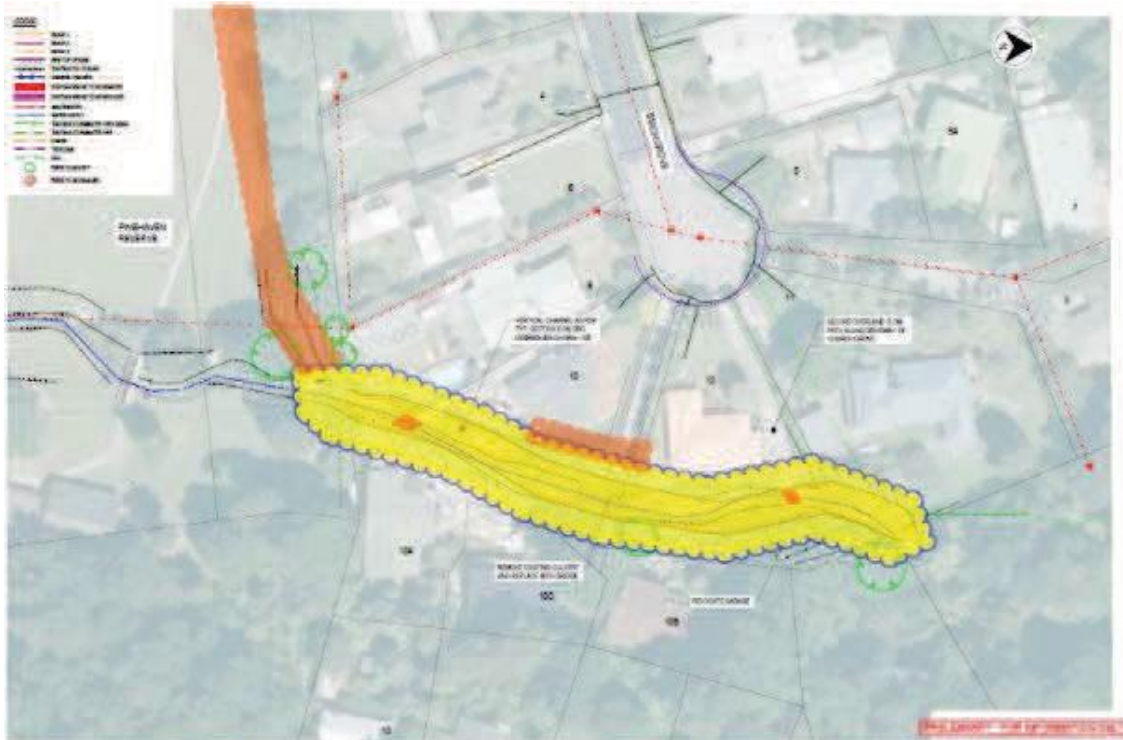
- **Stage 7 (Reach 3):** Will be from 8 to 11 Birch Grove. Access will be via temporary access at the existing culvert between 10 and 12 Birch Grove. Access to Pinehaven Reserve will be restricted to the summer period only.

Figure 8: Stage 7 Works near Birch Grove.

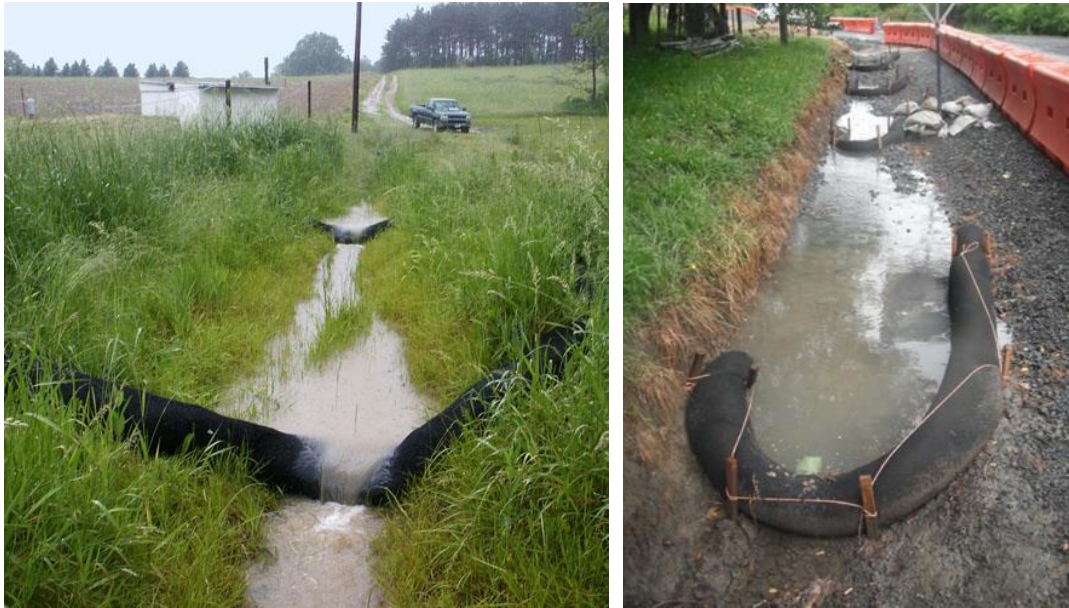
While the excavator and small dumper trucks are working in the stream there is the potential for sediment generation to occur. Due to the low flows expected during the works, it is proposed to utilise an appropriately sized filter sock downstream from the works to be implemented as shown in Figure 13 below to act as a 'check point' that would also serve to intercept and filter out low levels of sedimentation within the stream. The sock would be continually monitored for effectiveness and changed if showing signs of damage/deterioration or being outflanked.

**Figure 13: Example Photo of Filter Socks**

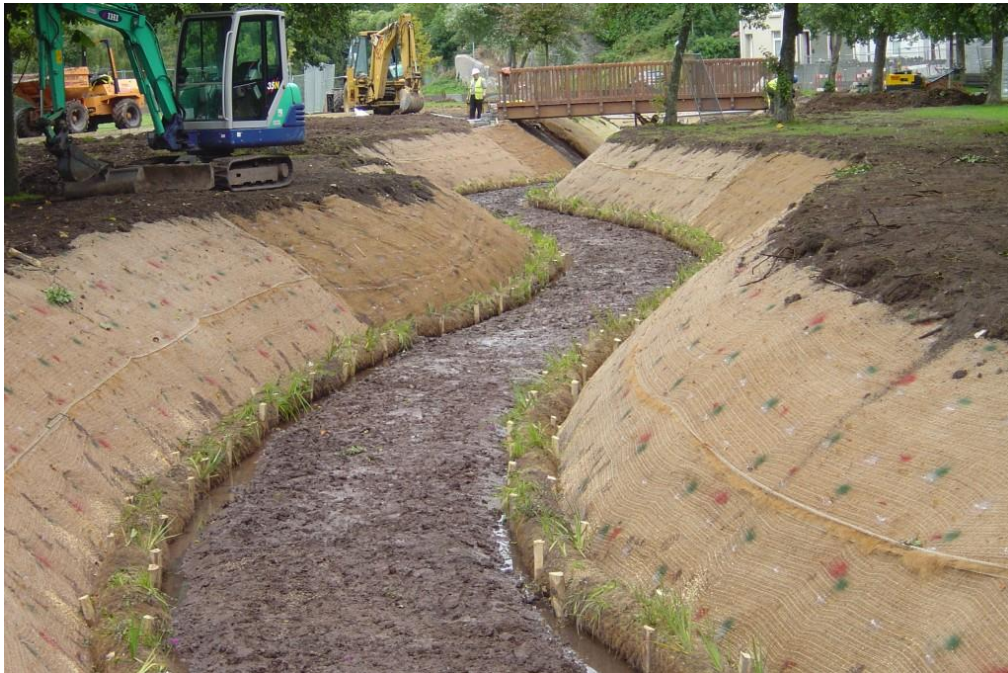
It is expected there will be a requirement to stabilise slopes in the short term, as the works proceed the next works location, and before the permanent riparian plantings and vegetation have established. . To achieve this, coconut matting (Bio-cor, dute-mesh, or similar) will be placed and secured with steel pegs. Figure 14 below illustrates the treatment.

Figure 14 – Short term stabilisation, illustration only.

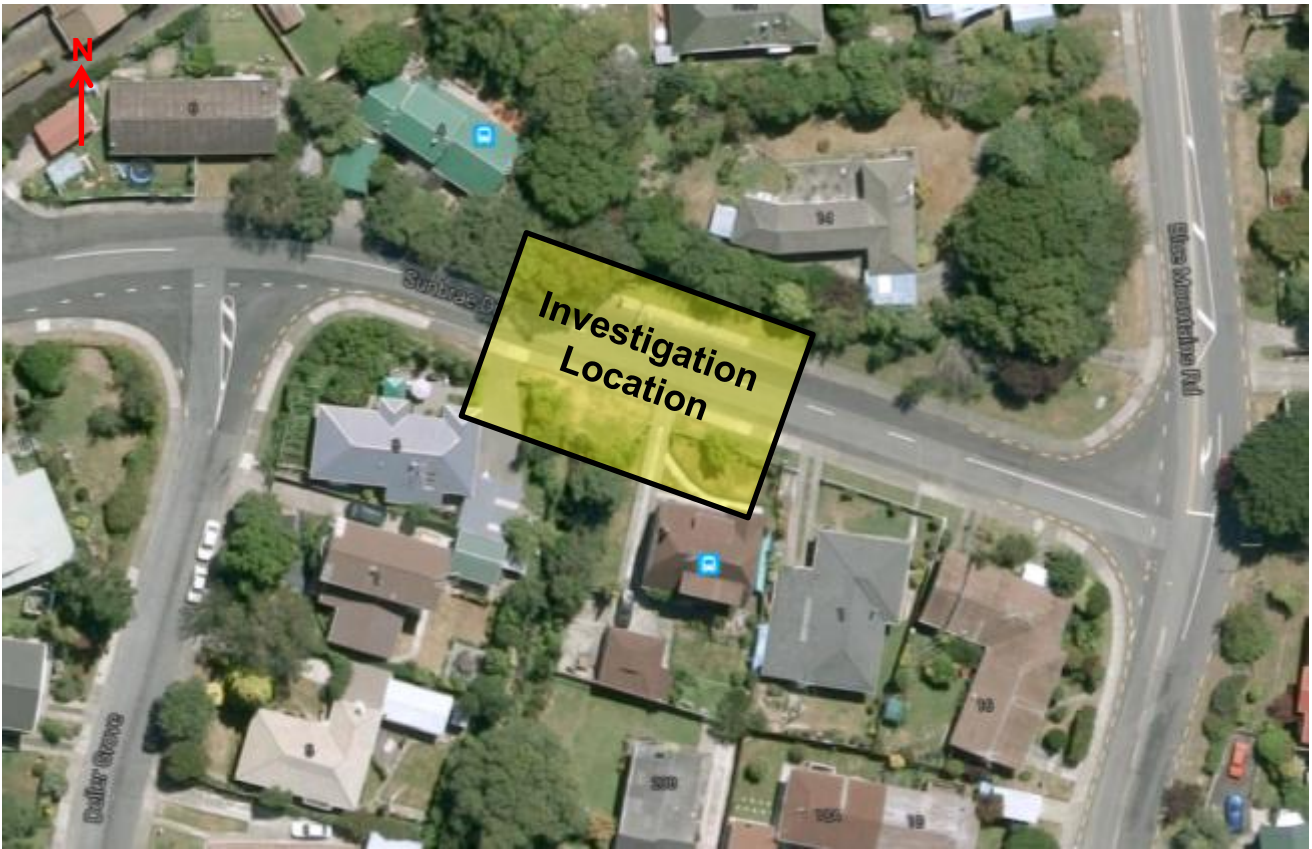
**Figure 2.2: Borehole investigation Location**

Geotechnical investigations (two machine bored boreholes) were undertaken in the vicinity of the proposed culvert upgrade at Sunbrae Drive (see Figure 2.2). The borehole locations are shown in Appendix A.

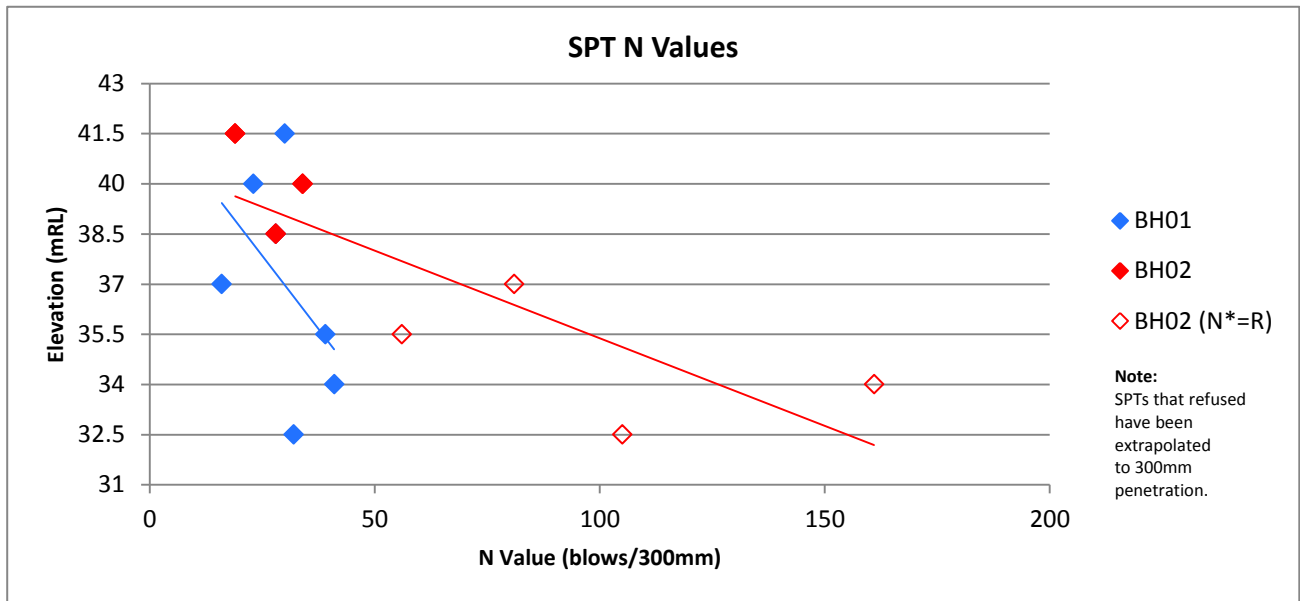
Figure 5-1: SPT Results

As mentioned in Section 4.2, standard penetration tests were undertaken at 1.5m intervals to determine the density/consistency of the subsurface materials. The results of the SPTs indicate that the material strength generally increases with depth as demonstrated in Figure 5.1.

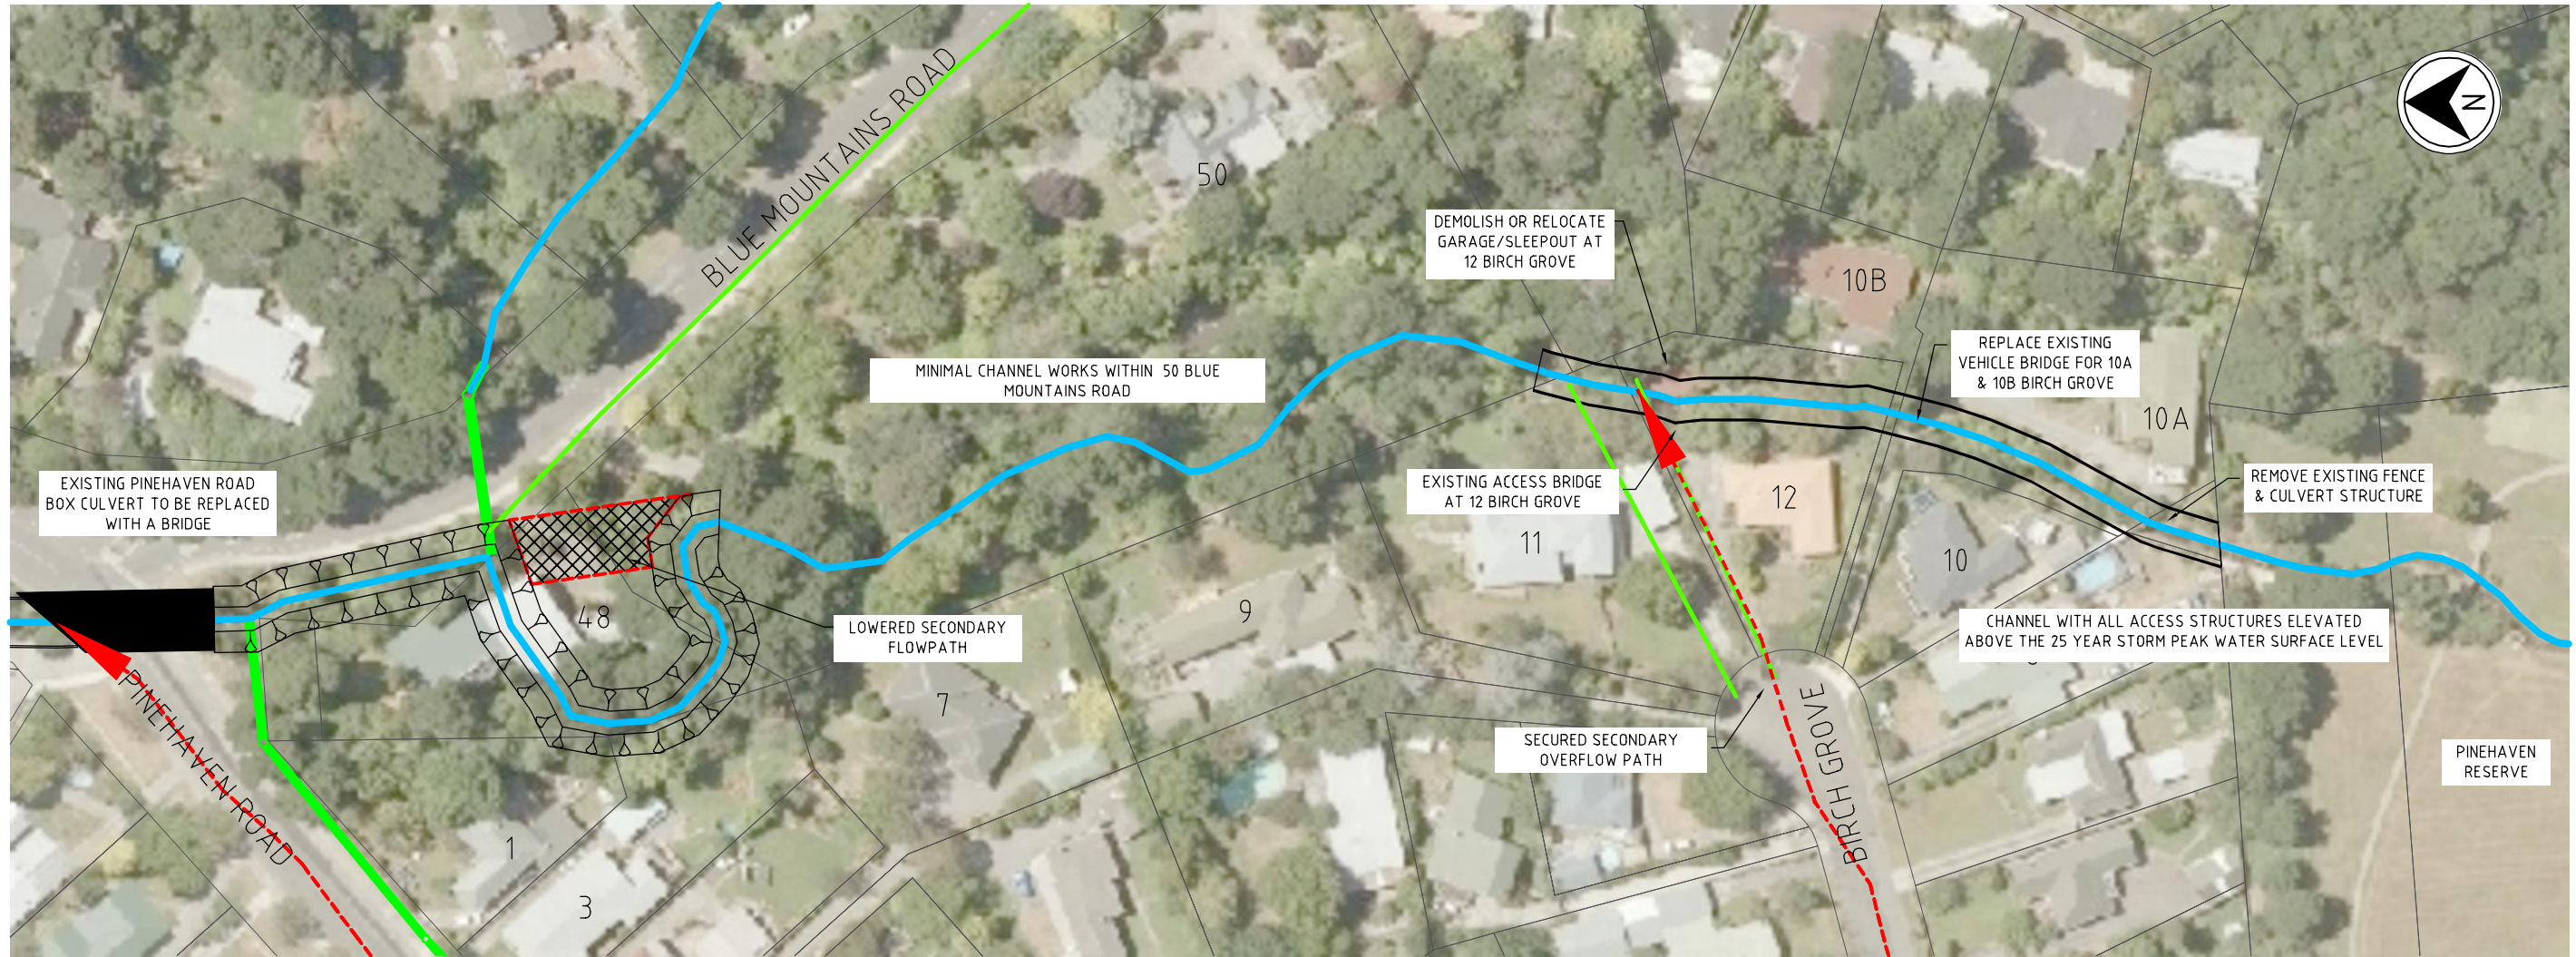
REACH 3 - HYBRID OPTION  
SCALE 1:1000 @ A1

TITLE PINEHAVEN STREAM REACH 3 PREFERRED OPTION			
SCALE AS SHOWN	PROJECT No AE03975	DRAWING No REACH3-003	AMDT A

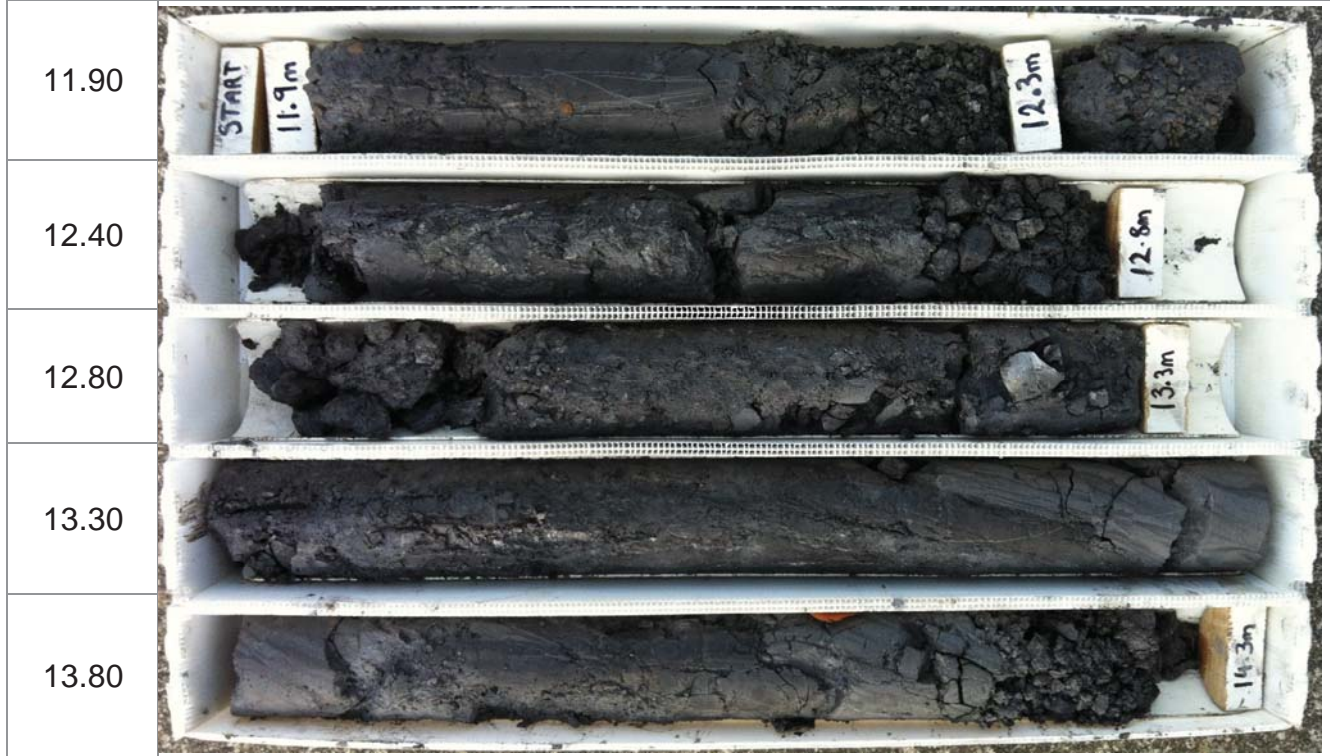
<b>Project No.:</b>	IZ018100-GEO	
<b>Client:</b>	Wellington Water	
<b>Borehole ID:</b>	BH02	
<b>No. of boxes:</b>	3

Depth (m)	Box	1 of 3	Start depth (m)	11.90	End depth (m)	14.30
-----------	-----	--------	-----------------	-------	---------------	-------

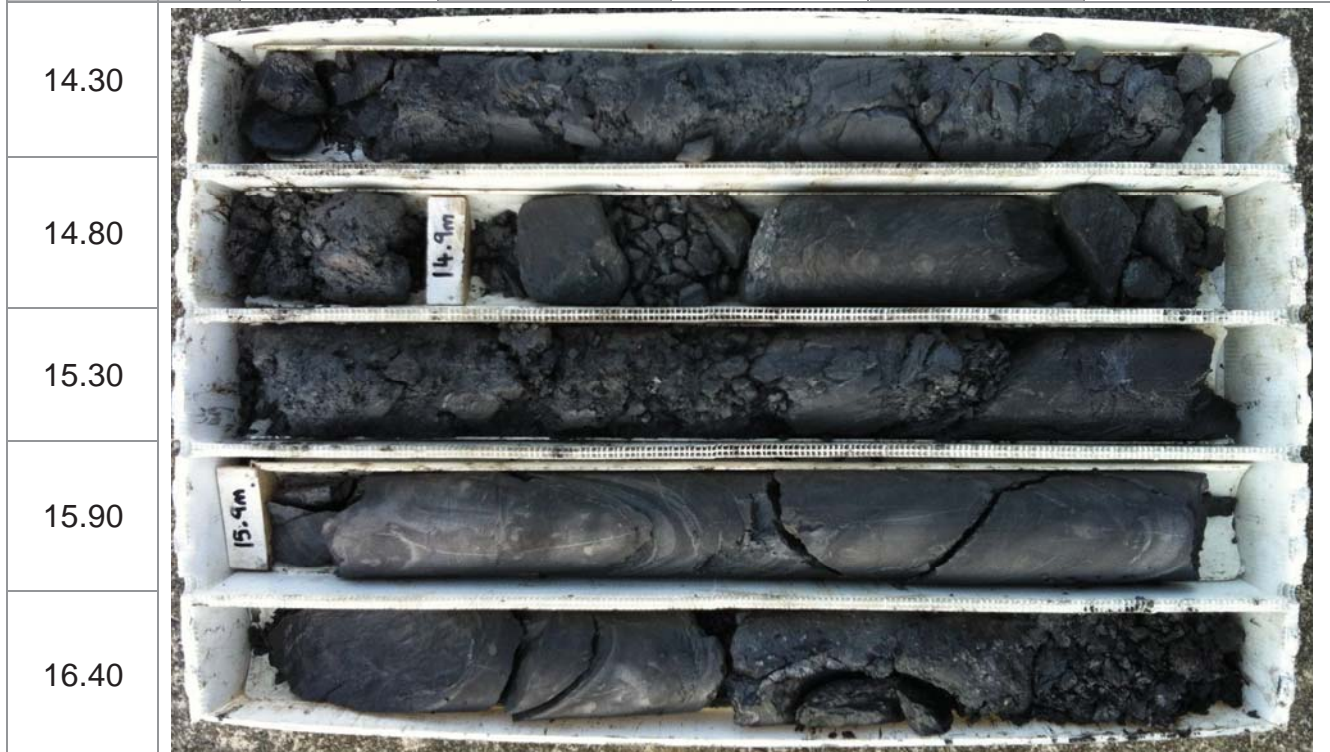
Depth (m)	Box	2 of 3	Start depth (m)	14.30	End depth (m)	16.90
-----------	-----	--------	-----------------	-------	---------------	-------

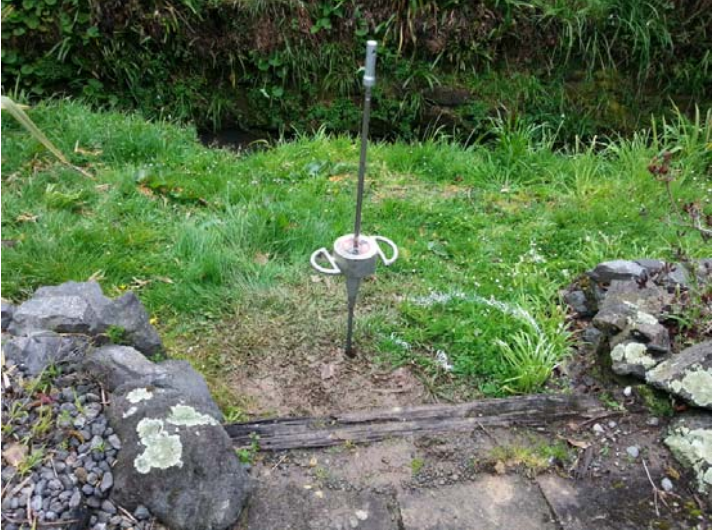
ID	Description	Photograph
1	Site location of HA1 looking towards the stream from the driveway.

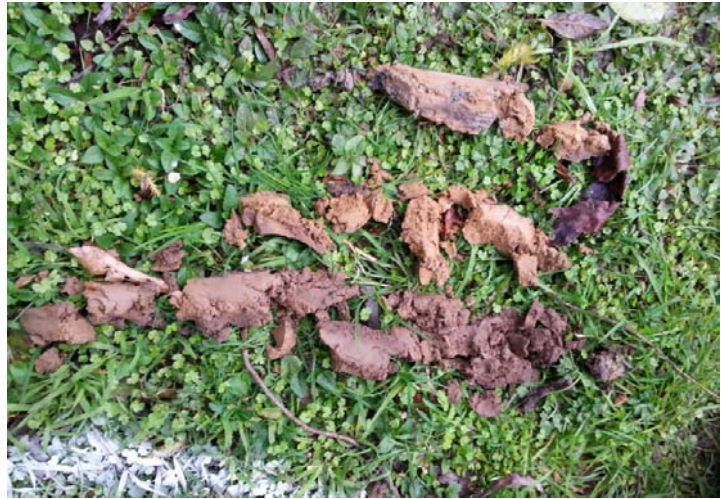
5 Close up of HA2 material.

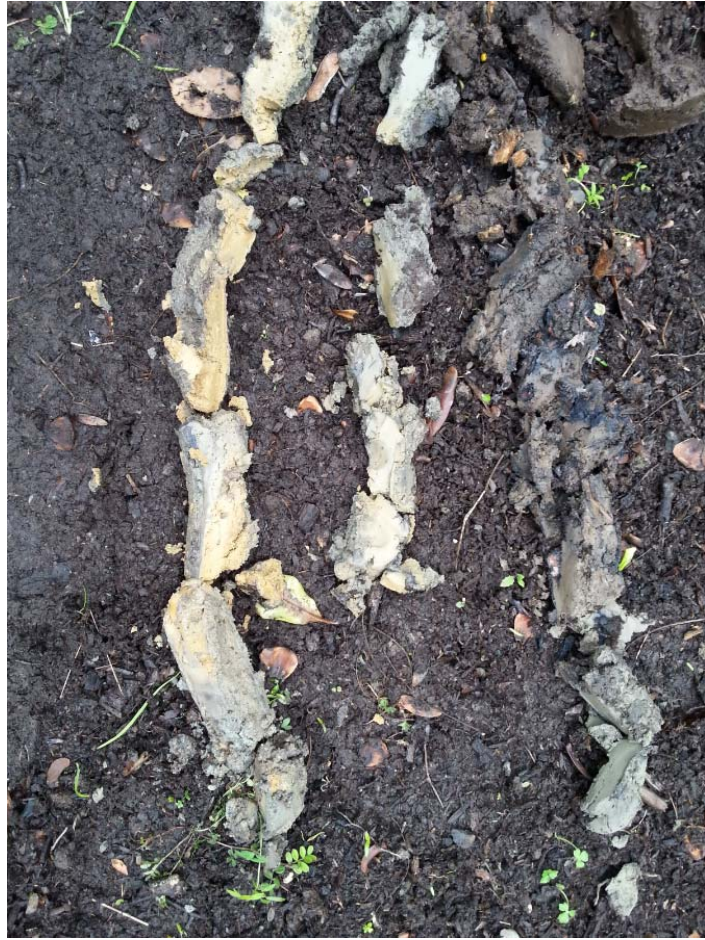
Close up of HA3 material.

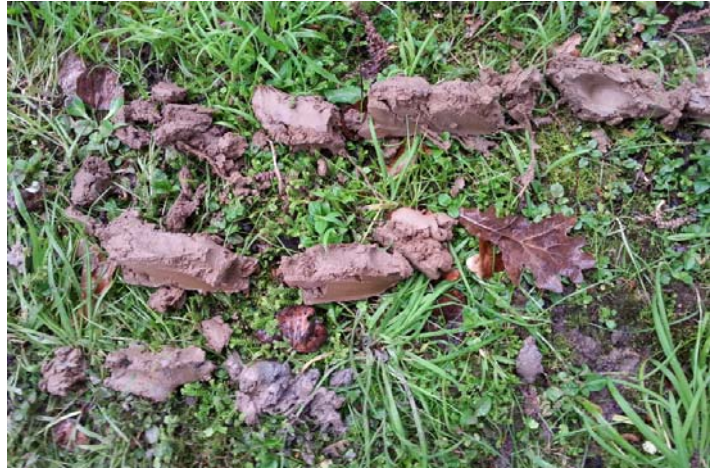
9 Close up of HA4 material.

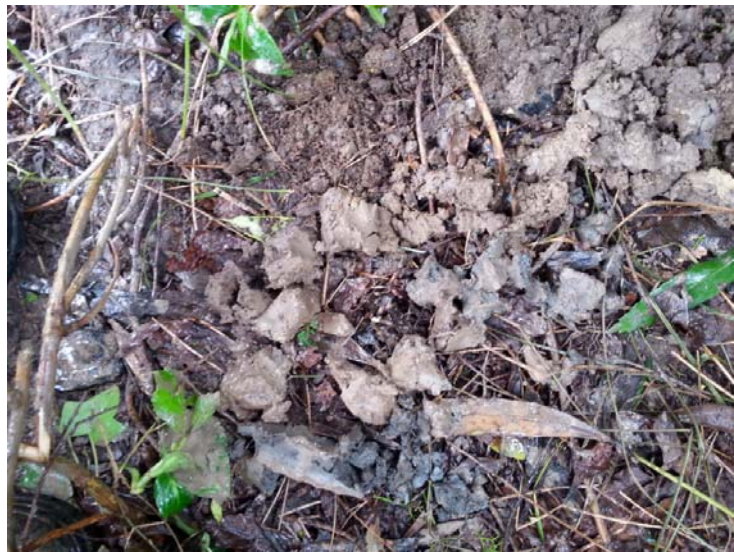
11 Close up of HA5 material.

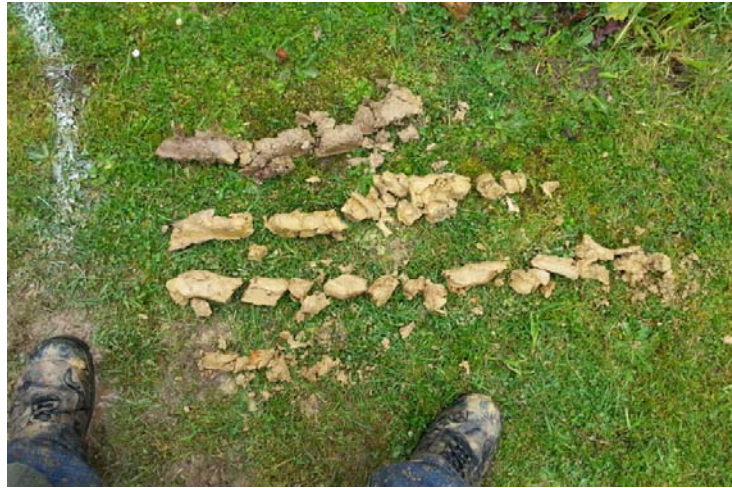
13 Close up of HA6 material.

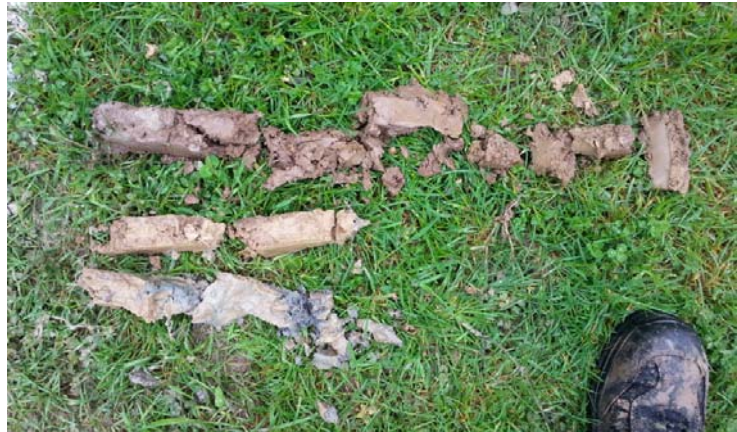
16 Close up of HA8 material

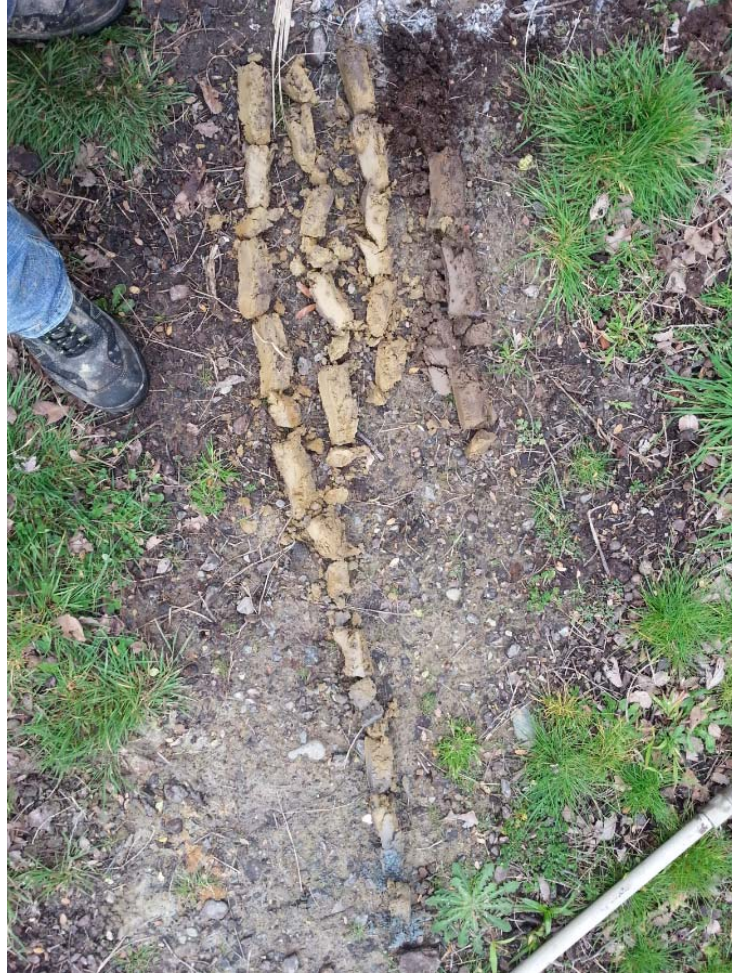
18 Close up of HA9 material.

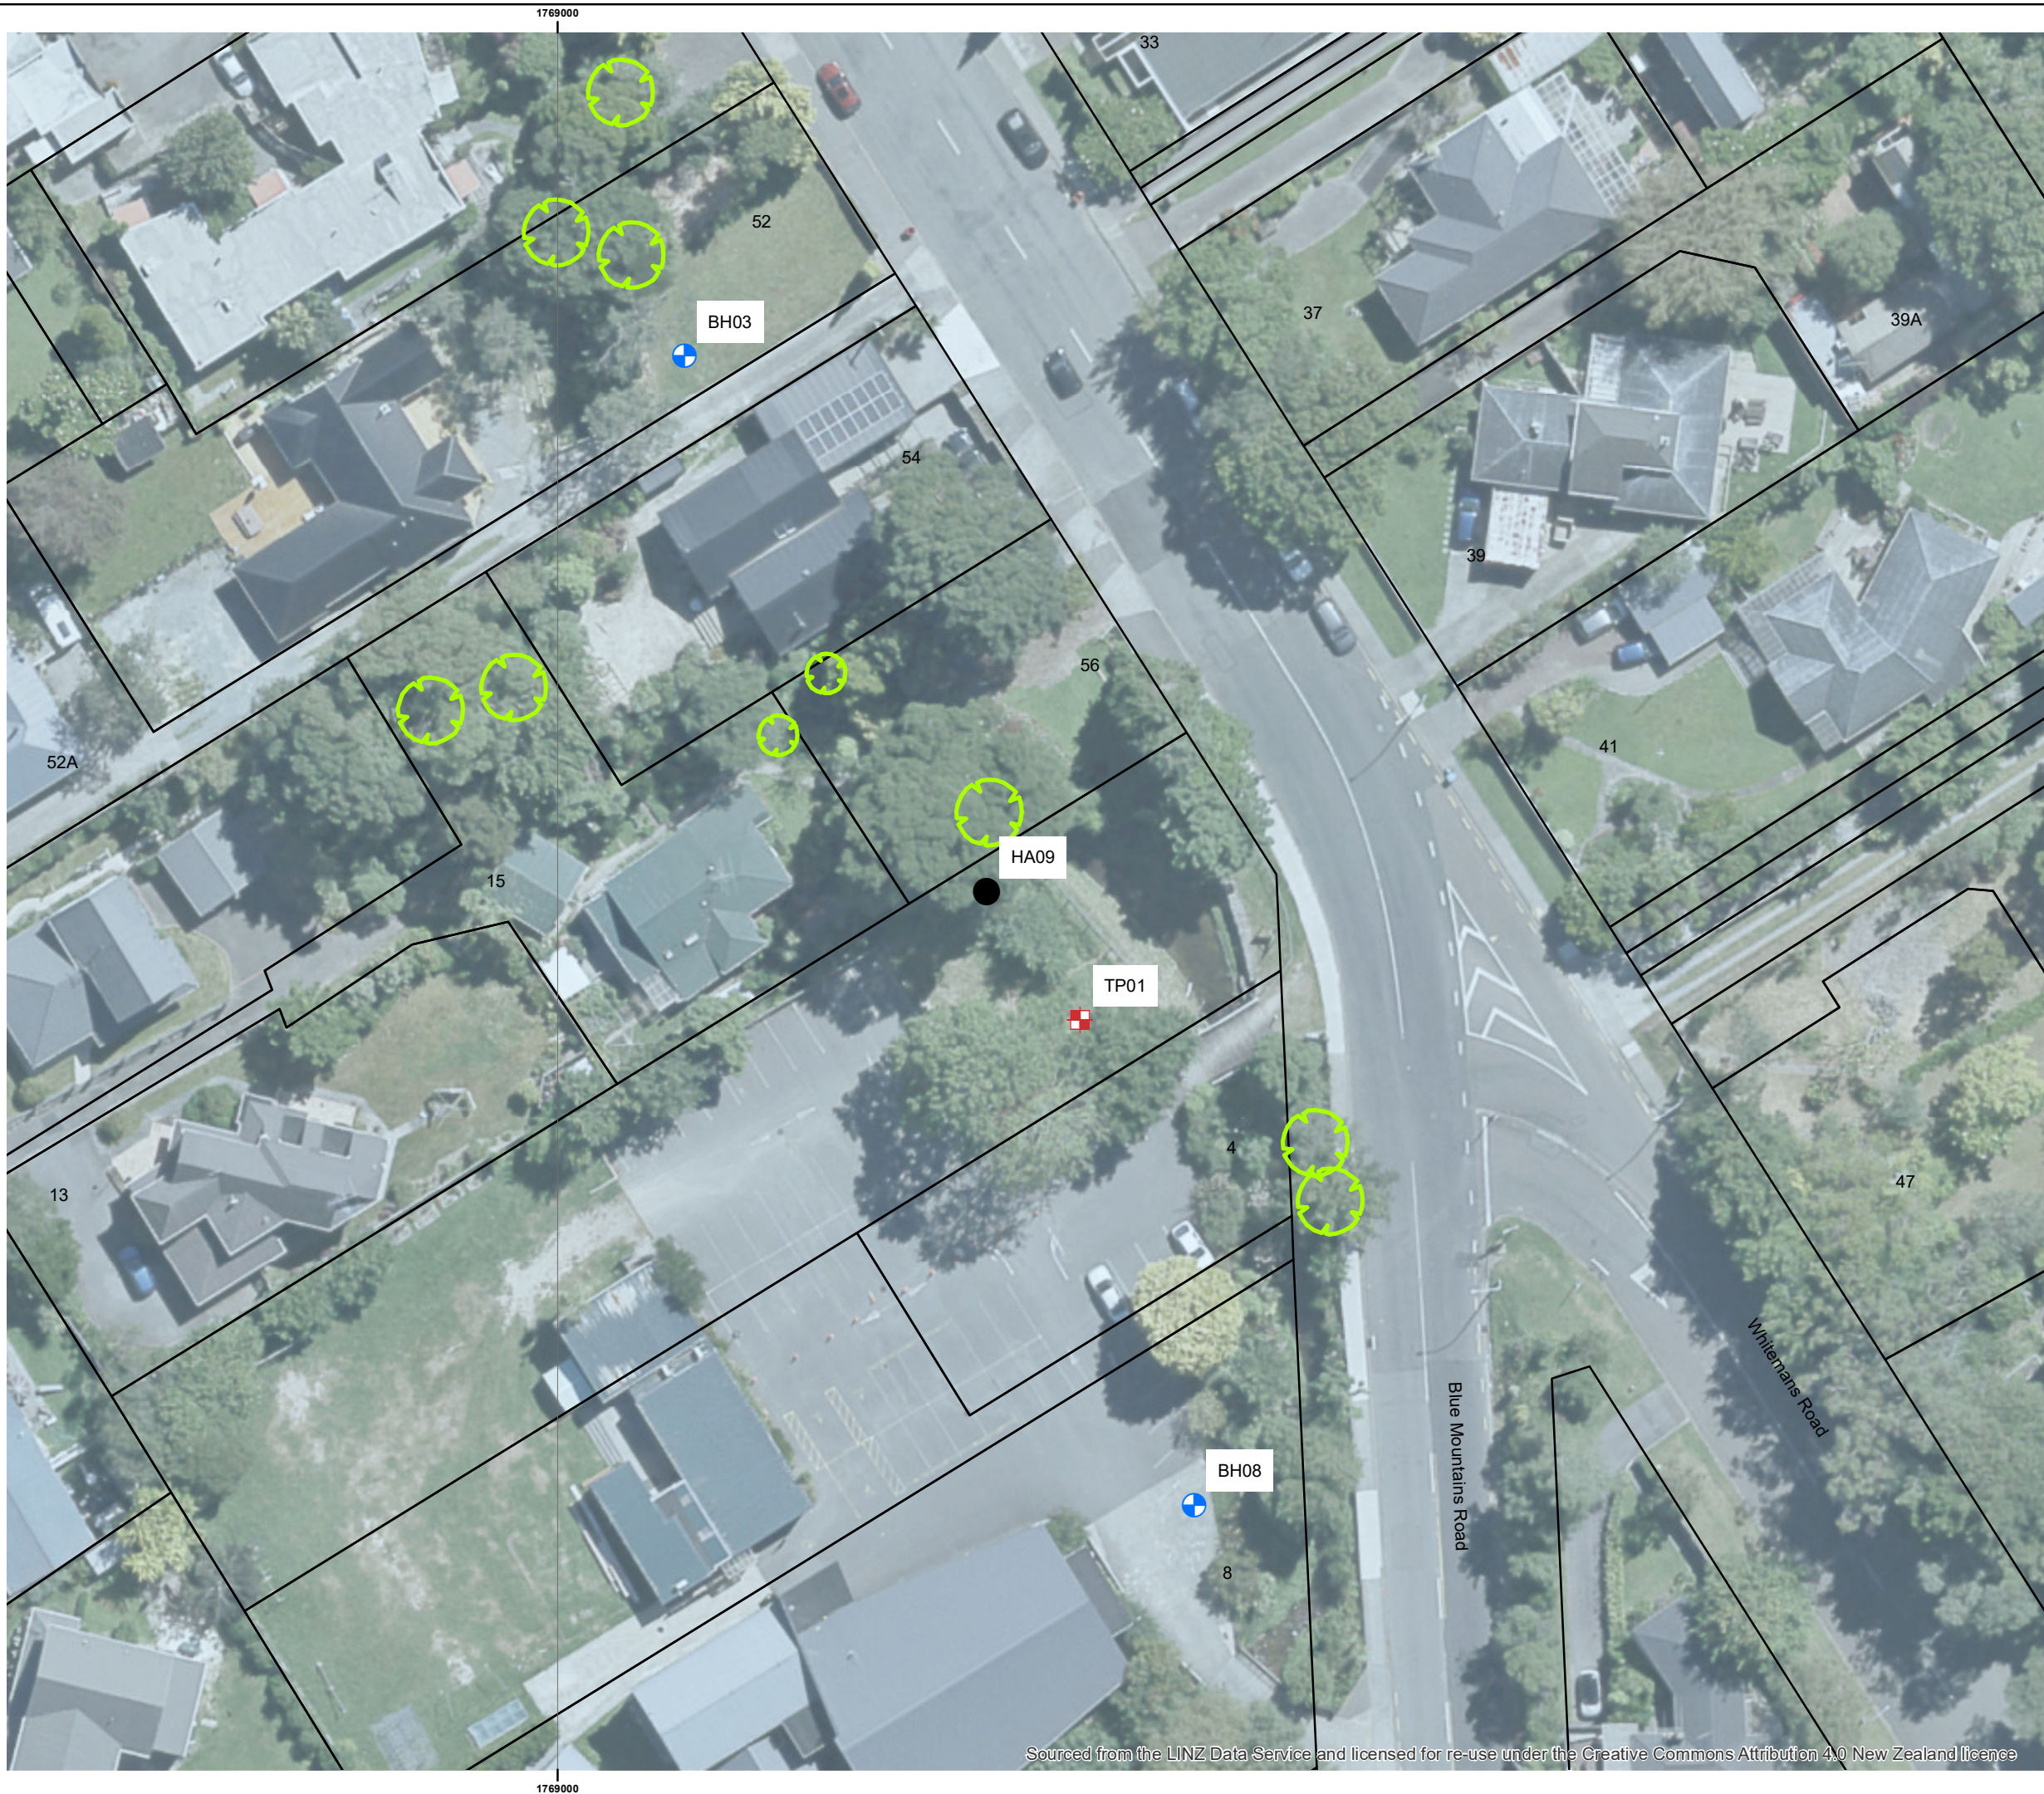
#### FIGURE 1

## **Appendix A. Ground Investigation Location Plans**

The site is located along the Pinehaven Stream in Pinehaven, Upper Hutt, running from the Pinehaven Reserve to 48 Whitemans Road. The site runs approximately north south along an 800m section of the Pinehaven Stream, as shown in . The ground investigation location plans are shown in Appendix A.

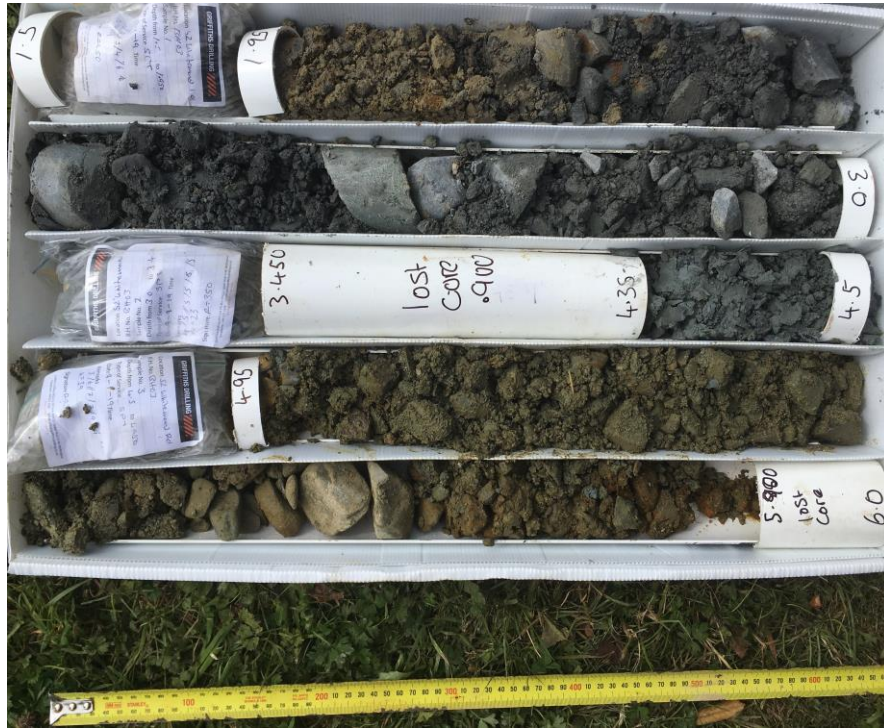
BH03, Box 1, 1.5 to 6 m

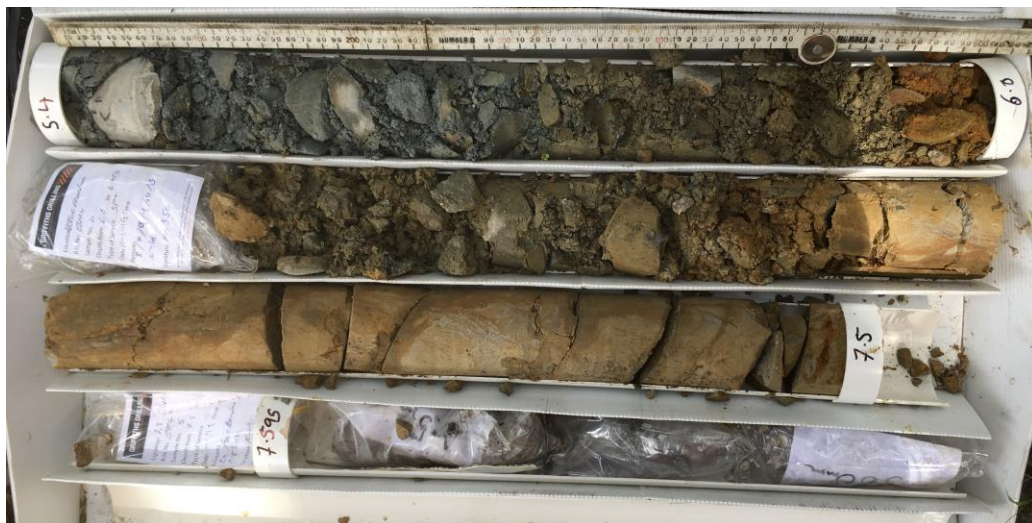
BH04, Box 2, 5.4 m to 7.6 m

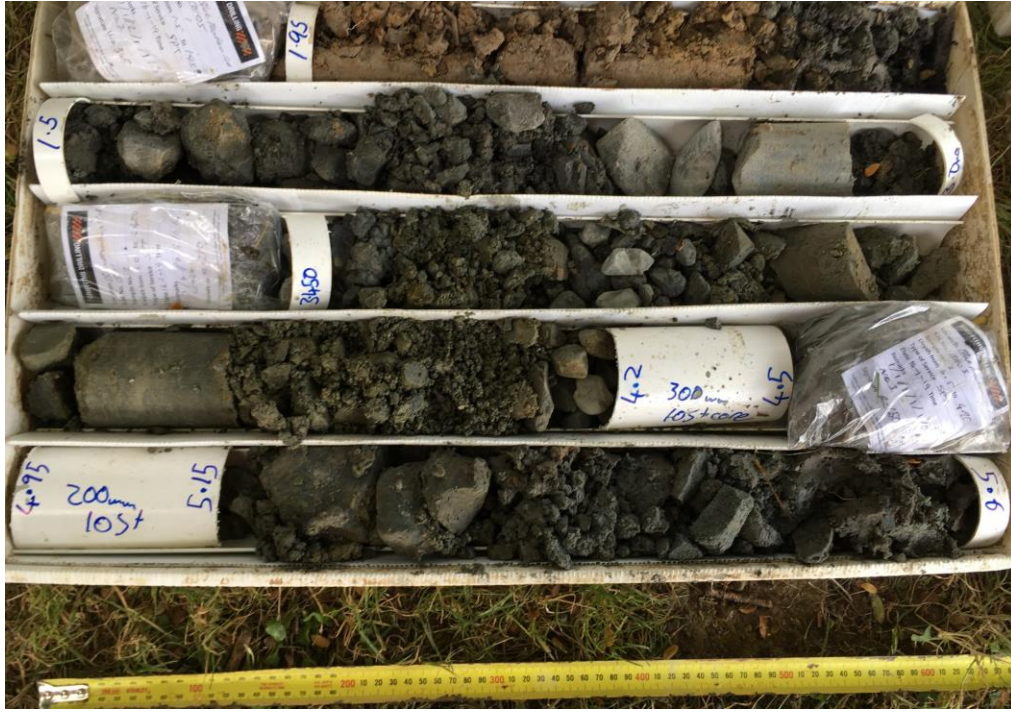
BH05, Box 1, 1.5 to 5.6 m

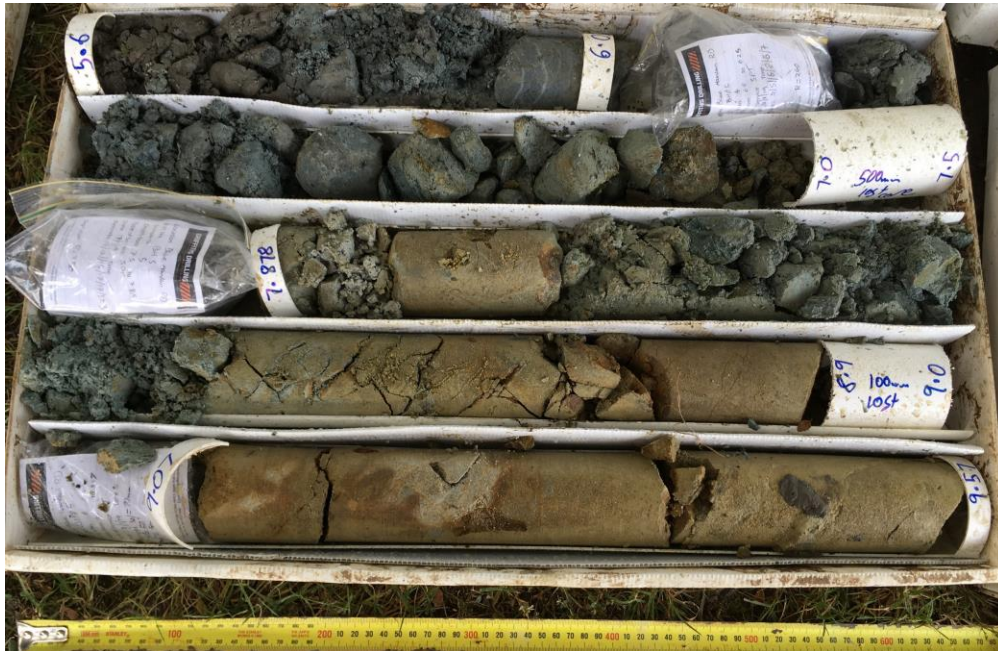
BH05, Box 2, 5.6 m to 9.57 m
