# Pinehaven Stream Improvements Erosion and Sediment Control Plan – Main Works

## Pinehaven Stream Improvements

Project No: IZ089000  
 Document Title: Preliminary Erosion and Sedimentation Control Plan - Main Works  
 Document No.: IZ089000-300-NW-RPT-0001  
 Revision: Rev 2  
 Date: 13 September 2019  
 Client Name: Wellington Water  
 Client No:  
 Project Manager: Eric Skowron  
 Author: Jerry Spinks (of Jacobs) / Michelle Flawn (of Downers)  
 File Name: J:\IE\Projects\02\_New Zealand\IZ089000\21 Deliverables (Live)\01 NoR and RC\Appendices\ESCP\IZ089000 Pinehaven Stream Improvements - ESCP Main Works - Rev2.clean.docx

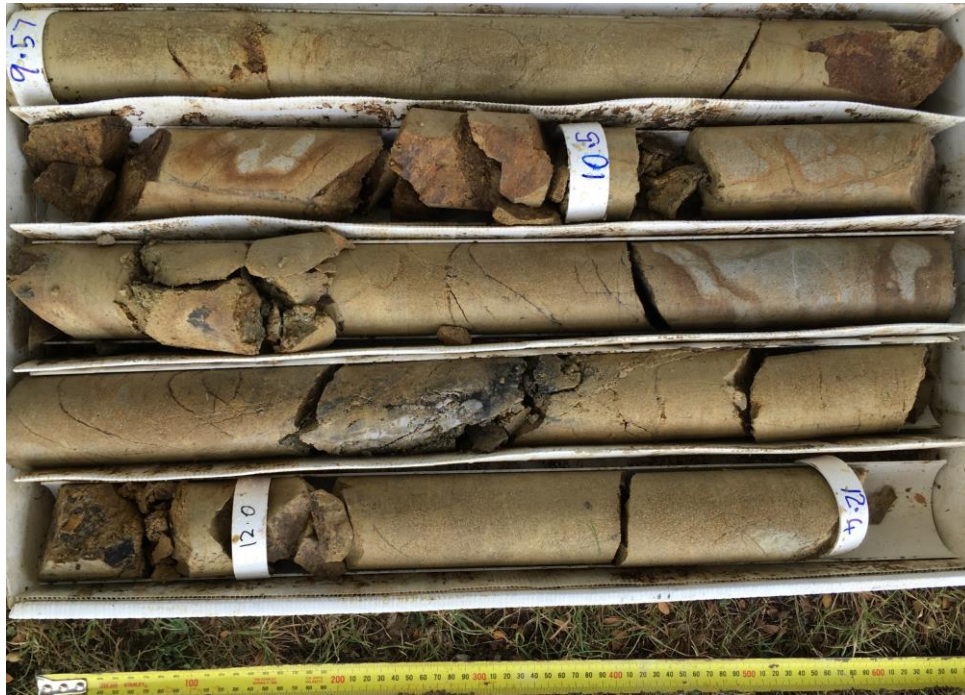
BH05, Box 3, 9.57 m to 12.4 m

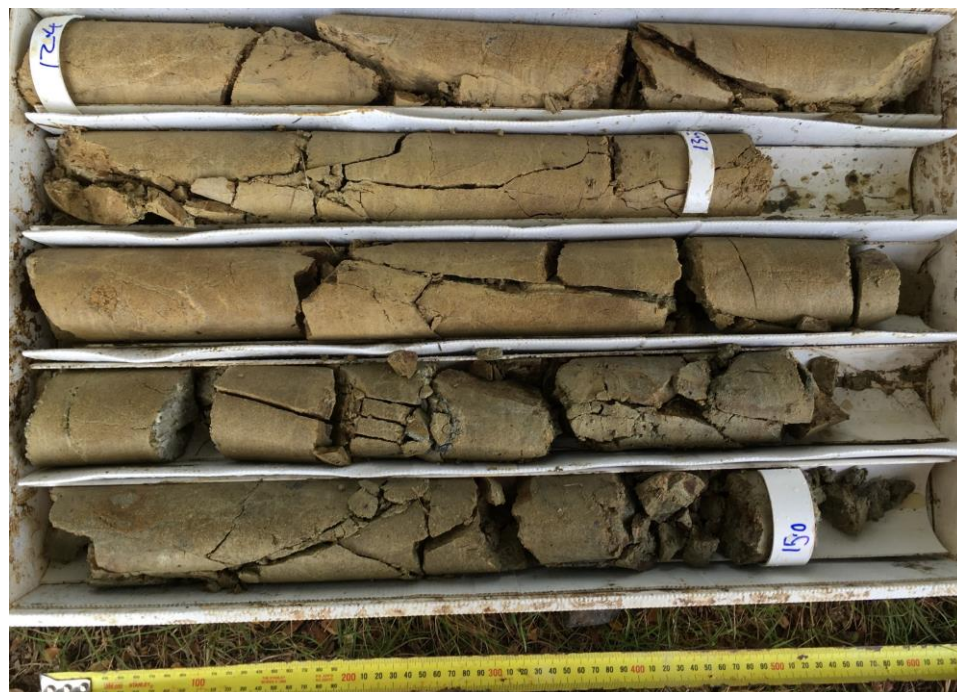
BH05, Box 4, 12.4 m to 15.0 m

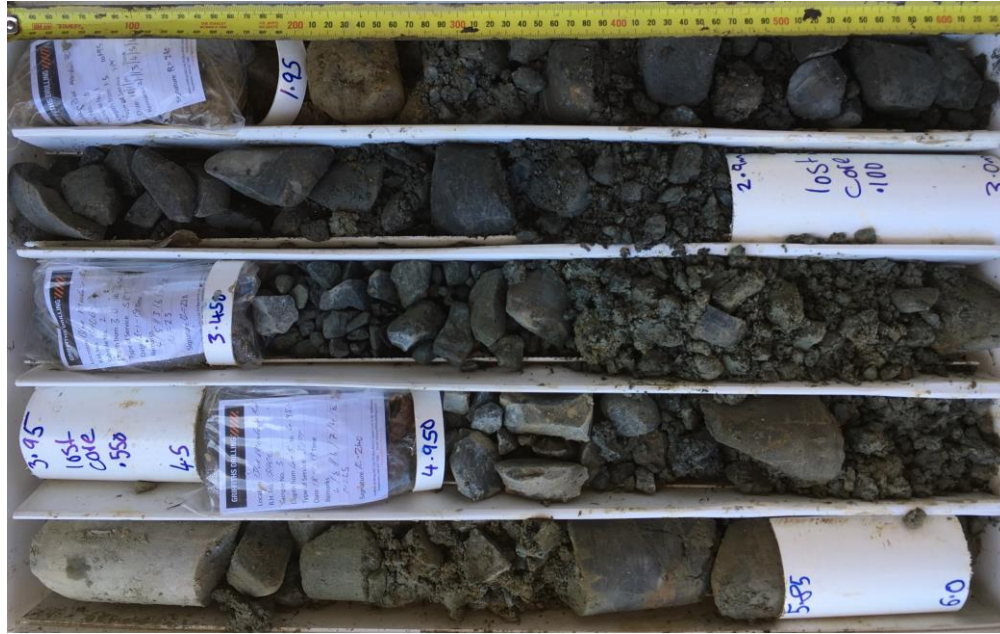
BH06, Box 1, 1.5 to 6.0 m

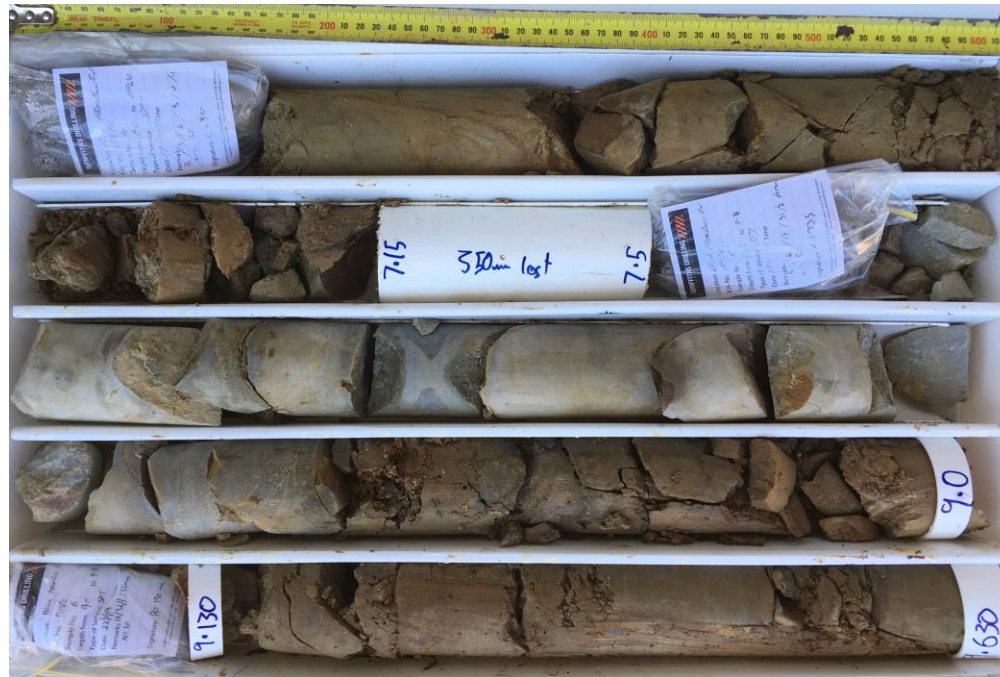
BH06, Box 2, 6.0 m to 9.63 m

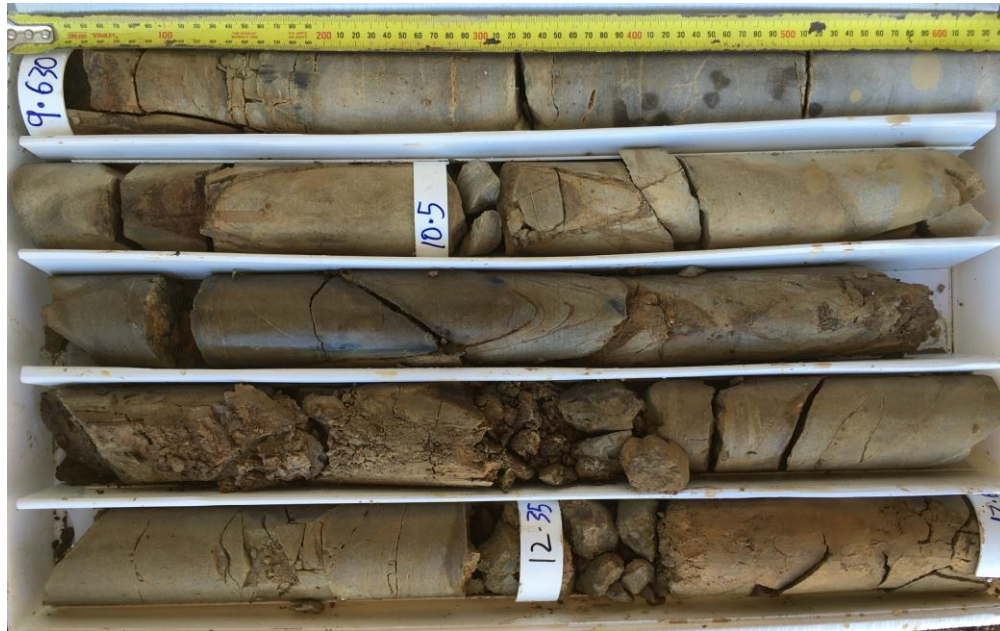
BH06, Box 3, 9.63 m to 12.65 m

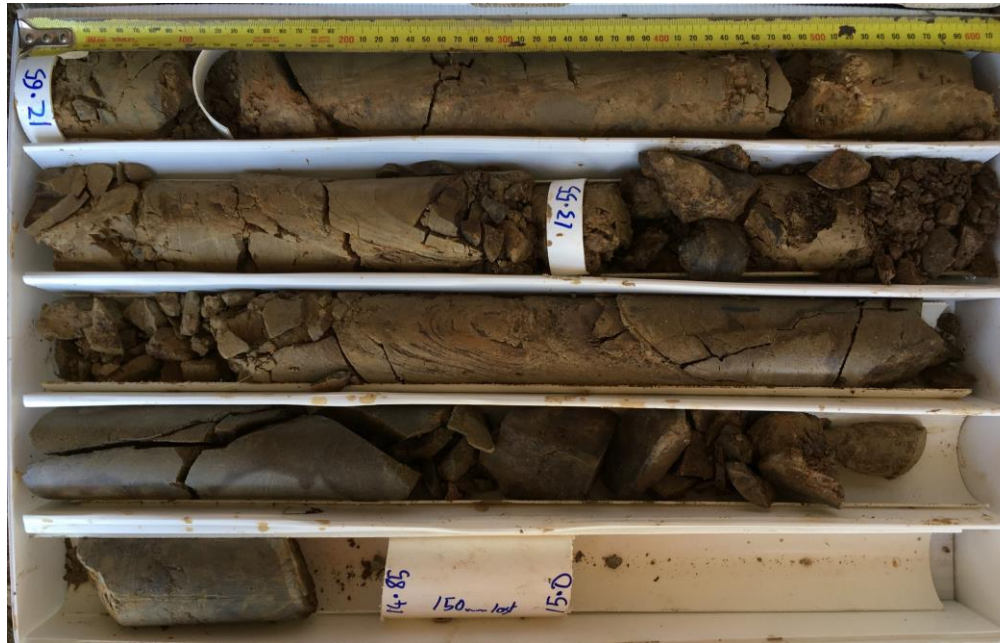
BH06 Box 4, 12.65 m to 15.0 m

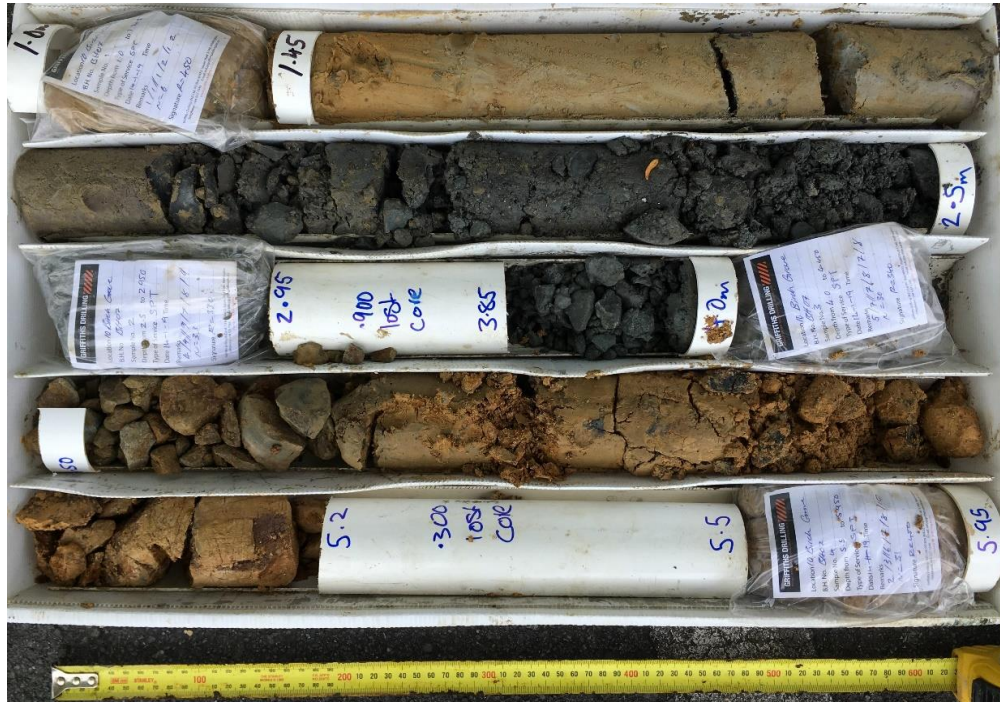
BH07, Box 1, 1.0 to 5.95 m

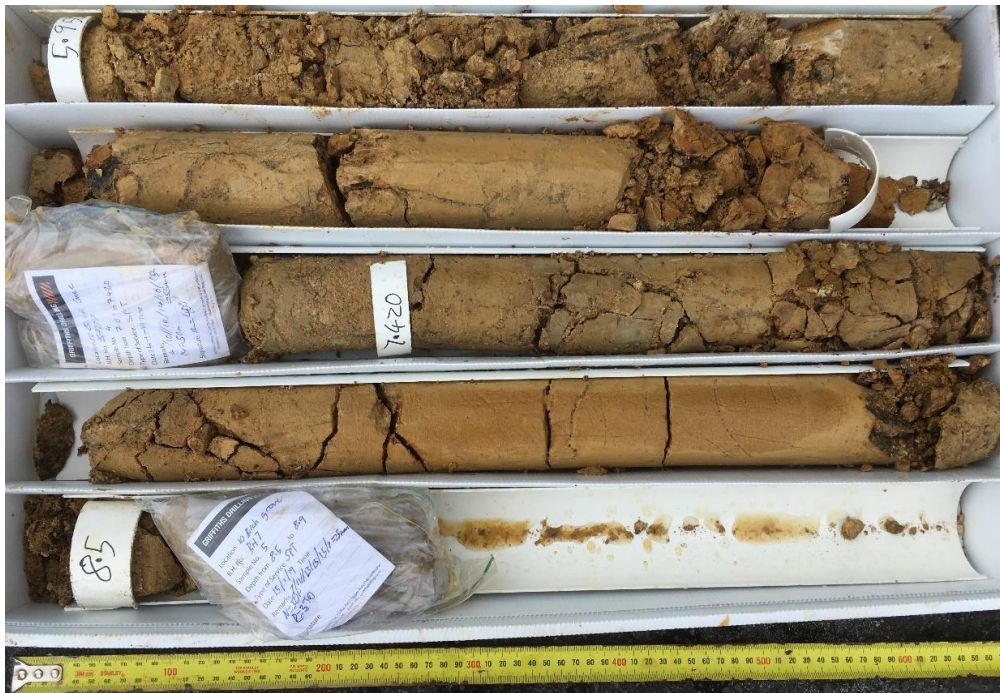
BH07, Box 2, 5.95 m to 8.9 m

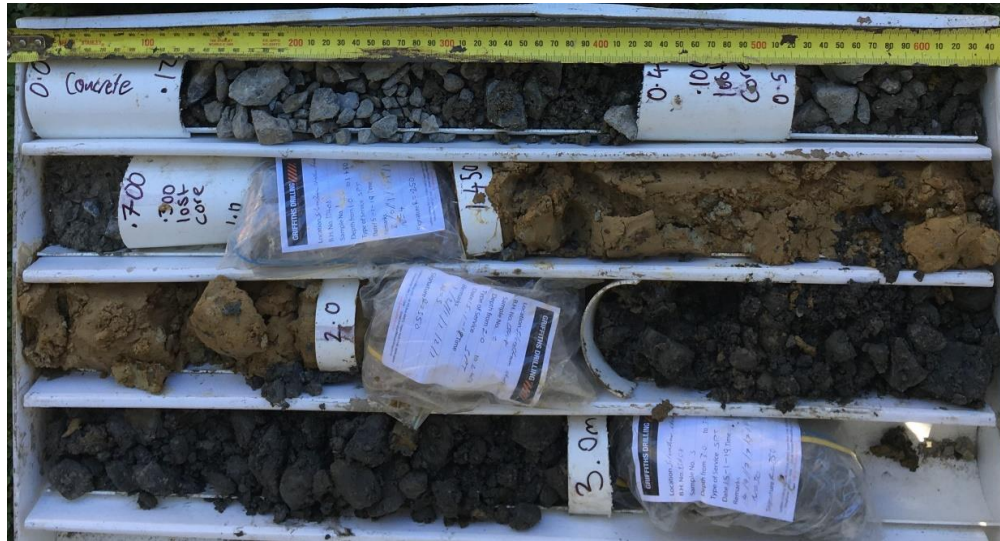
BH08, Box 1, 0.0 to 3.45 m

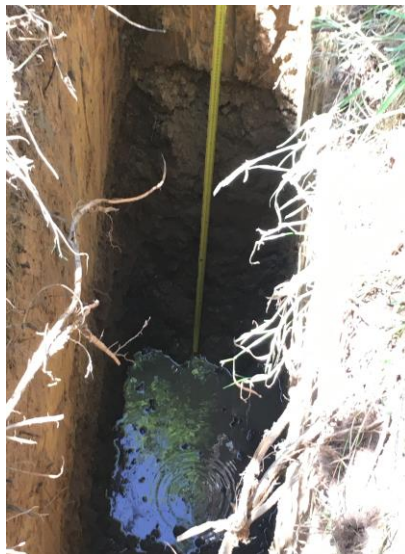
TP01 Face A

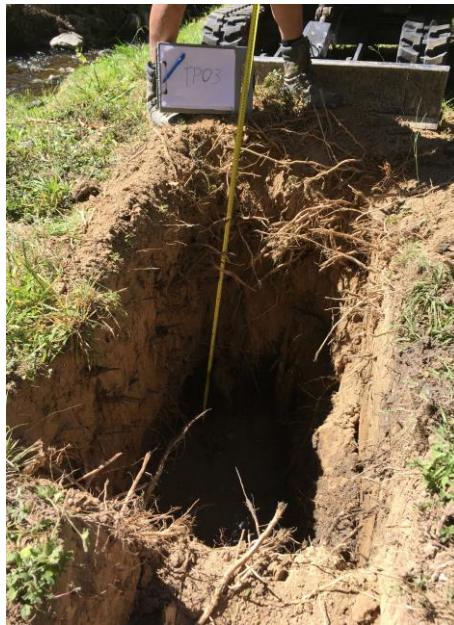
TP03 Face A

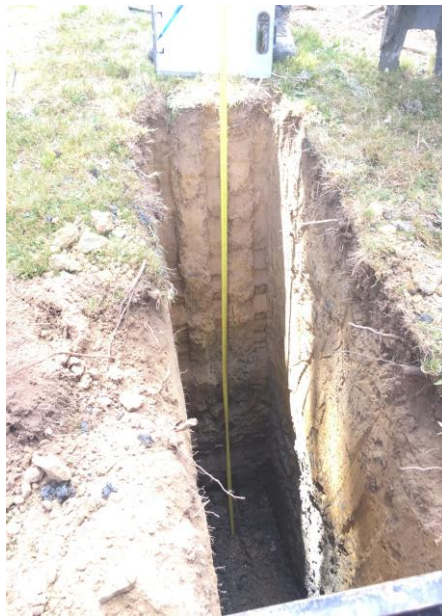
TP05 Face A

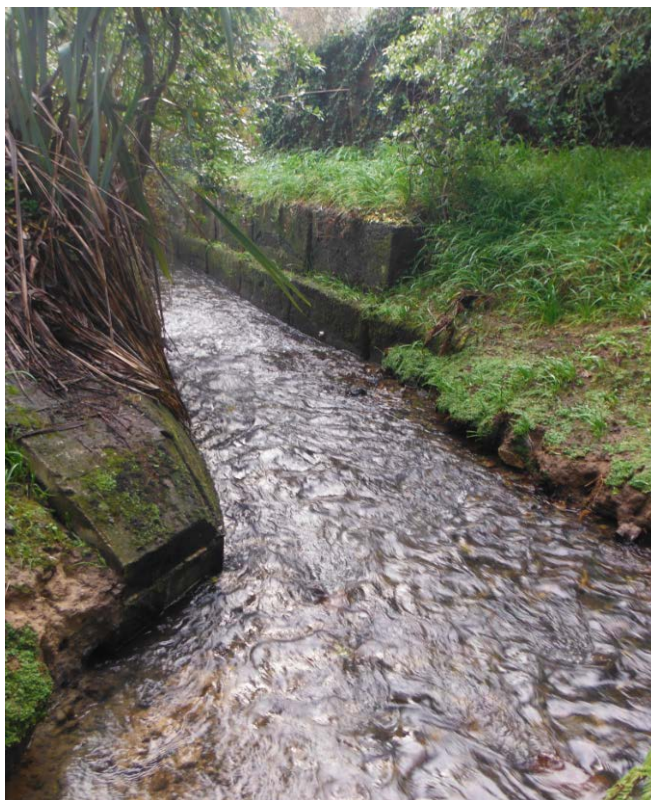
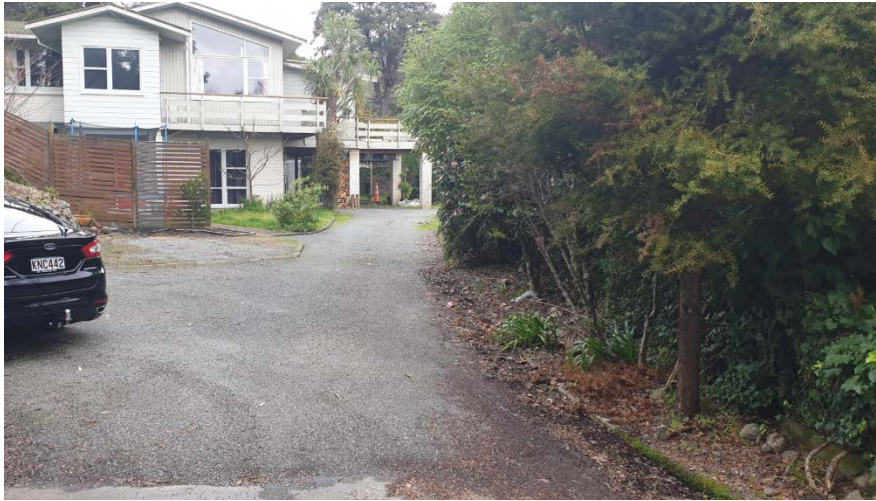
Section 1 10A -10C Birch

Assuming pipe will be approx 450-650mm dia Civil Boss or similar

### Sequence of section 1

1. Remove Bridge and install ramp into stream
2. Install pipe and Dam, working from in the stream, the sediment will most probably be greater than 150g/m<sup>3</sup> but for short term ( activity duration only)
3. Install Sump pump near down steam dam and treat water through sediment curtain

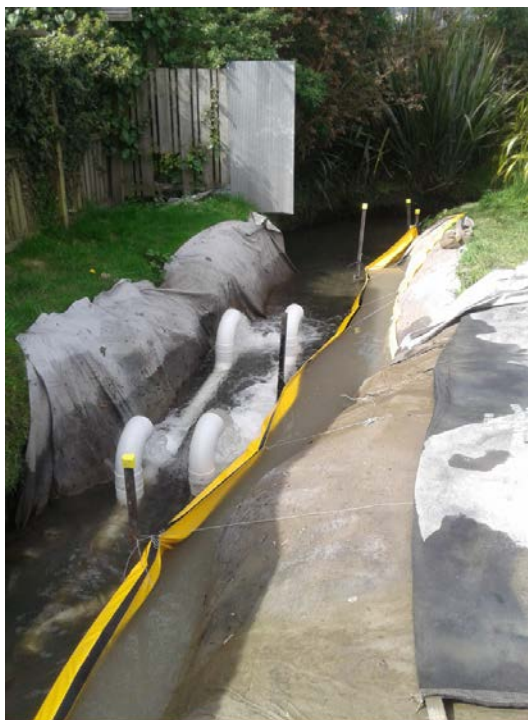
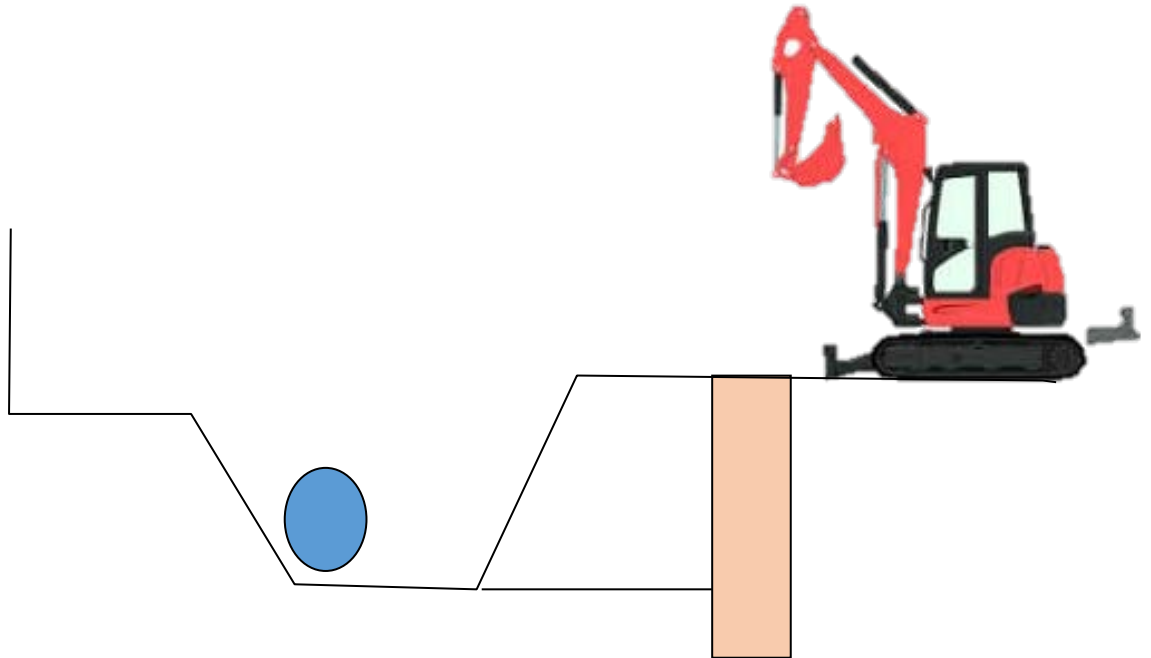
What size pipe is required? What flow will the pipe allow? What happens in a weather event and dams are still in place? Is this a option for all year round?

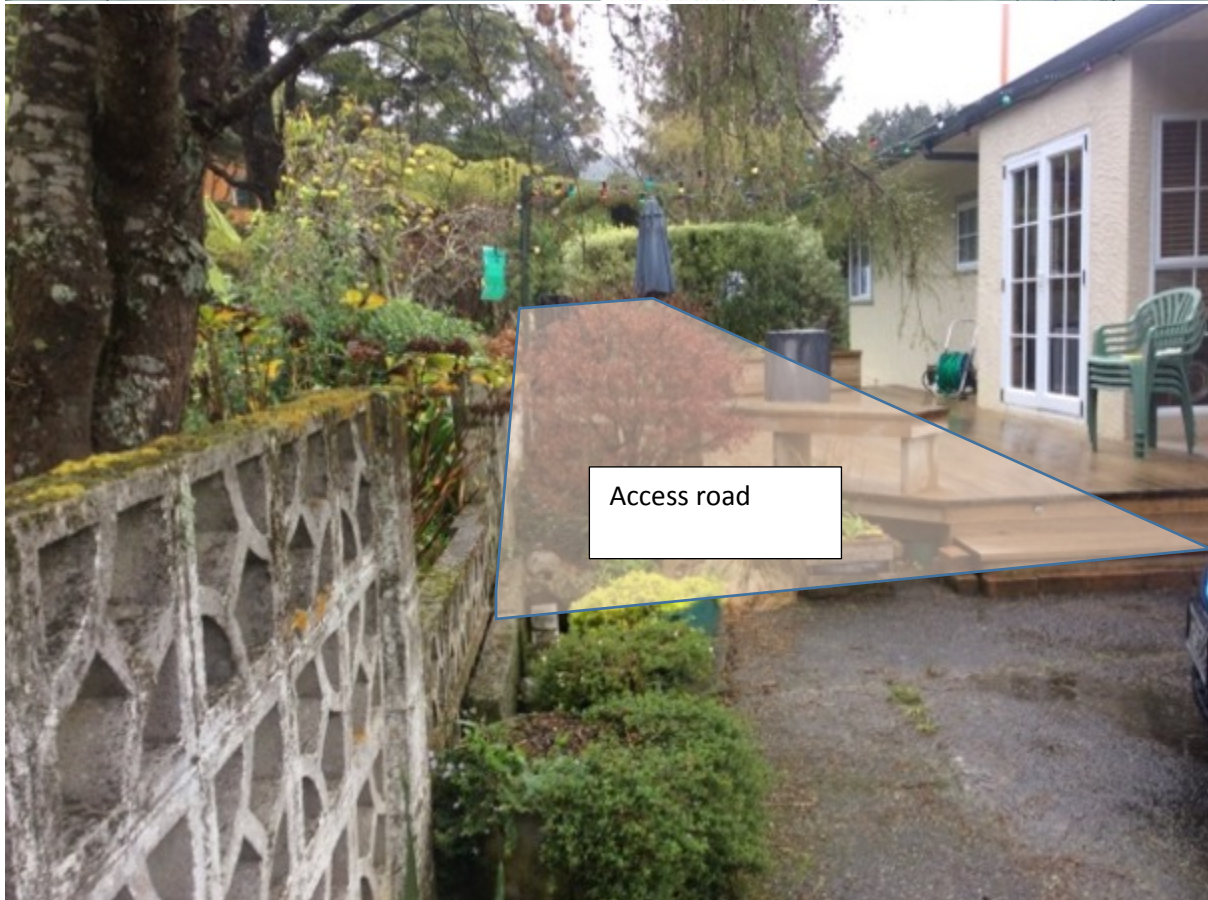
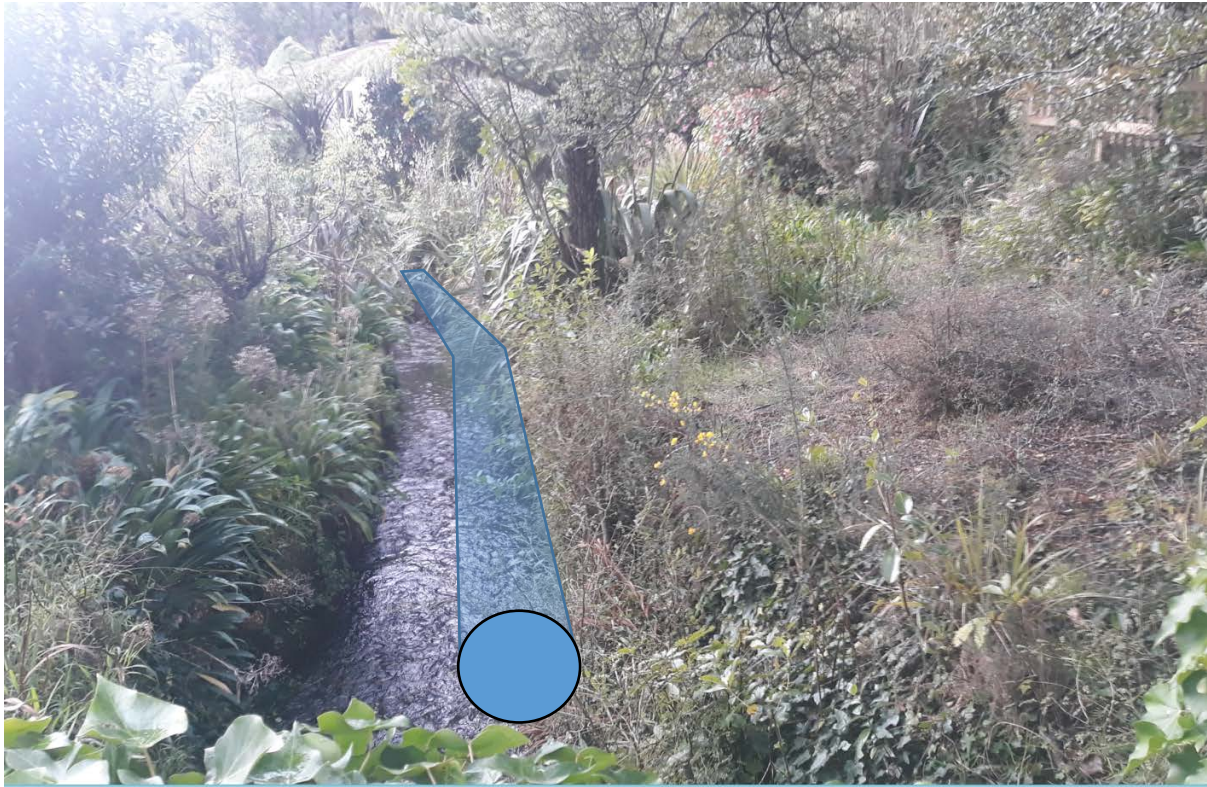
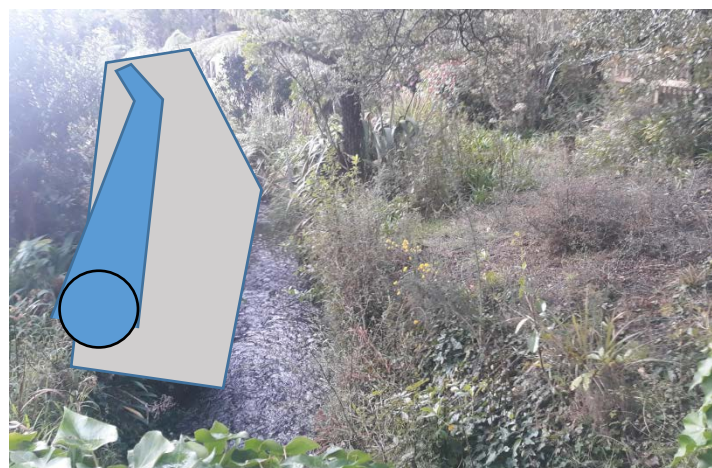
Section 2 – Major stakeholder interaction!!!! 12,11 Birch to 2A Freeman

What is the dam made from? Can this section be constructed at the same time and section 1?

1. Install access road by removing decking and back garden from 12 & 11 Birch
2. Remove garage/shed/office
3. Remove bridge
4. Install dam and pipe ( pipe on right side of stream ) , the sediment will most probably be greater than 150g/m<sup>3</sup> but for short term ( activity duration only)
5. Install ramp into dry stream
6. Excavate and install Left retaining wall up to access ramp
7. Relocate pipe to Left side, install ramp over pipe

8. Excavate and install right side from the dry stream all the way to 2A freeman property
9. Move pipe to the right side
10. Complete left side from the ramp to 2A freeman and remove the ramp (working from the bank/Garden)
11. Remove pipe and dam, the sediment will most probably be greater than 150g/m<sup>3</sup> but for short term ( activity duration only)
12. Install new pedestrian bridge
13. Install new office/ shed
14. Reinstate gardens

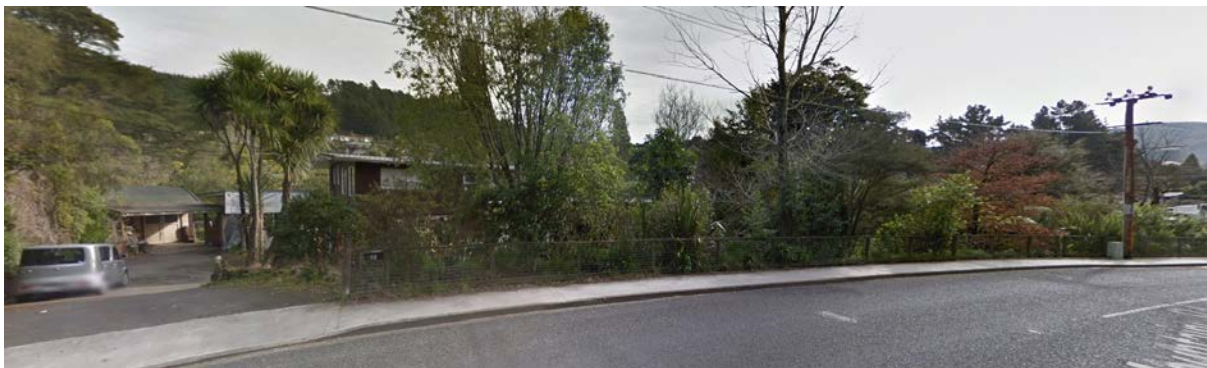
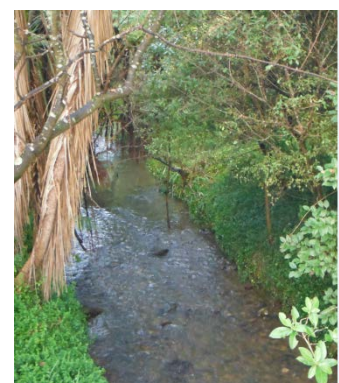
**Section 4      48 Blue Mountain**

1. Install ramp into stream
2. Install dam and pipe on Left side, Excavator to enter stream to install dam, bank High approx 2.5m-3m, most probably the sediment will be greater than 150g/m<sup>3</sup> but for short term ( activity duration only)
3. Remove House
4. Working from the dry stream bed excavate and install new retaining wall and batter
5. Relocate pipe to Right side and install ramp over pipe
6. Construct left side wall /Bank

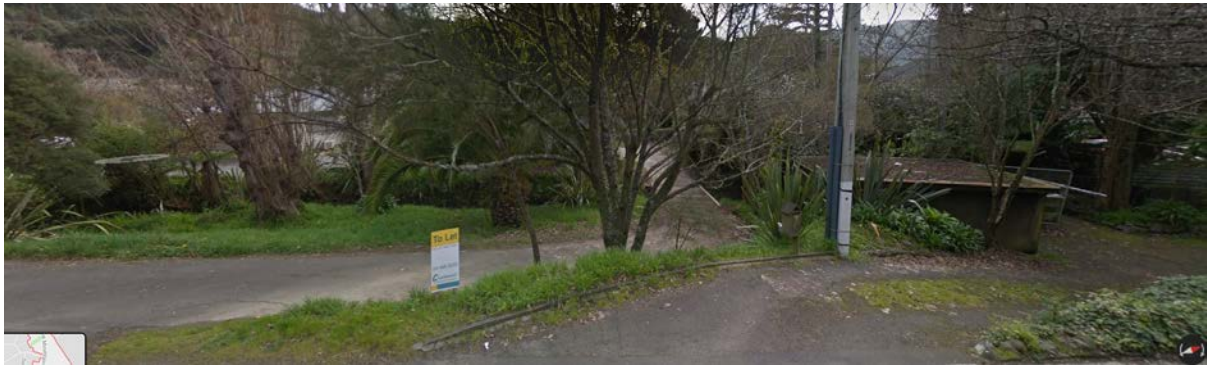
## Section 5 40 -34 Blue Mountain

1. Install private road access
2. Install construction access road along right bank
3. Install Dam and pipe, the sediment will most probably be greater than 150g/m<sup>3</sup> but for short term ( activity duration only)
4. Remove bridges
5. Excavate and install Right retaining wall
6. Move pipe to the right side
7. Excavate and install Left retaining wall from Private access lane ( no vehicle access for the residence, only pedestrian)

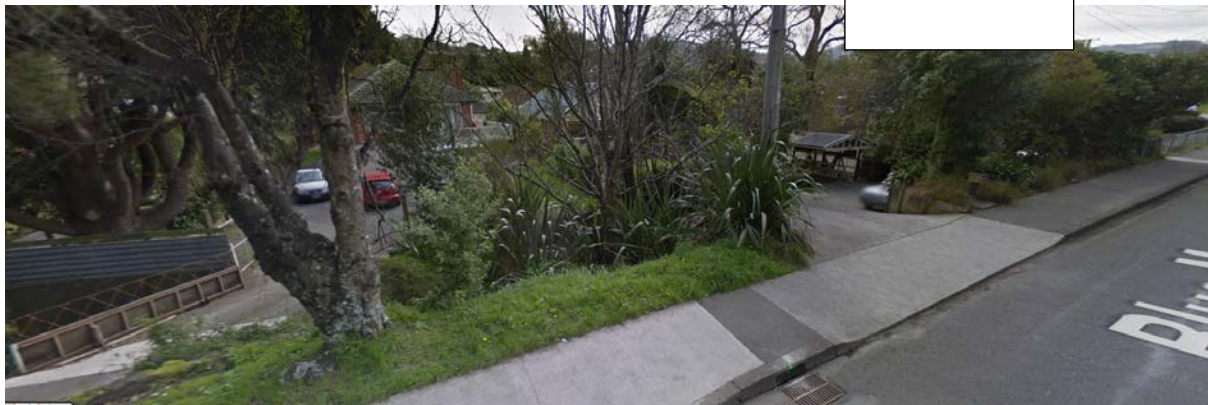
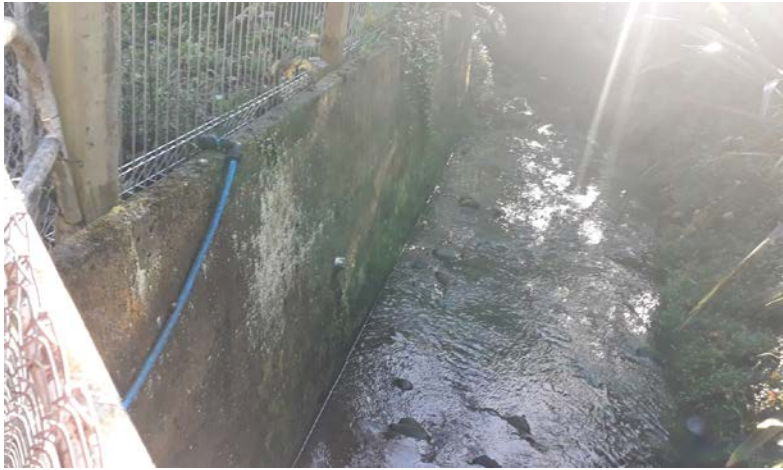
Section 6 32 -28 Blue Mountain

1. Install Temp bridge at 28 Blue mountain and install new private lane
2. Install dam and pipe on Left side into new diverted stream location (section 7 already constructed off line) the sediment will most probably be greater than 150g/m<sup>3</sup> but for short term ( activity duration only) **Is there enough room for pipe and excavator?** Take site measurement

3. Remove stakeholders bridges
4. Install temp pedestrian bridge or can they gain pedestrian access from 34 Blue mountain?
5. Install access ramp over pipe
6. Construct Right Retaining wall
7. Move pipe to the Right side and construct the Left
8. Remove pipe and dam

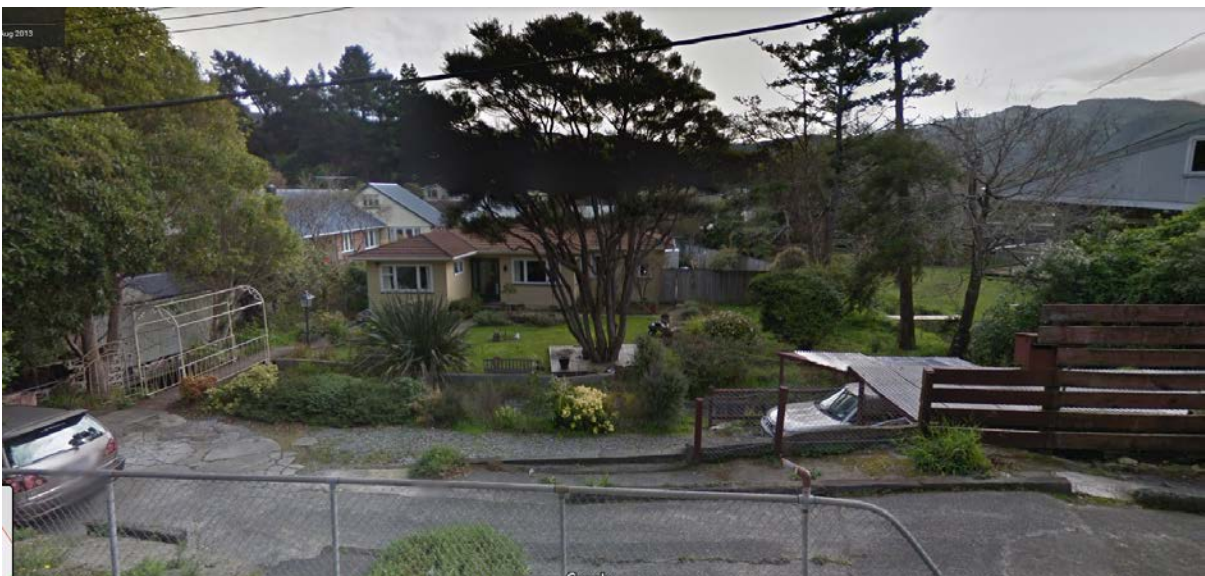
28 Blue Mountain

Constructed off line to the stream

Connection and diverting the stream will elevate the sediment levels, but for short term only

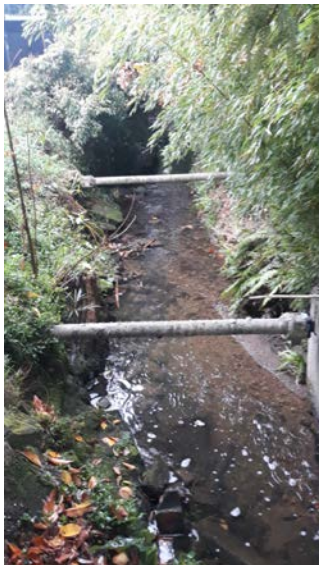
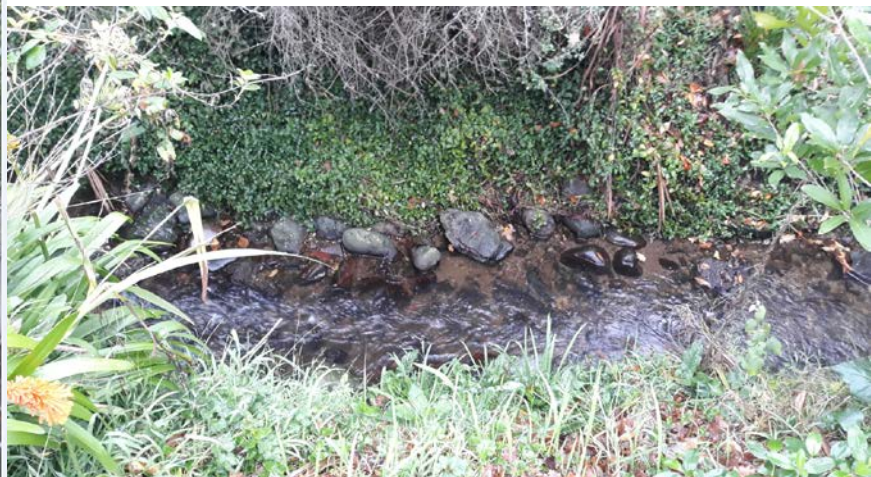
## Section 8 26 Blue mountain to Sunbrae Culvert

1. Sewers to be diverted before these section starts
2. Install dam and pipe work on the right side of the stream, the sediment will most probably be greater than 150g/m<sup>3</sup> but for short term ( activity duration only)
3. Install ramp over pipe
4. Excavate and install new Left Batter Bank
5. Relocate pipe to the Left side of the river
6. Excavate and install Right side of batter bank
7. Remove Dam and pipe , the sediment will most probably be greater than 150g/m<sup>3</sup> but for short term ( activity duration only)

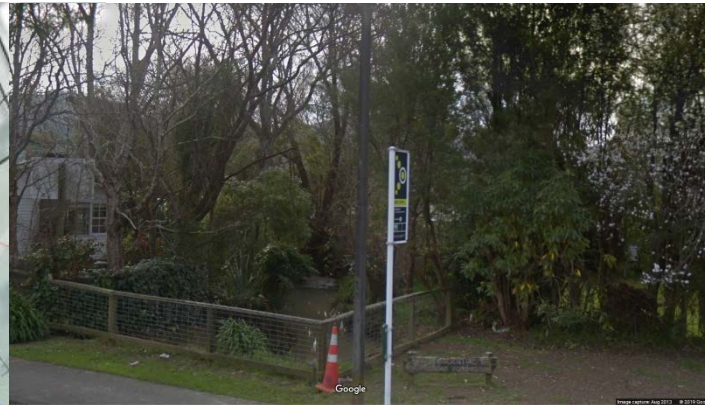
## Section 9 4 Sunbrae to 1 Tapestry

1. House to be removed before this section starts
2. Install dam and pipe, the sediment will most probably be greater than 150g/m<sup>3</sup> but for short term ( activity duration only)
3. Excavate and construct retaining walls on the right side from the dry stream bed
4. Relocate pipe to the right
5. Excavate and install retaining wall on the left from the dry stream bed

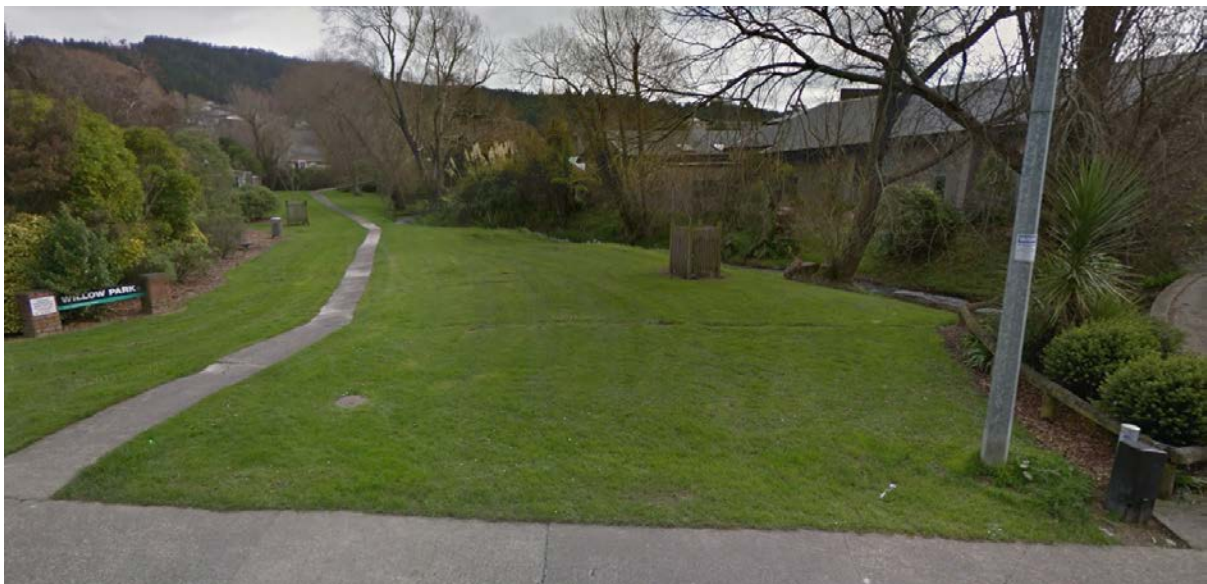
## Section 10 Willow Park

1. Dam and Install pipe
2. Excavate Willow park to new formation
3. Remove dam and pipe

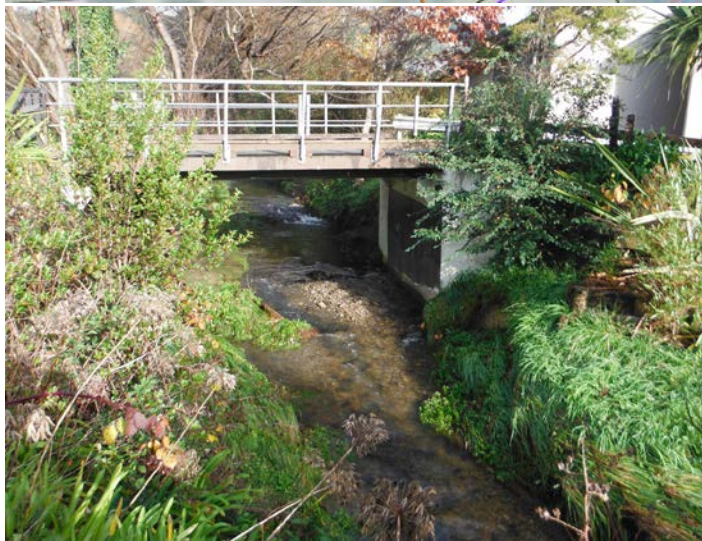
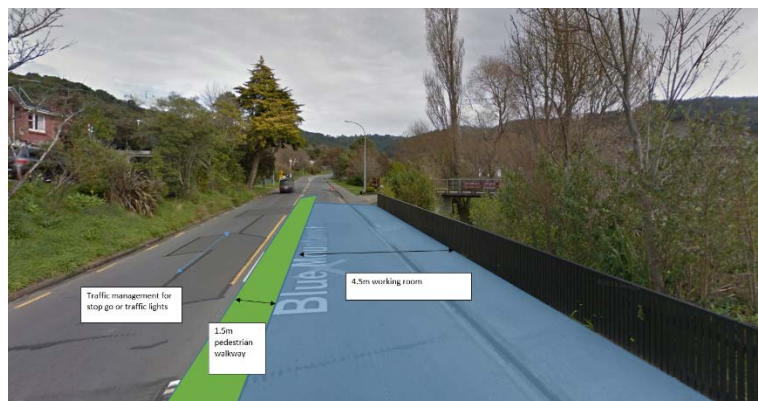
**Section 11 Reformed Church**

1. Install Bund and pipe
2. Construct both sides form top of bank with larger plant
3. If existing bridge cannot take the construction load, then work will be completed from in the dry stream bed

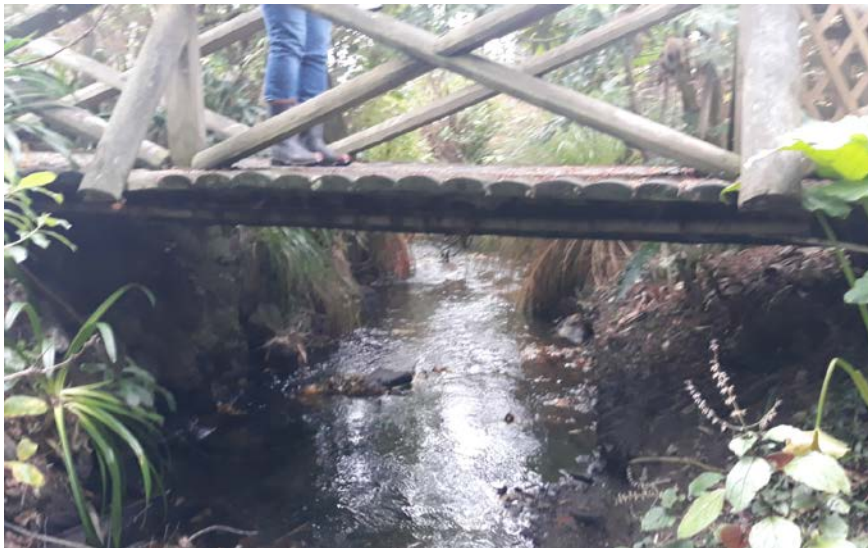
## Section 12 56-48 Whitemans

This section of stream will not be upgraded, but the existing bridges are to be replaced.

There is not enough room to install a pipe and track down the stream

The excavator would be required to be in the live stream on 4no visits. Track in to remove 2no bridges and then replace them.
