Upper Hutt City Council Residential & Rural Chapter Review

This page has been left intentionally blank

Residential & Rural Chapter Review

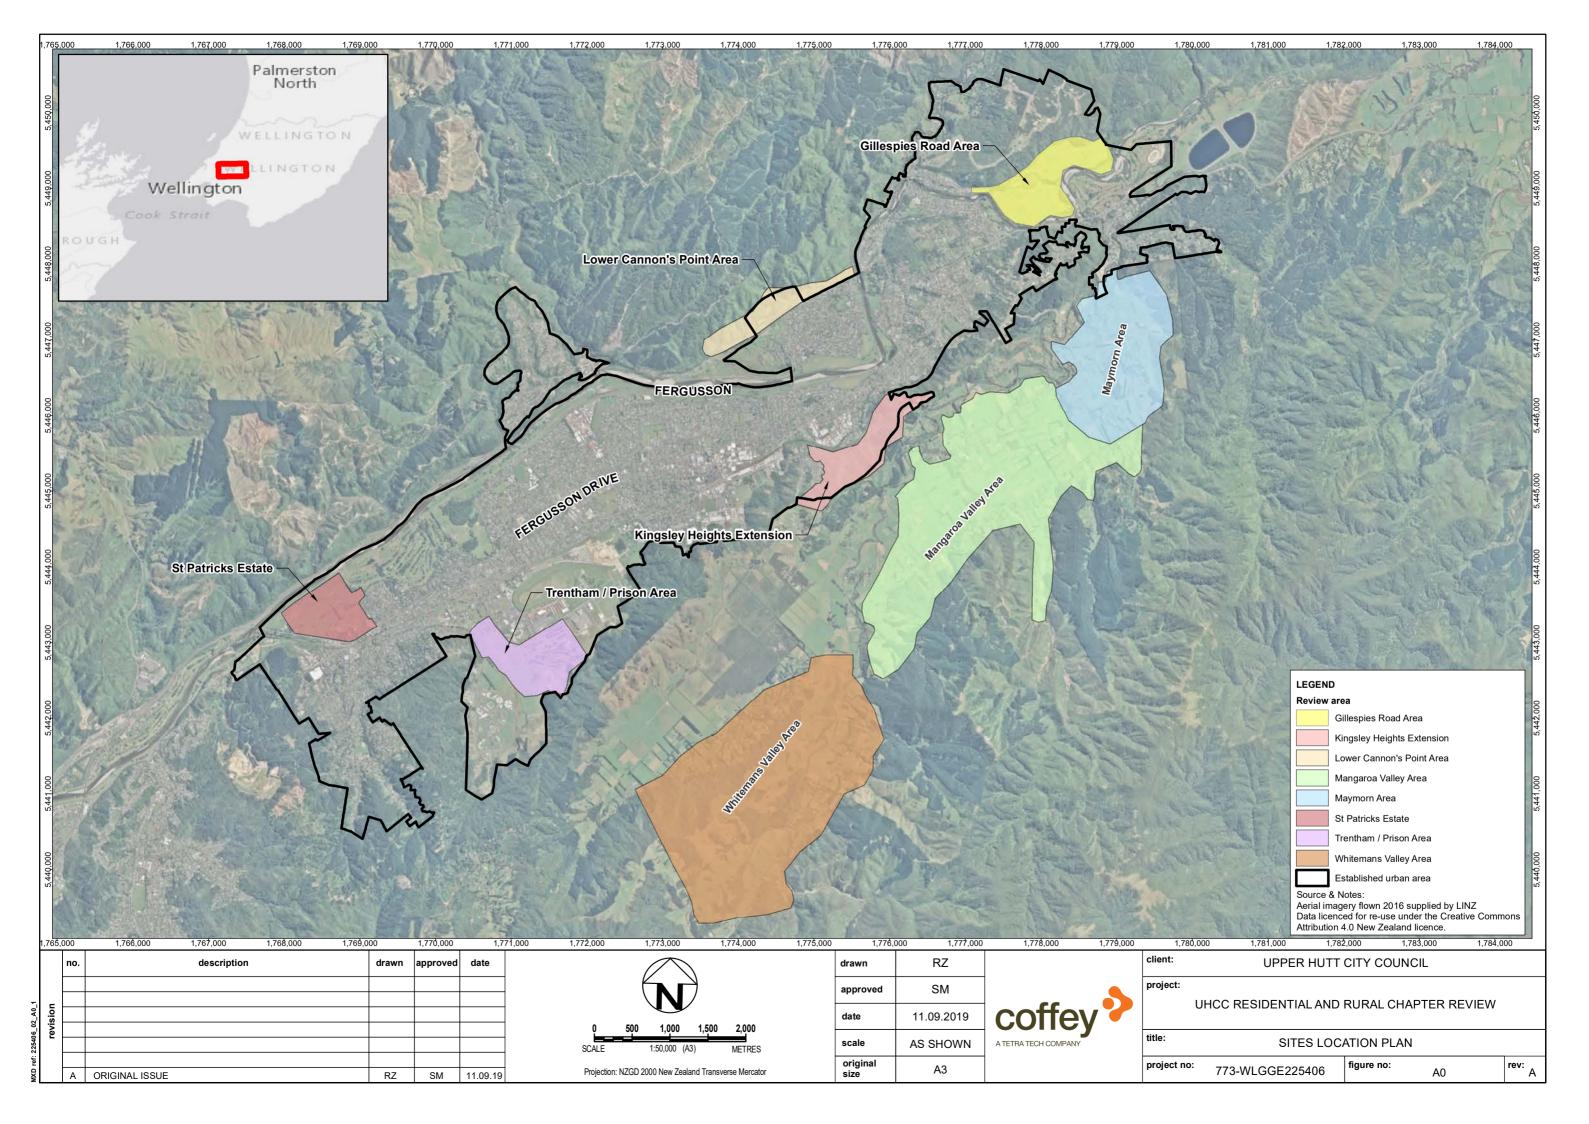
- 1. Gillespies Road Area;
- 2. Maymorn Area;
- 3. Mangaroa Valley Area;
- 4. Kingsley Heights Extension;
- 5. Lower Cannon's Point Area;
- 6. Whitemans Valley Area;
- 7. Trentham/ Prison Area;
- 8. St Patricks Estate; and
- 9. Established Urban Area noted as "Urban Rural Boundary (Iteration 2)".

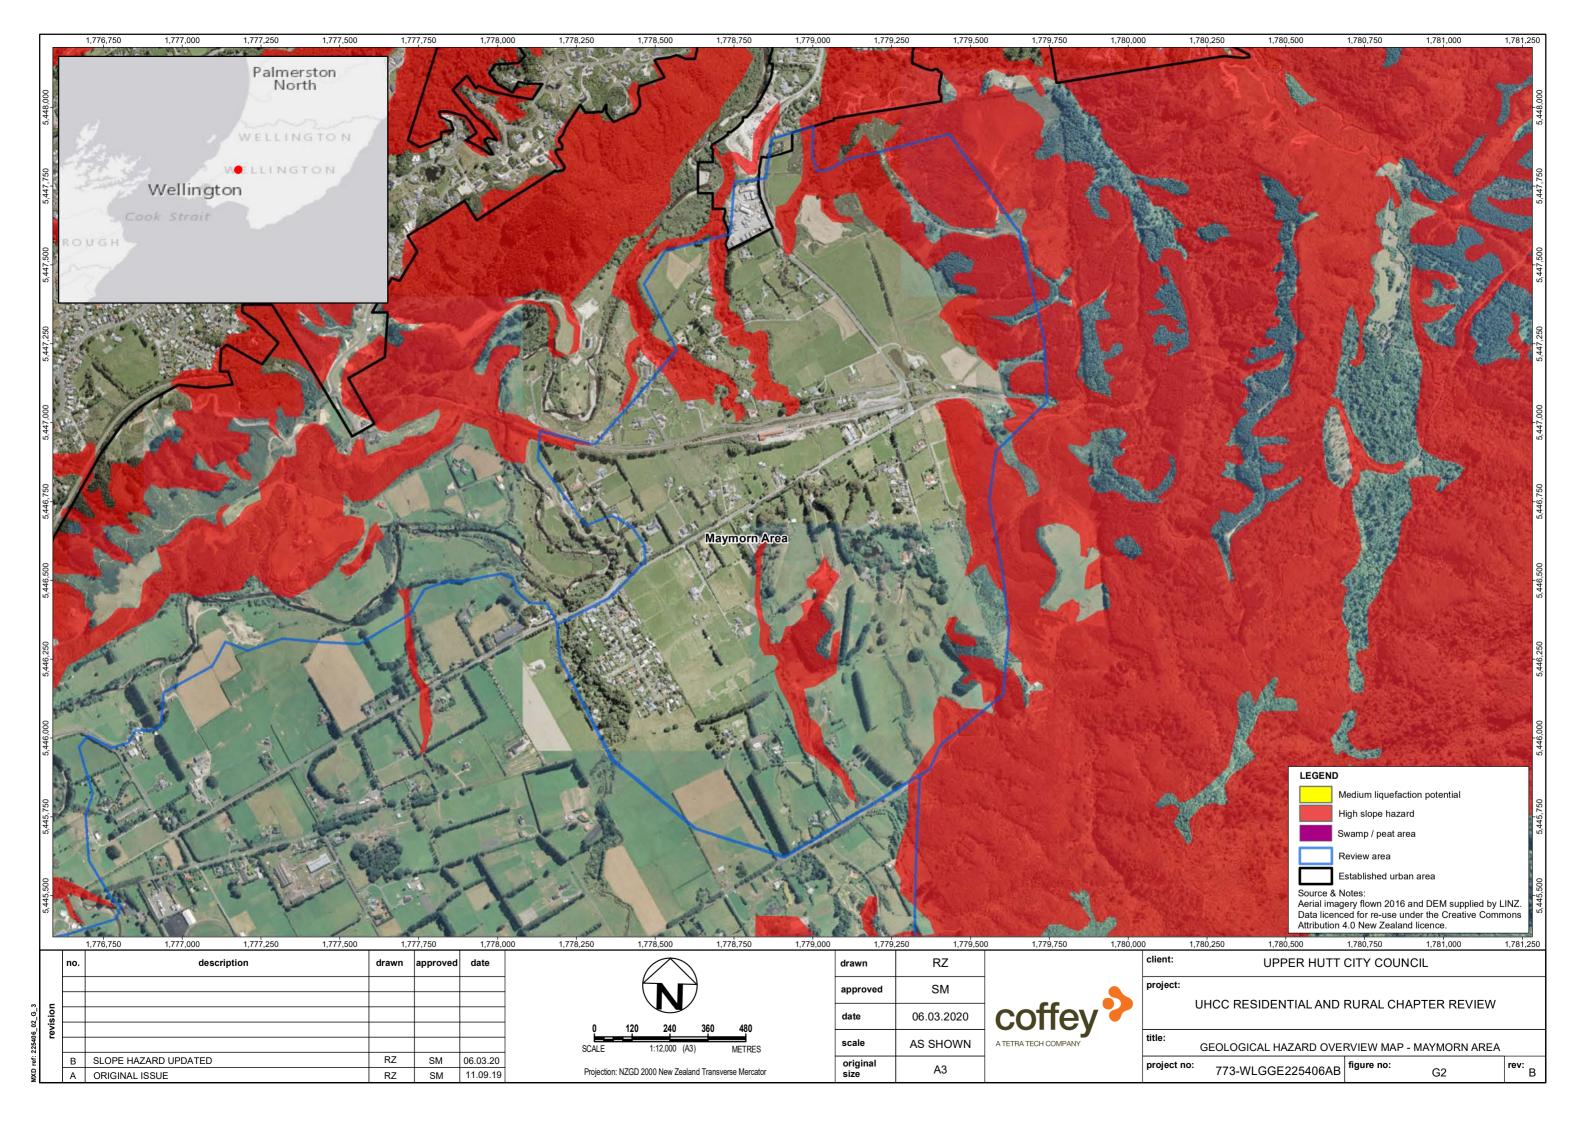
The Maymorn, Mangaroa and Whitemans Valley Areas are located in a basin/valley separated from Upper Hutt basin/valley by a low, north-east trending range of greywacke hills. The Mangaroa Valley is at an approximately 100m higher elevation than Upper Hutt. The Mangaroa/Maymorn Area is accessed by Maymorn Road from SH2 at Te Marua in the north, by Mangaroa Hills Road and Wallaceville Road into Upper Hutt to the south-west, and Whitemans Valley Road through Blue Mountains to Silverstream in the south.

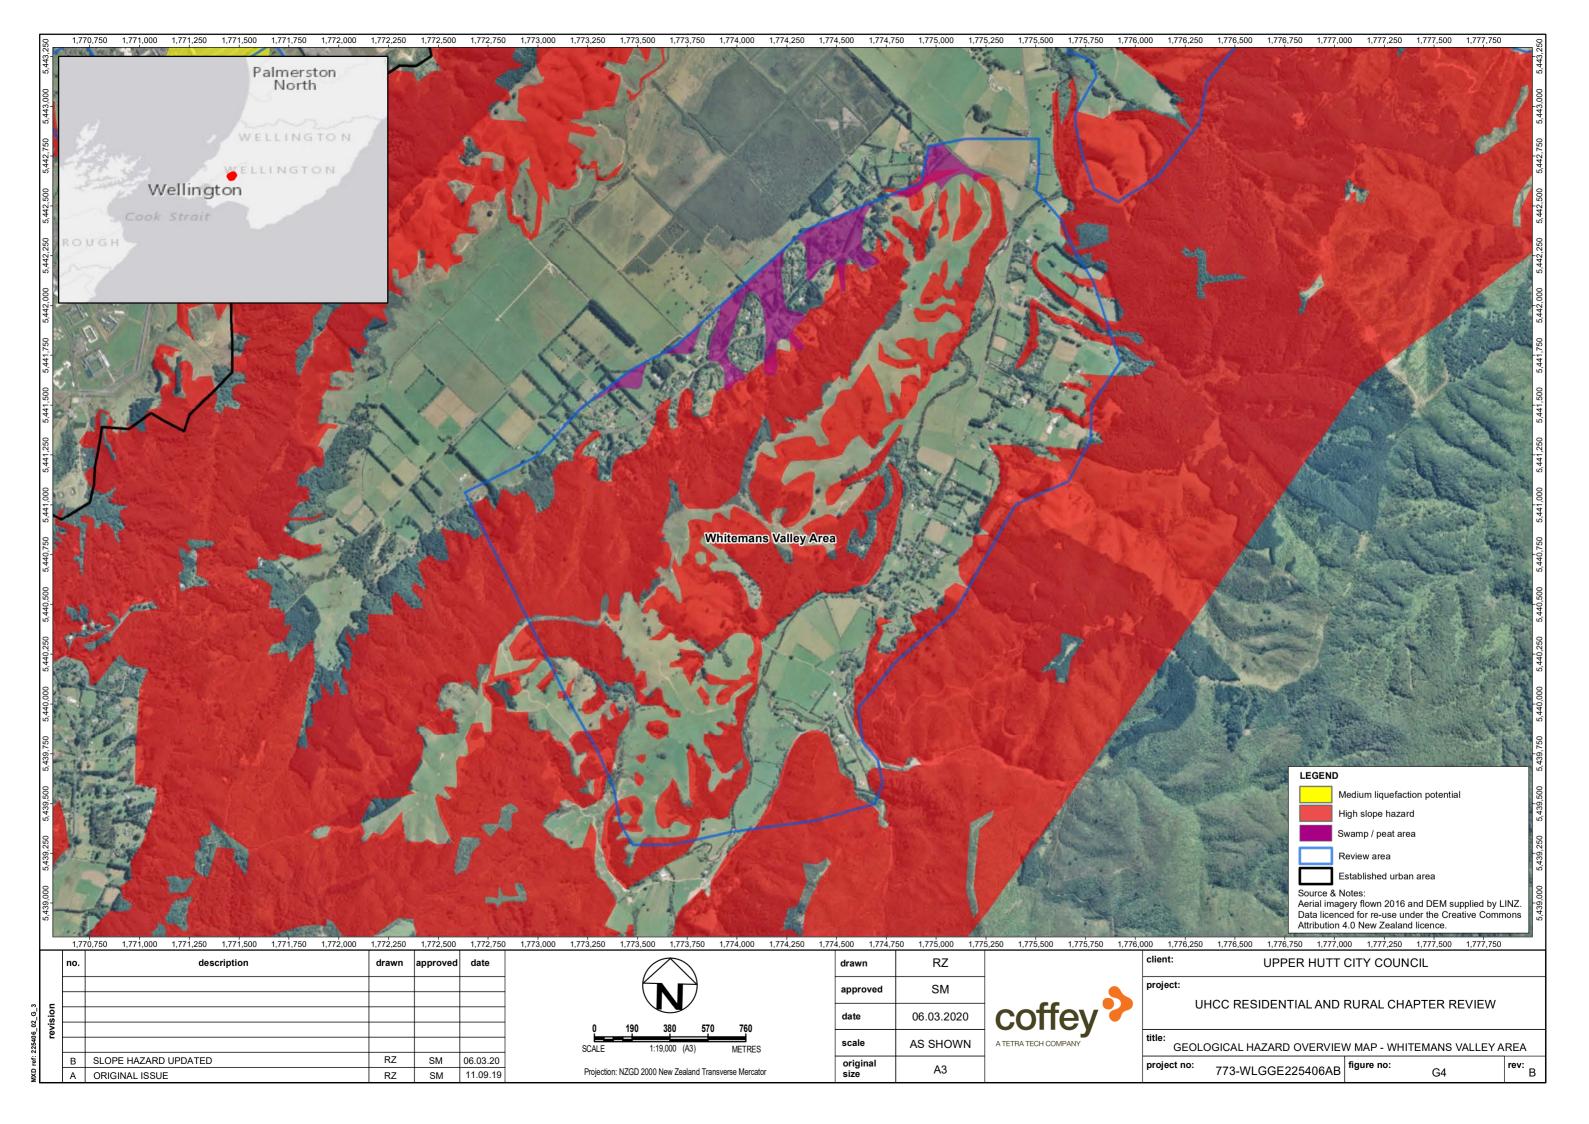
As is the case for Maymorn and Mangaroa Areas, the Whitemans Valley Area is accessed by Maymorn Road from SH2 at Te Marua in the north, by Mangaroa Hills Road and Wallaceville Road into Upper Hutt to the south-west, and Whitemans Valley Road through Blue Mountains to Silverstream in the south.

3.7.1. Geology

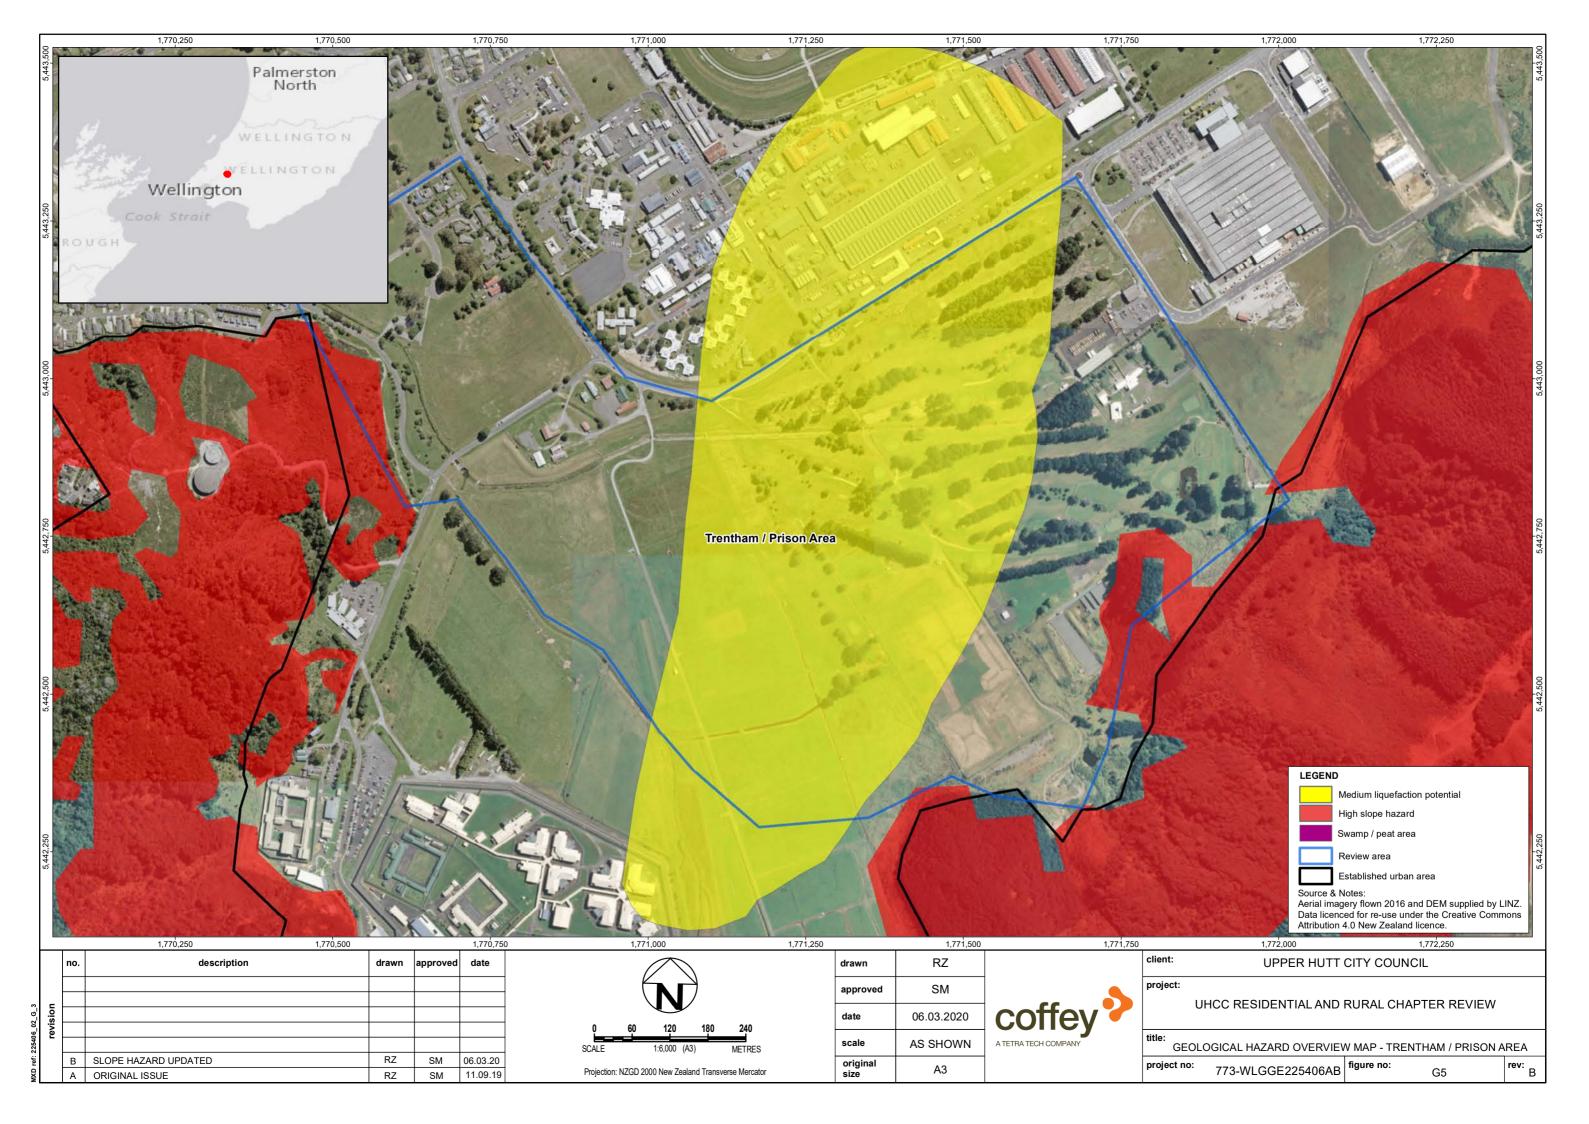
The Trentham /Prison Area is located at the southern end of the of Upper Hutt basin. It backs onto the Blue Mountains to the east and to Rimutaka Prison to the south. The land is predominantly defence force land as part of Trentham Military base. It also includes Trentham Camp Golf Club and Davis sports field. To the north of the site is Trentham Racecourse and residential dwellings.

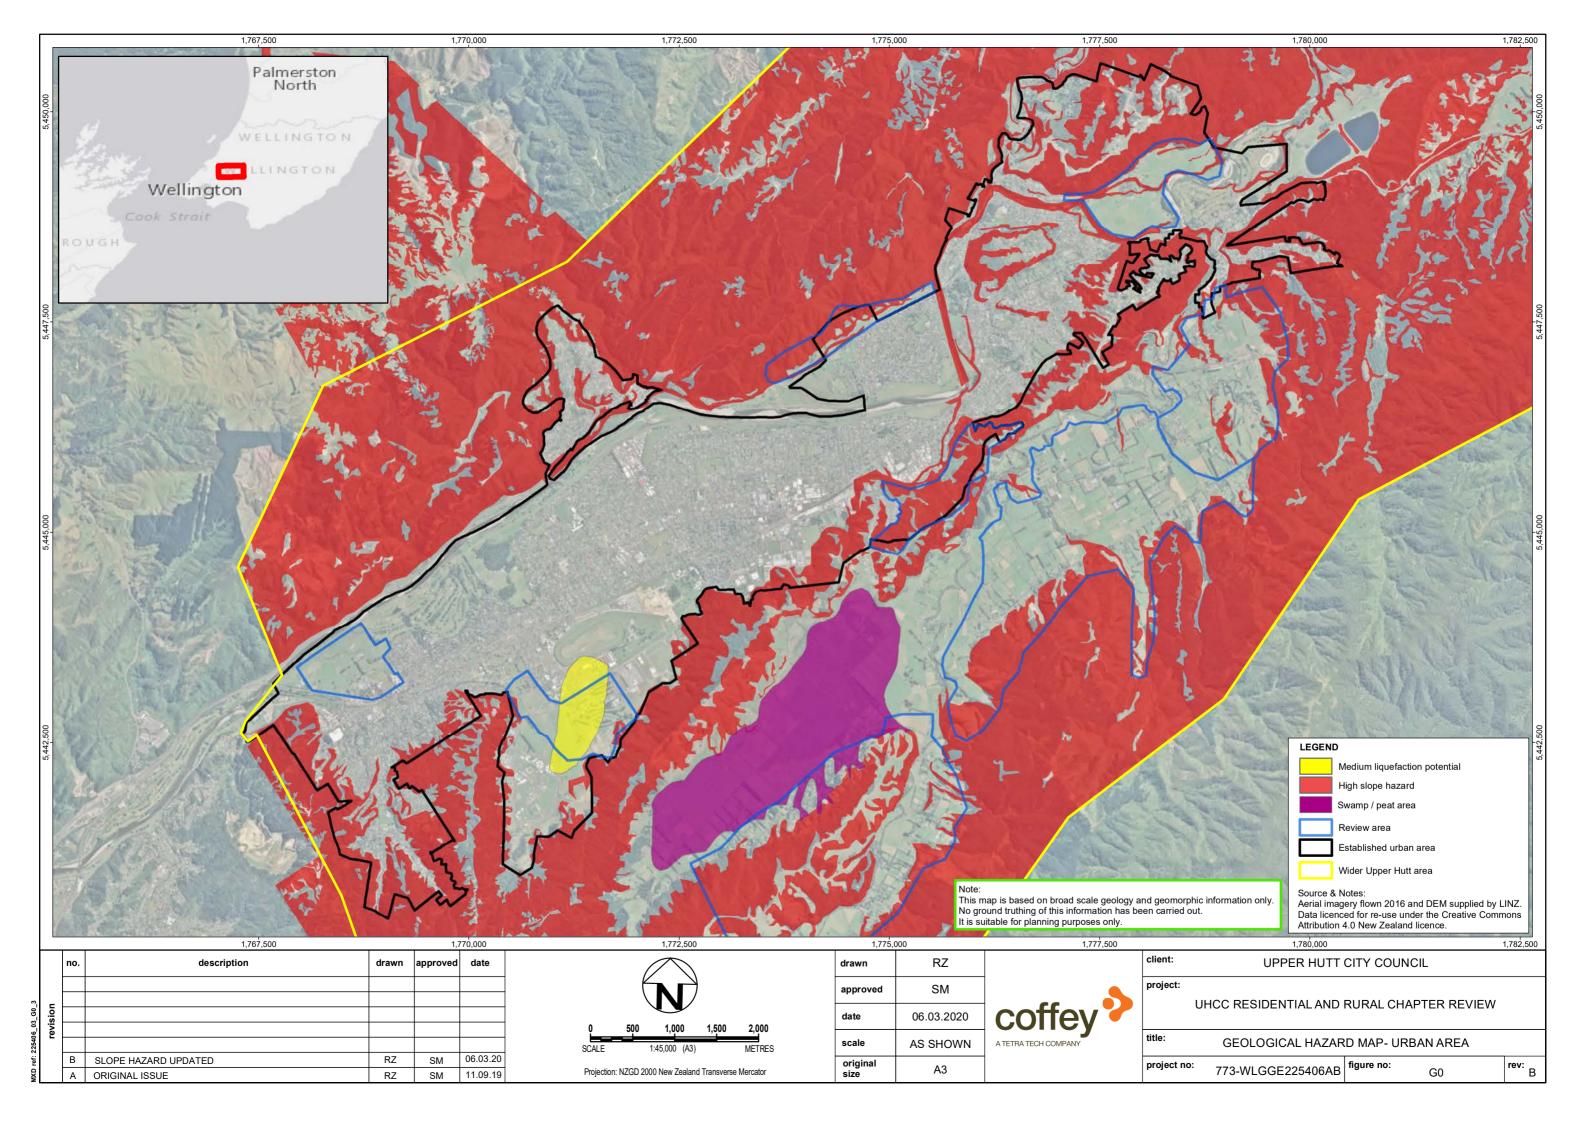
The flat (blue) area is mainly the Holocene flood plain terrace of the Hutt River. At Totara Park it has older, more elevated terraces uplifted by the Wellington Fault which passes through the area along California Drive. At Silverstream and Pinehaven there are alluvial valleys in the greywacke hills. At Riverstone Terraces there are ancient river terraces, also uplifted by the Wellington Fault.

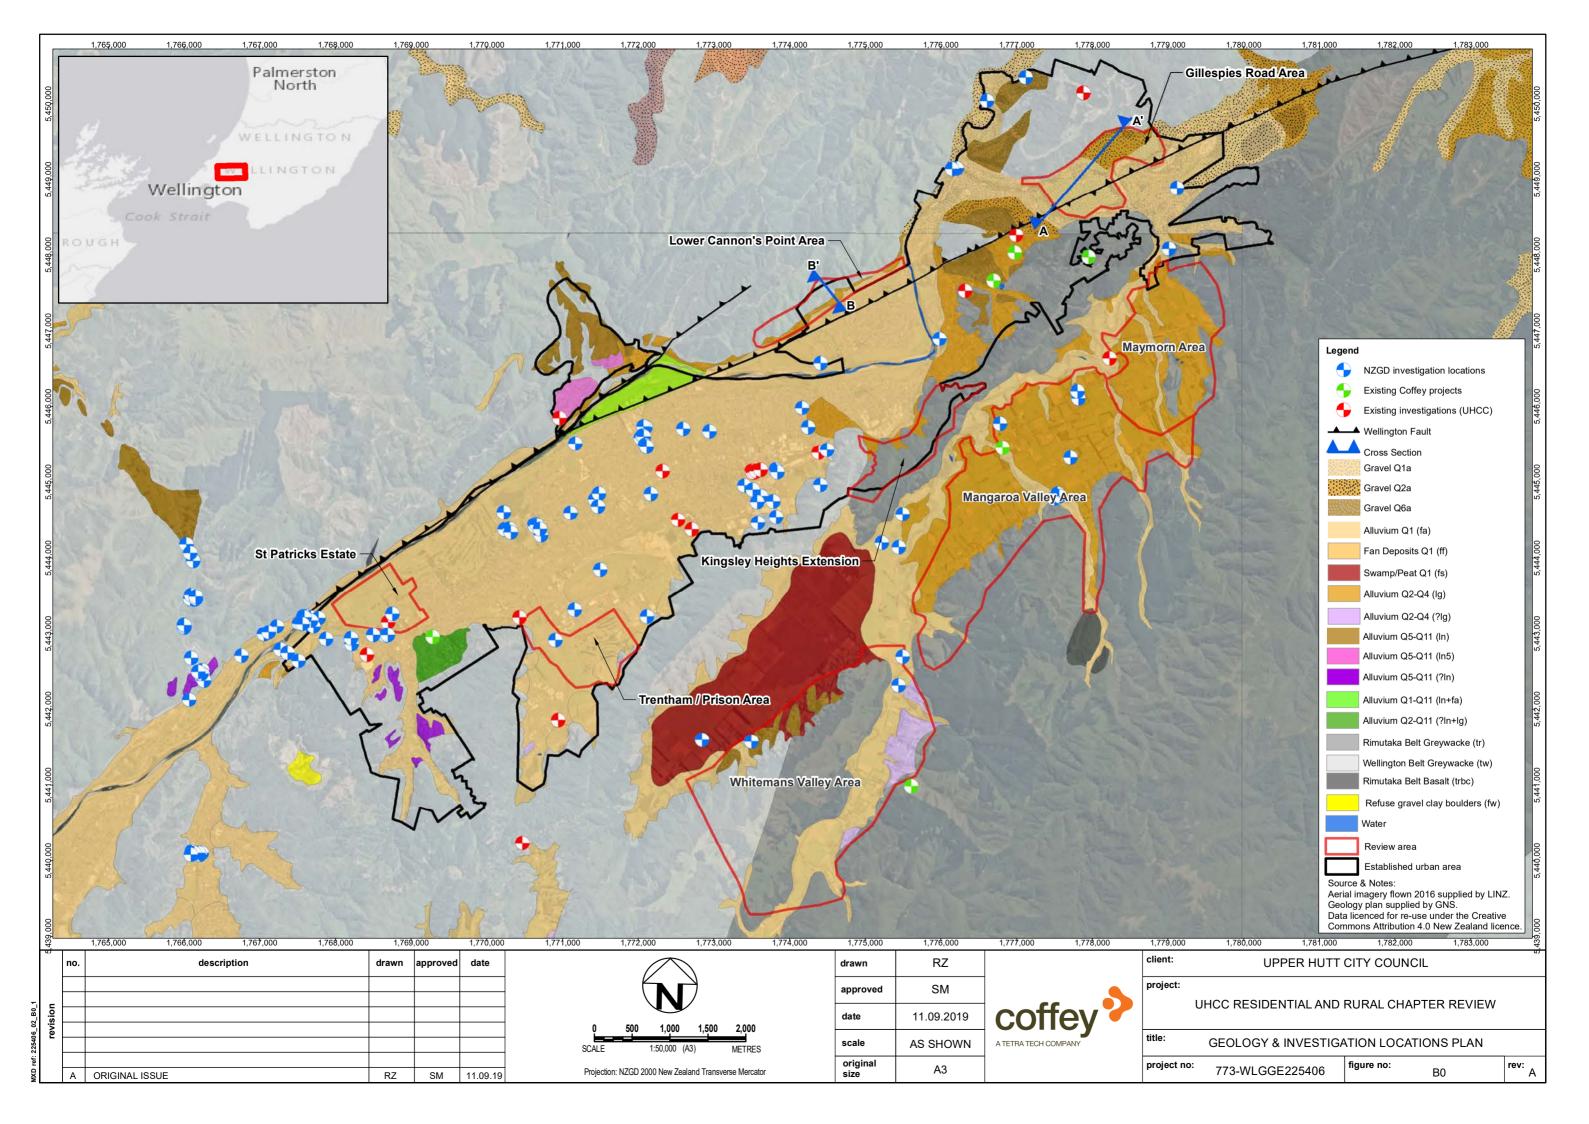
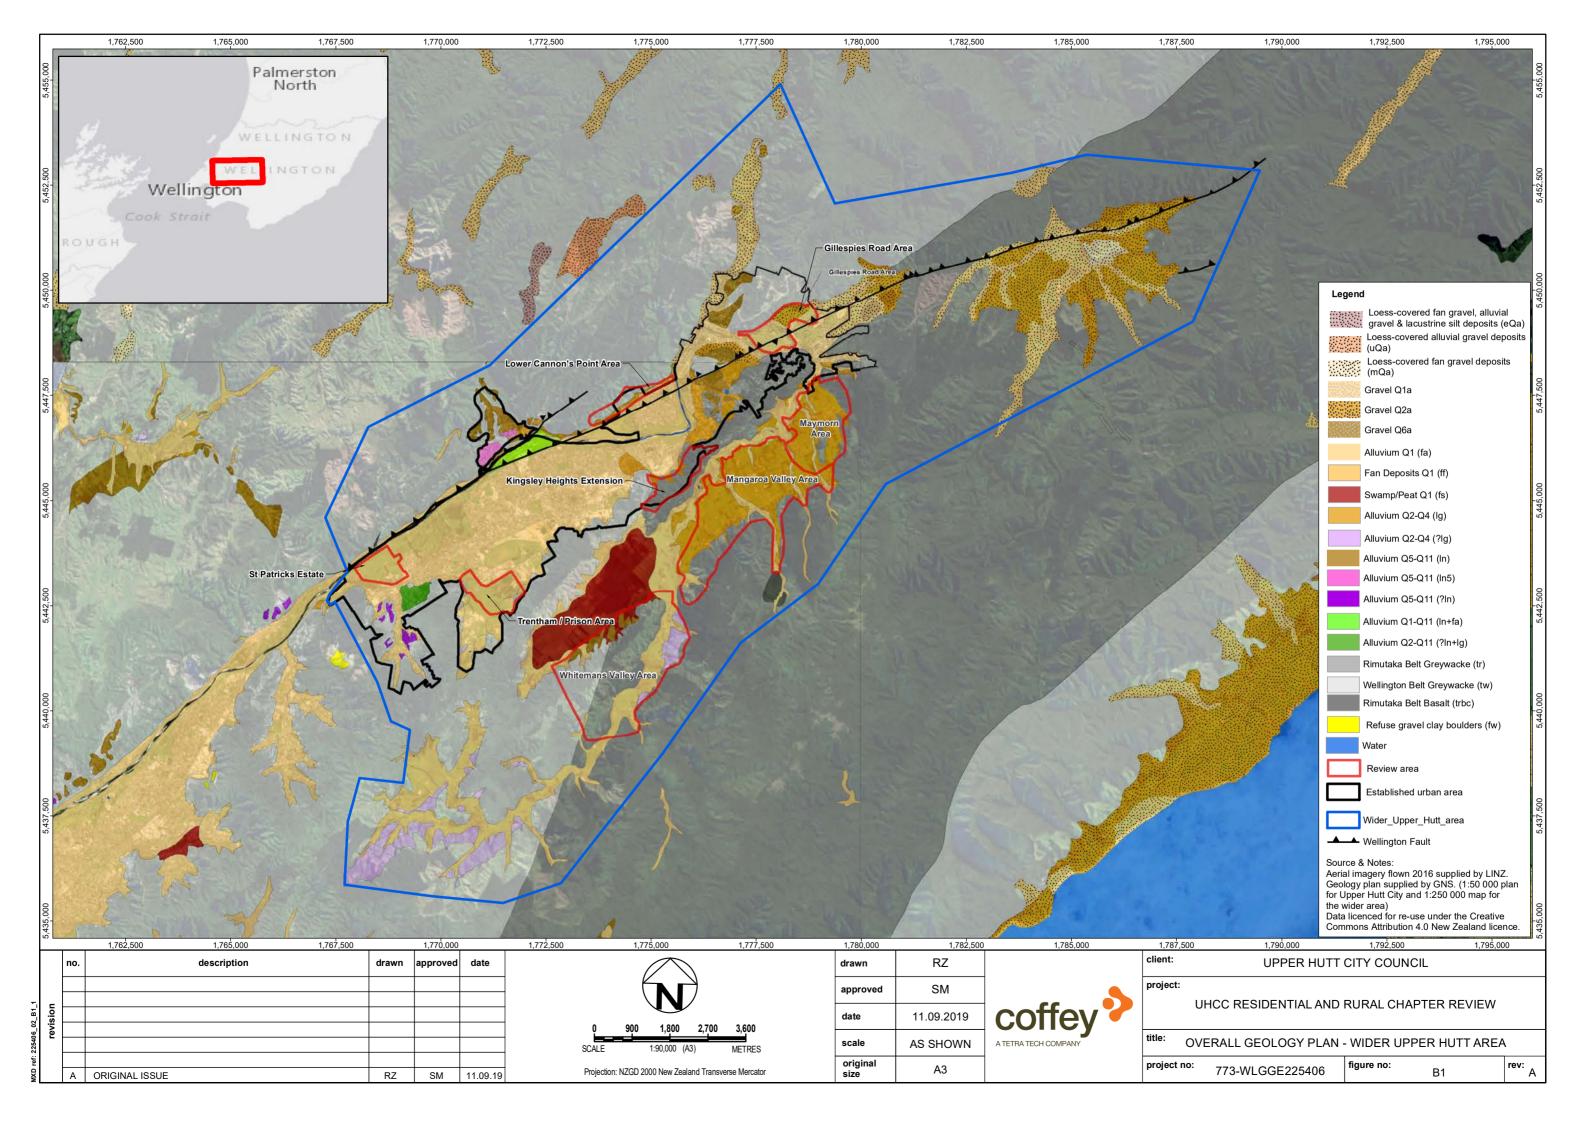
- B 0 Geology and Investigation Locations Plan
 B 1: Overall Geology Plan Wider Upper Hutt Area

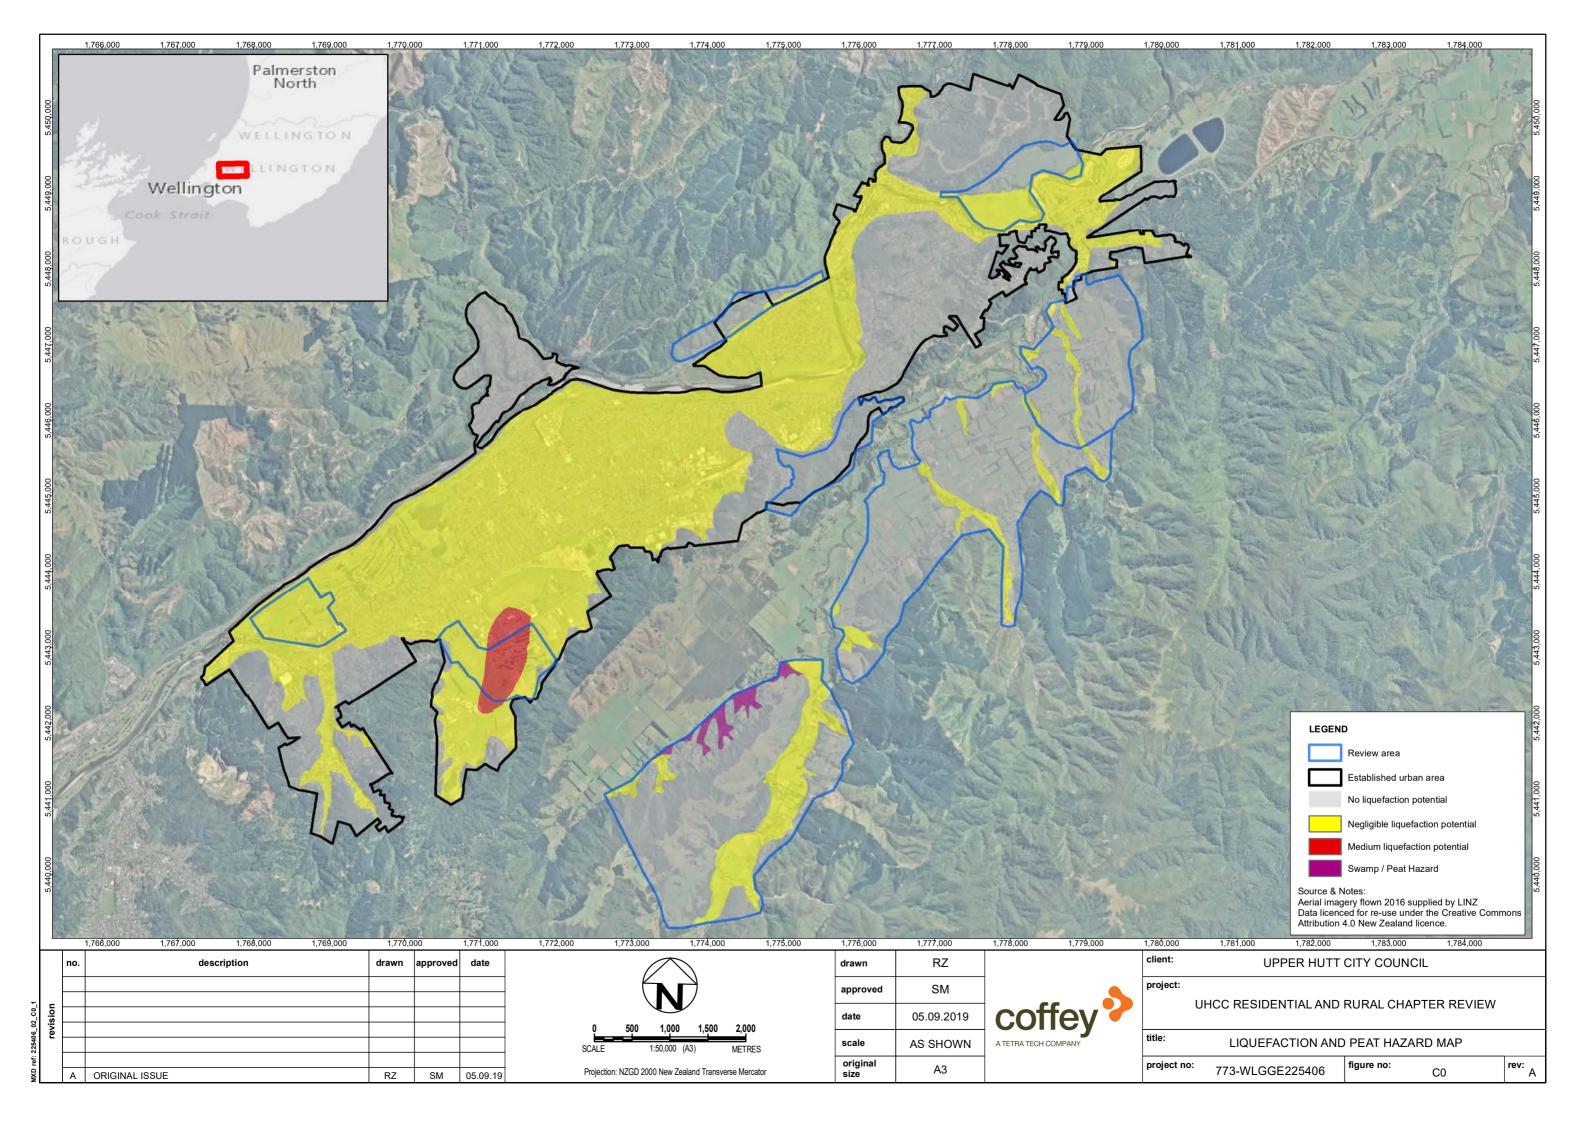
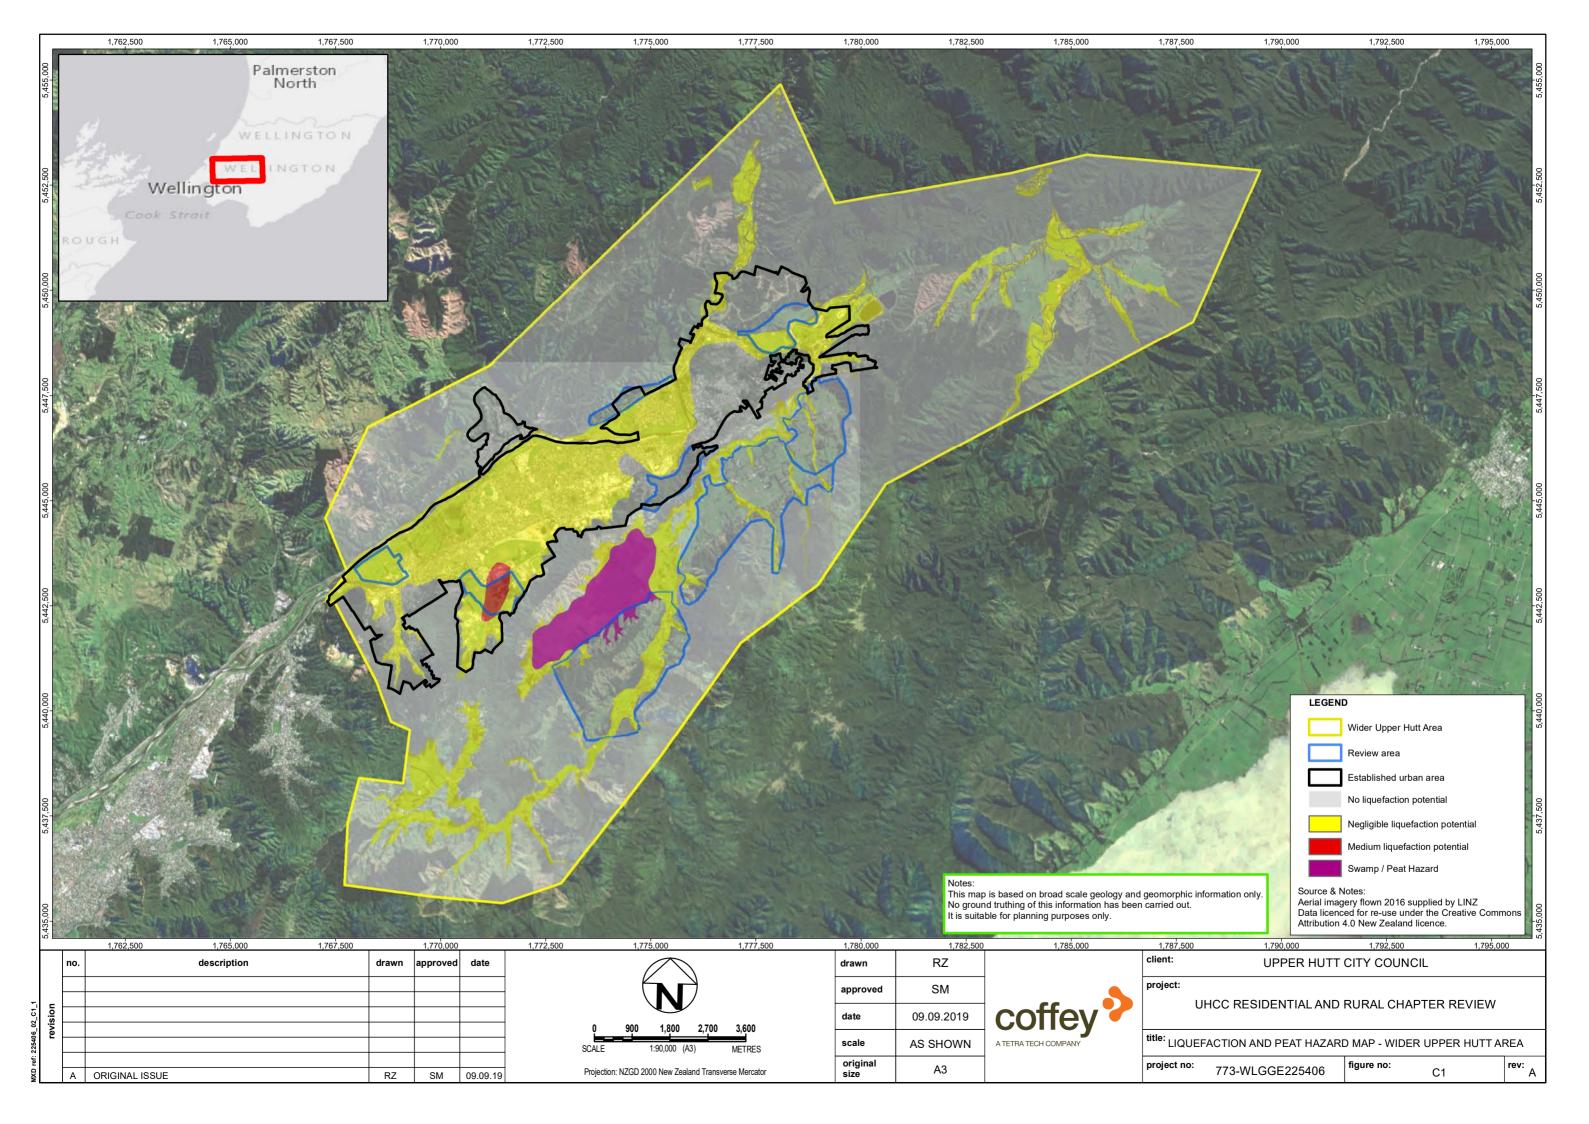
C - 0: Liquefaction and Peat Hazard Map
C - 1: Liquefaction and Peat Hazard Map – Wider Upper Hutt Area

Trentham/Prison Area: A medium liquefaction potential has been identified in part of the Trentham/Prison Area and adjacent urban area. This is based on previous studies that have identified this hazard based on "peaty soils". As discussed in section 3.8 above, based on the information available to us, we do not believe this area has an elevated liquefaction hazard. We have not been able to sight the original data this assessment is based on. As such do not have sufficient confidence to remove this medium hazard area without viewing the existing information or additional investigation in the area. An intrusive investigation of the order of 2-3 days CPT work (large truck mounted rig – 20 tons) to ~10 to 20m depth or refusal within this area would be sufficient to better characterise the liquefaction hazard.

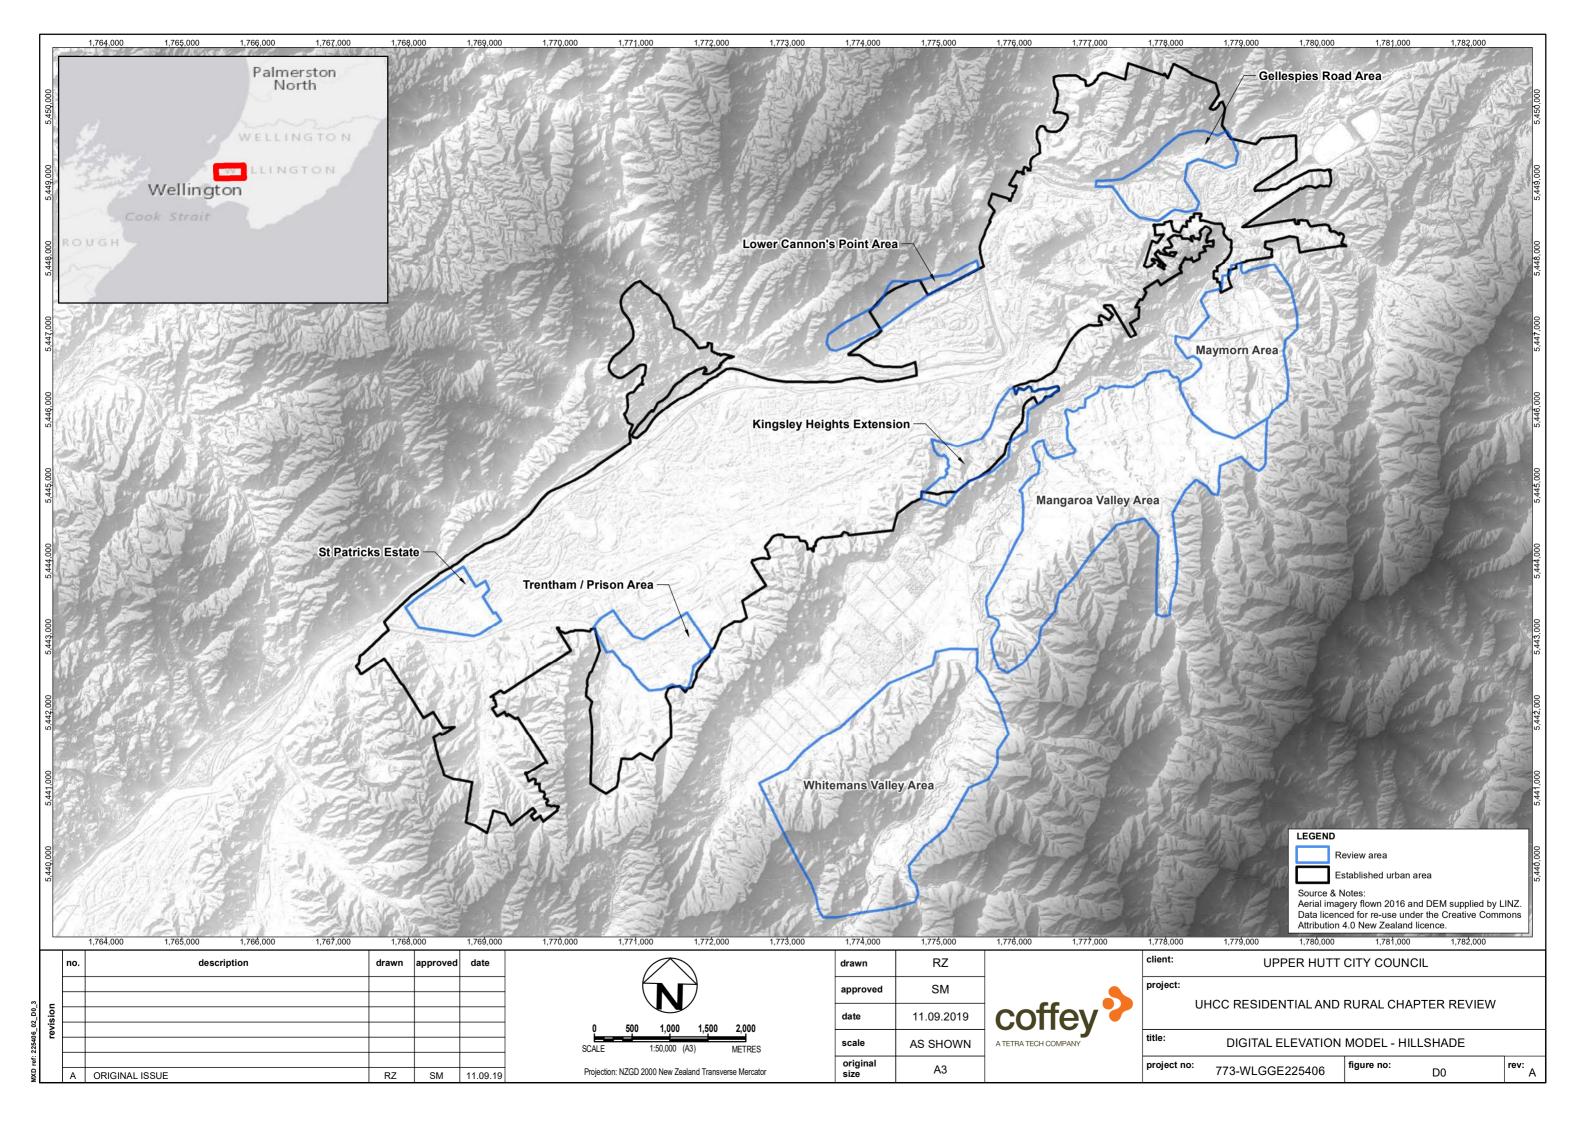
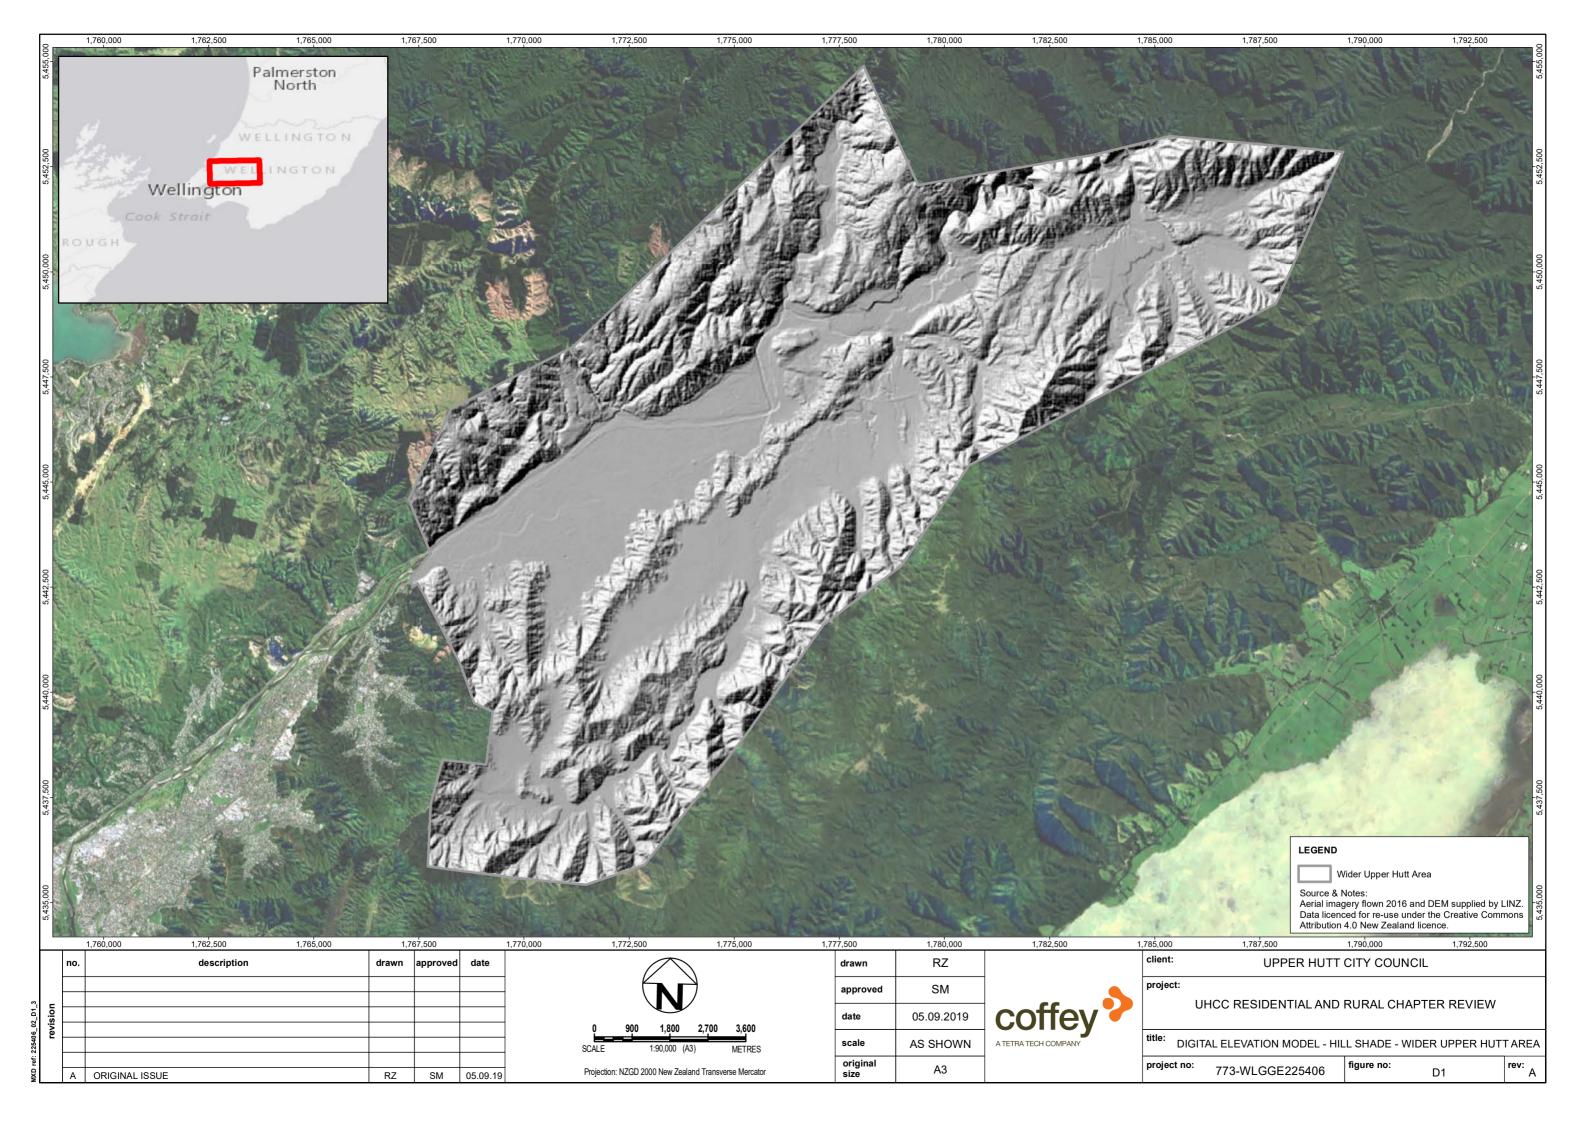
Figure D - 0: Digital Elevation Model – Hillshade Figure D - 1: Digital Elevation Model – Hillshade – Wider Upper Hutt Area
