Upper Hutt City Council Residential & Rural Chapter Review

This page has been left intentionally blank

Residential & Rural Chapter Review

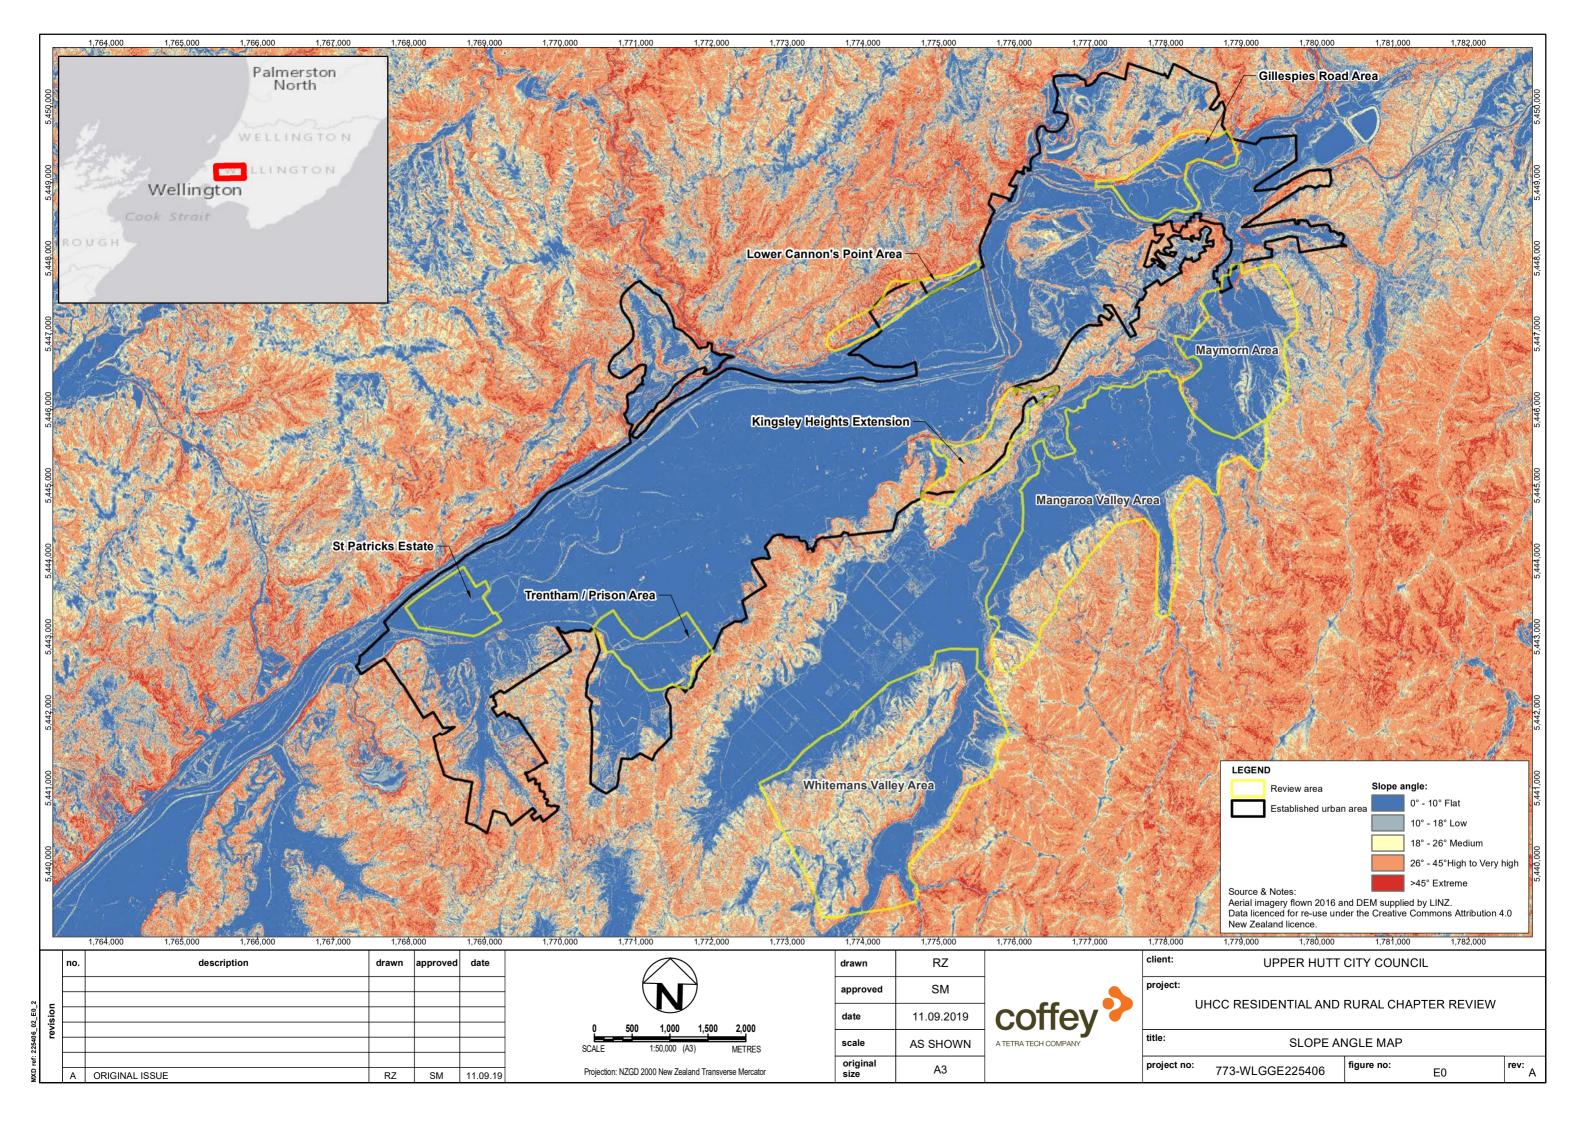
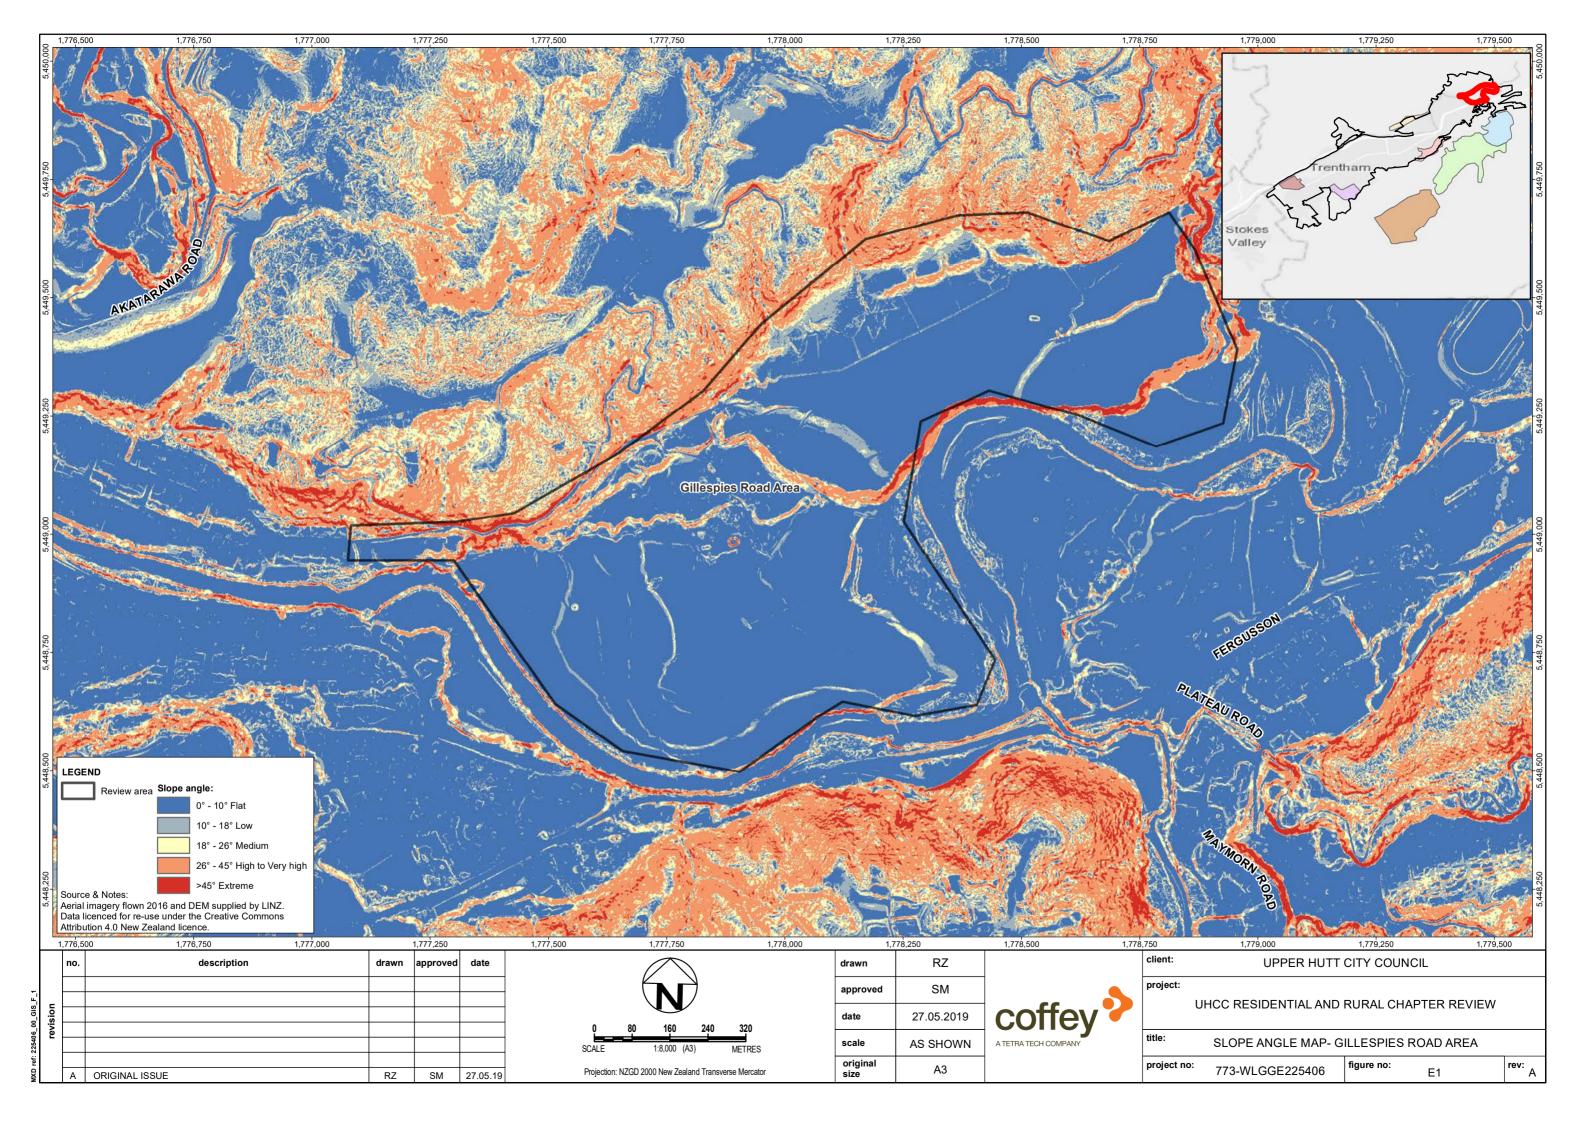
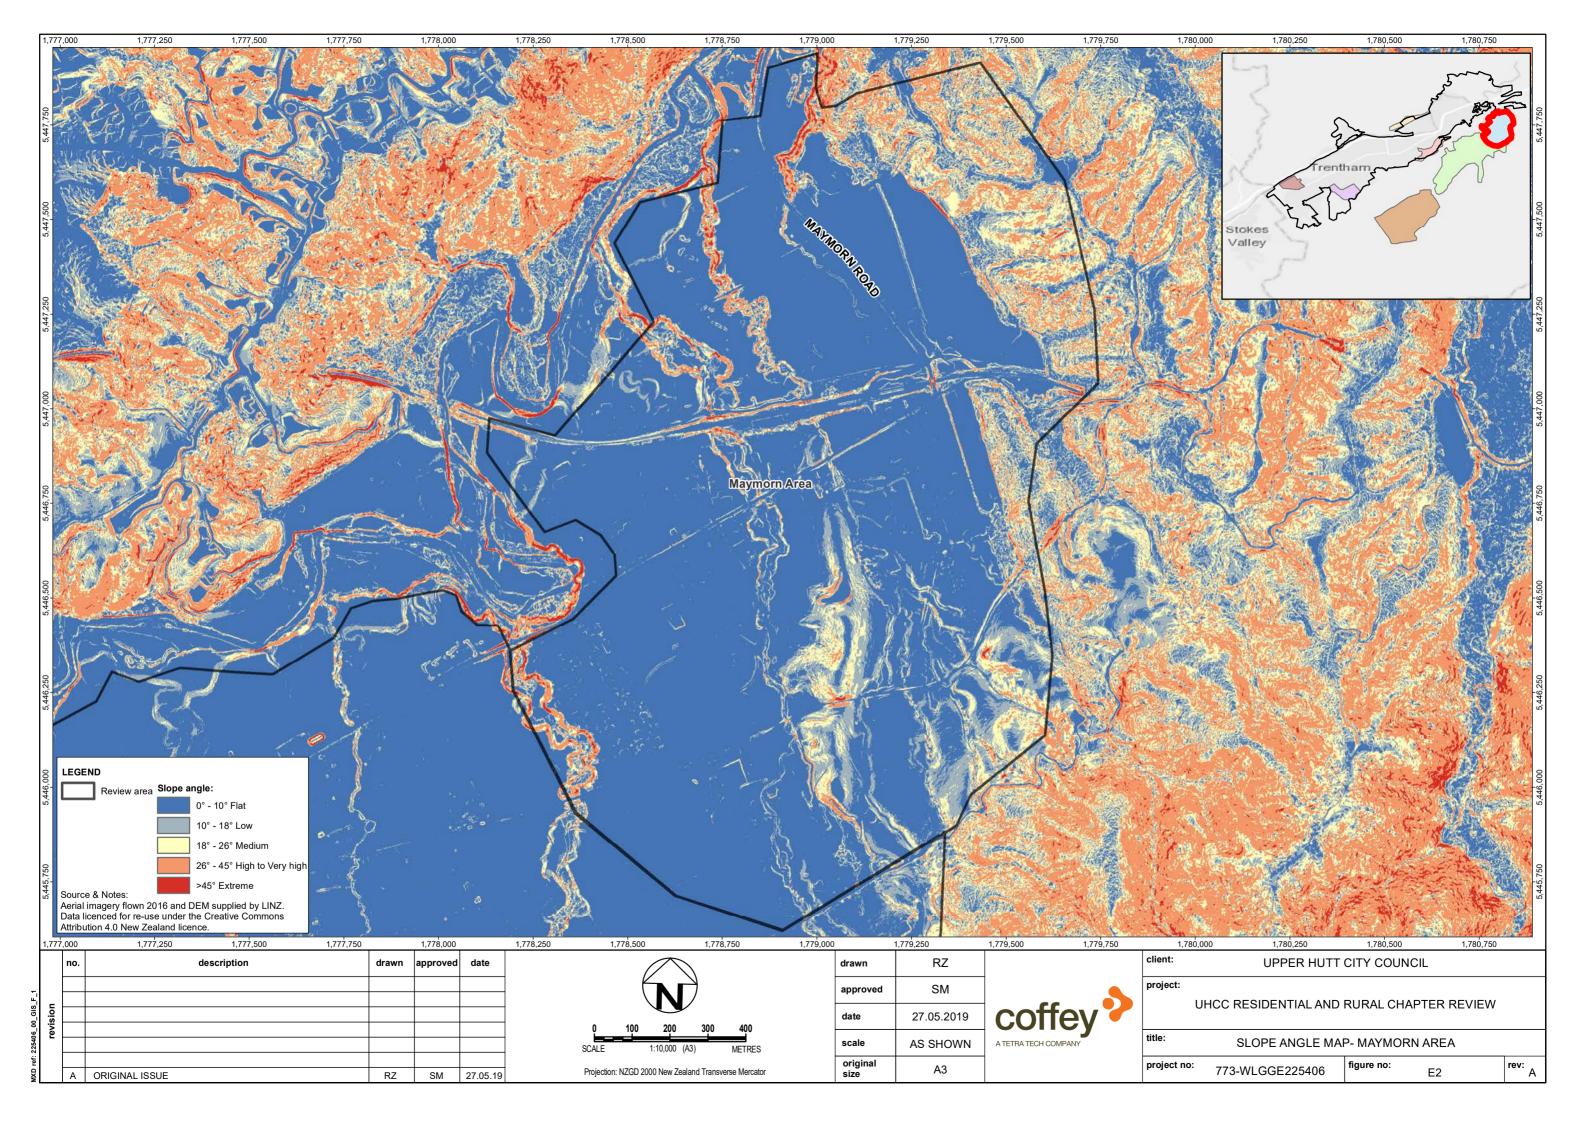
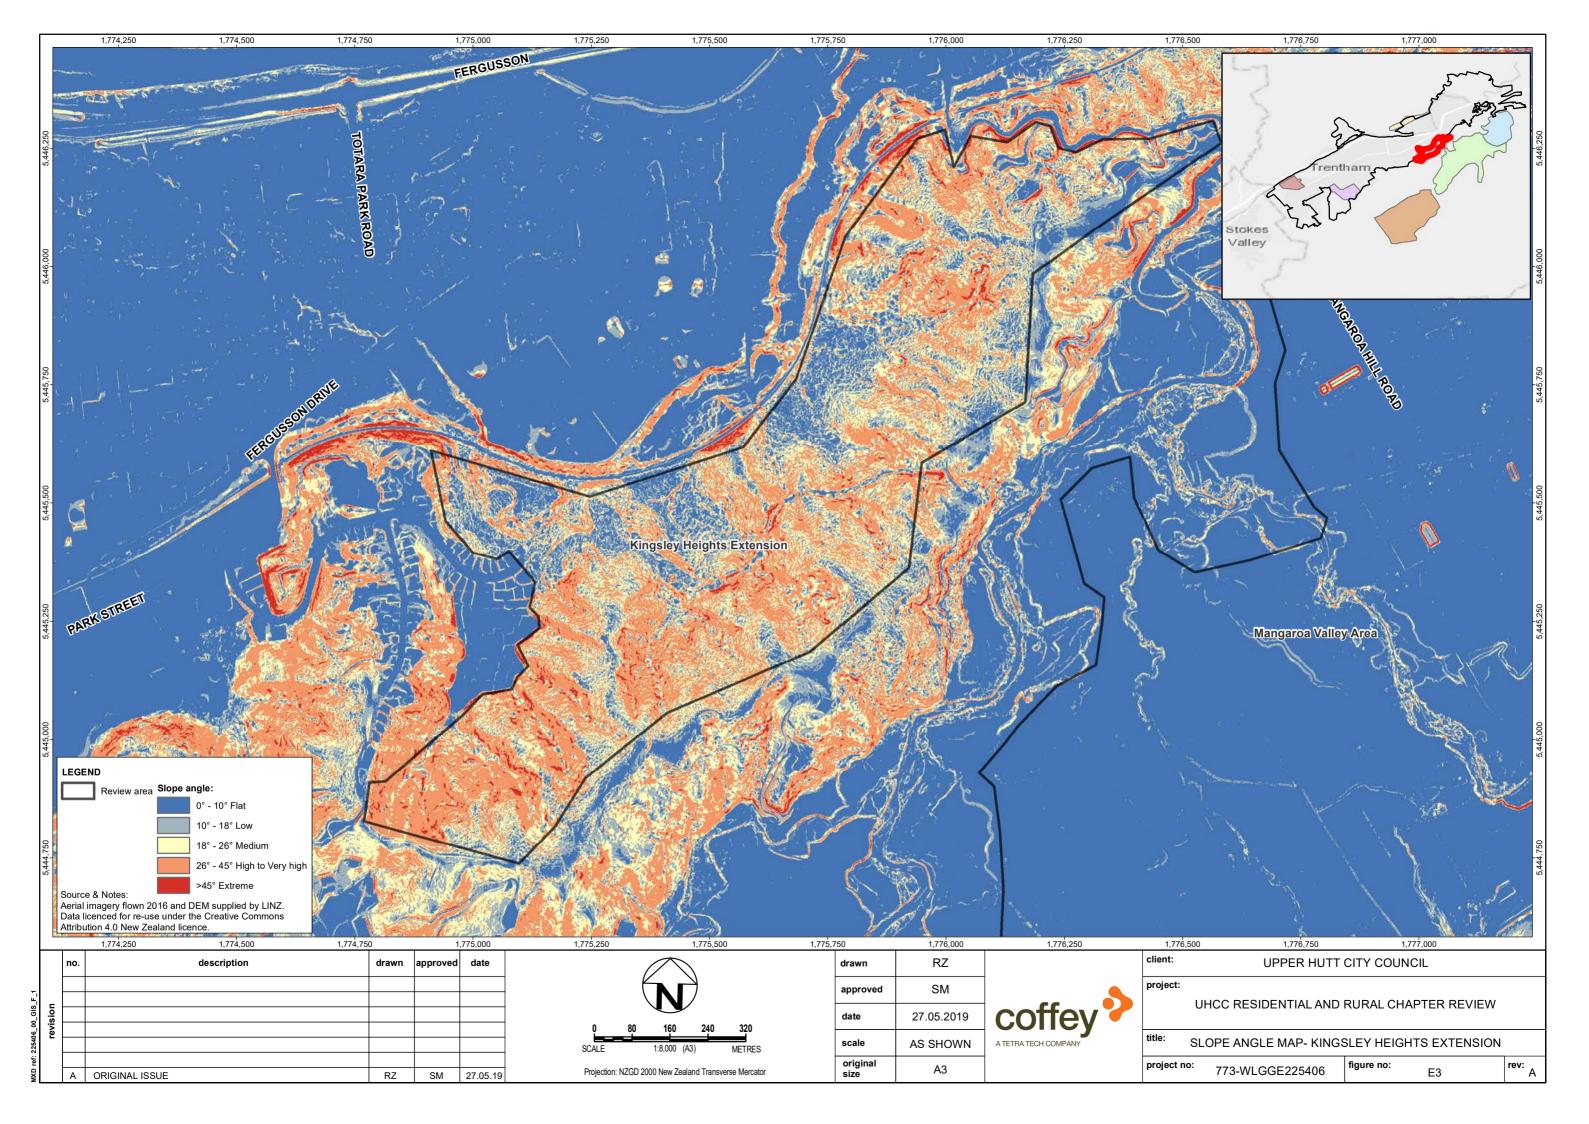
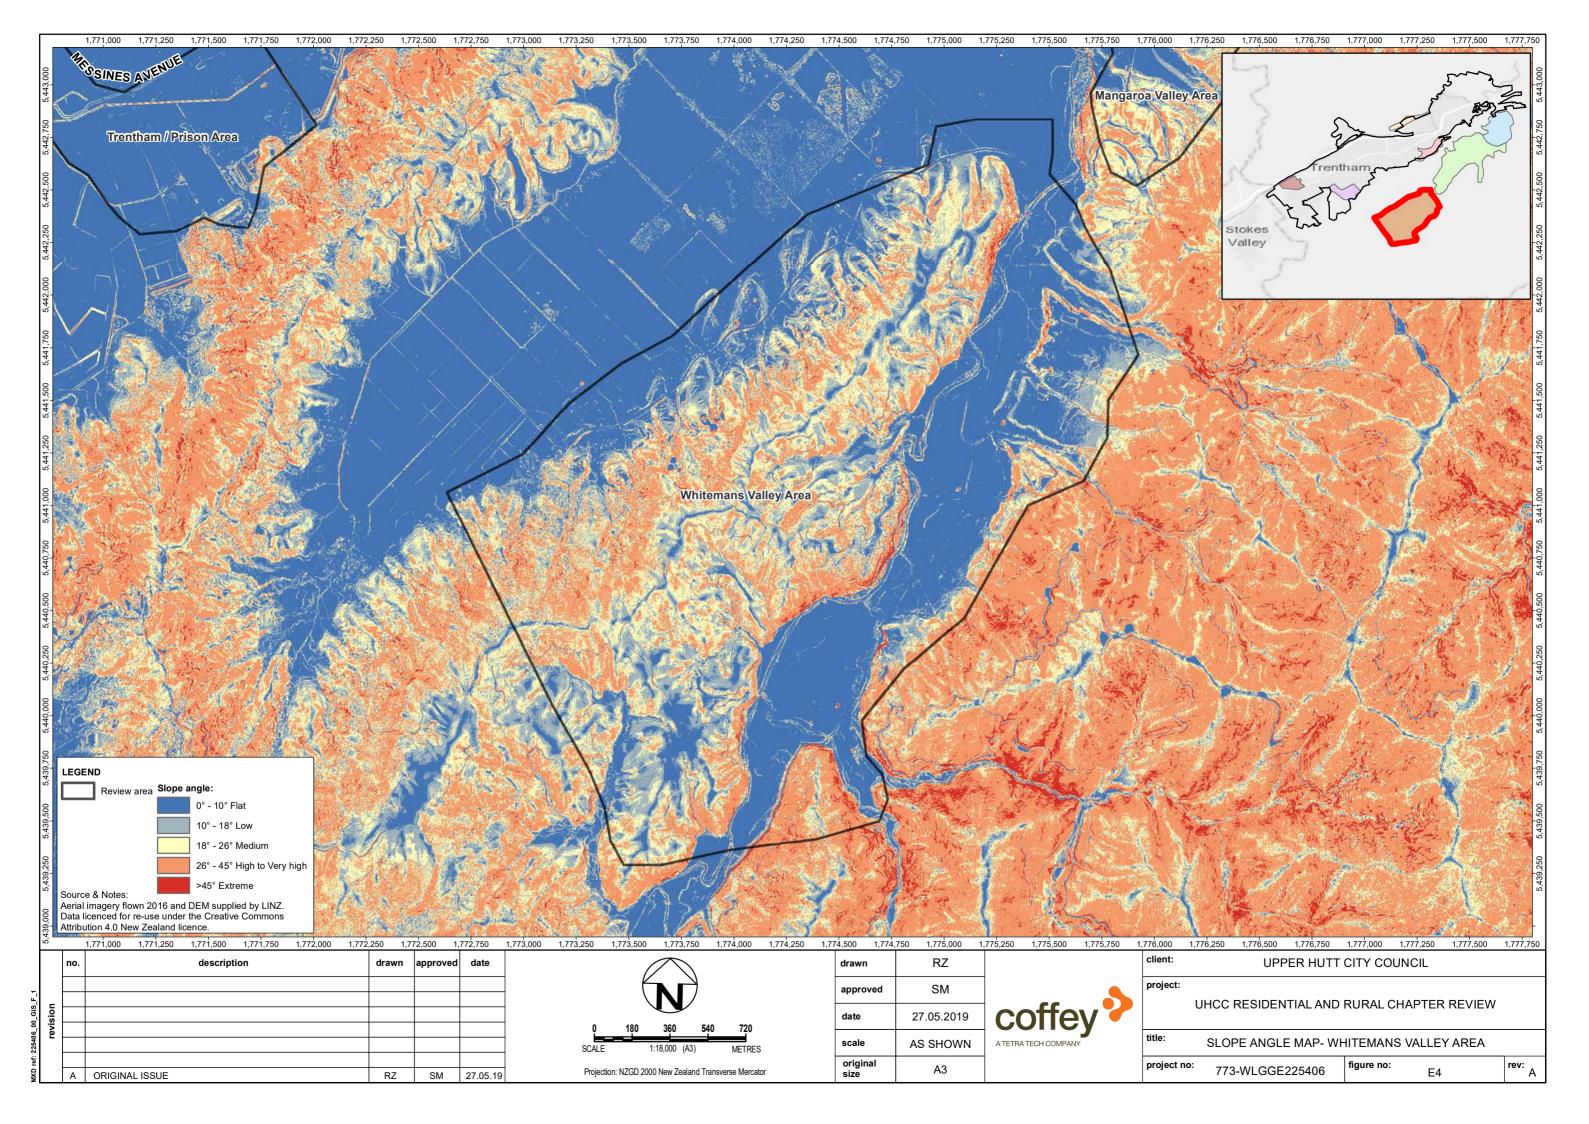
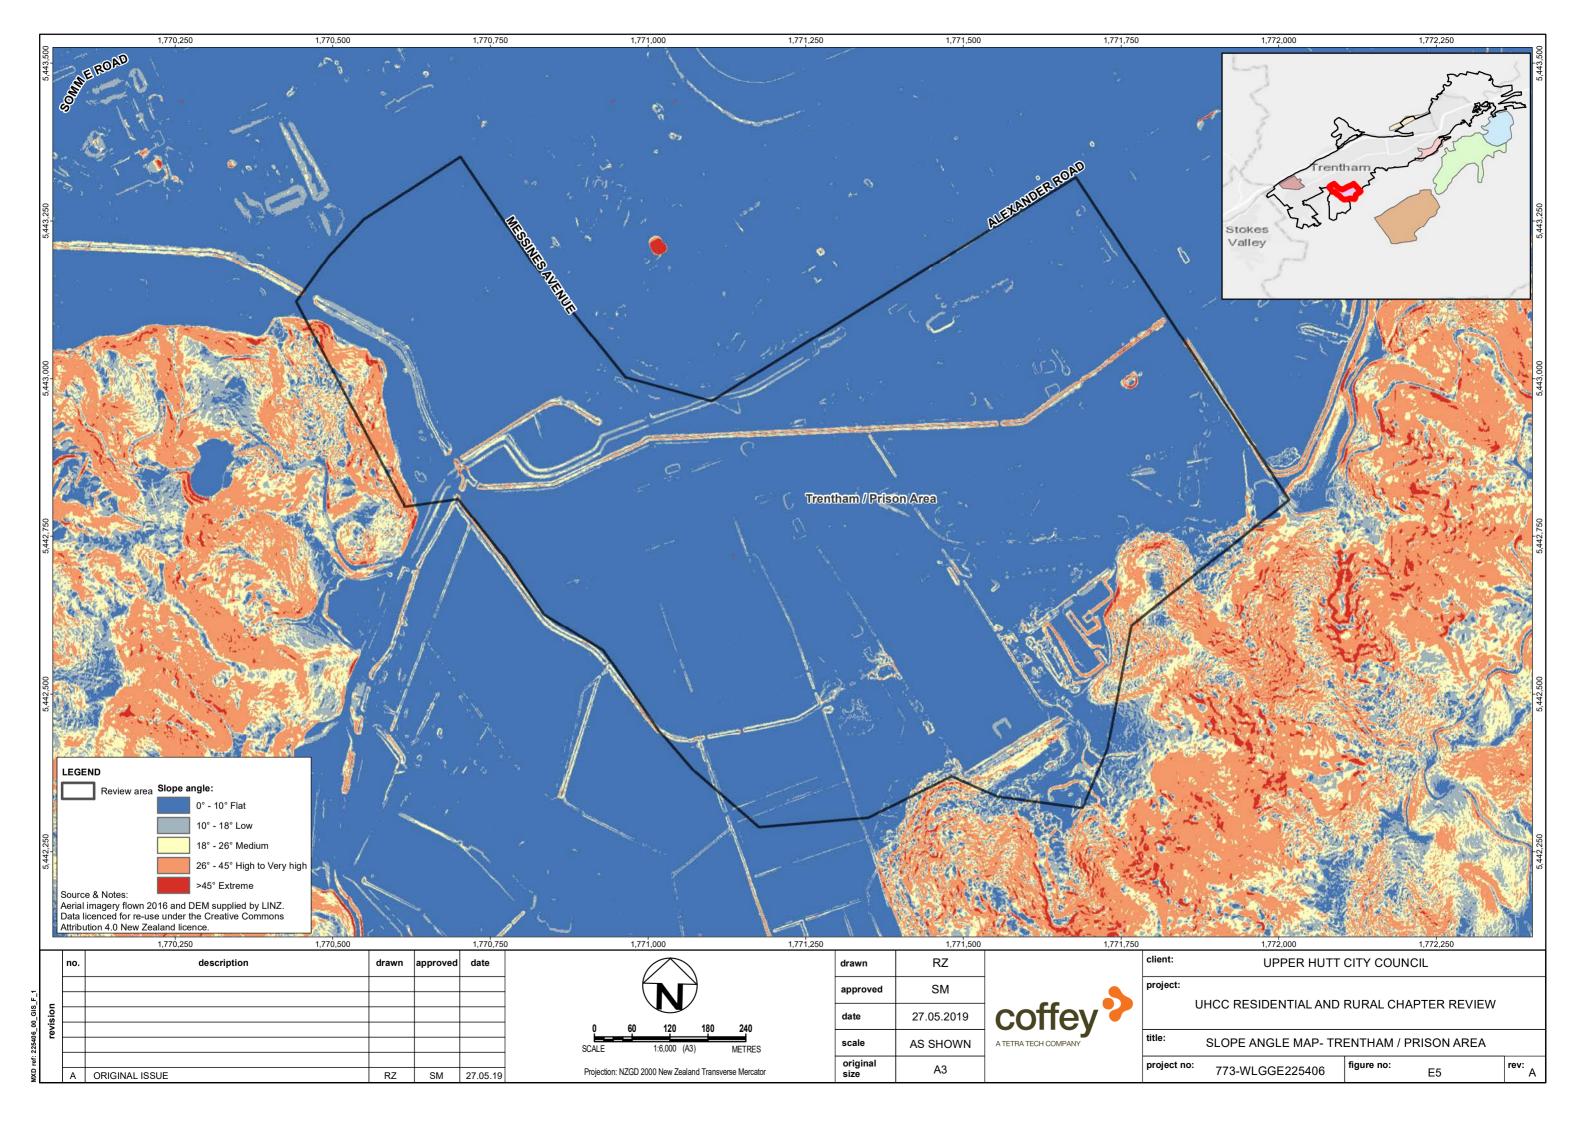
Figure E - 0: Slope Angle Map

Figure E - 1: Slope Angle Map – Gillespies Road Area Figure E - 2: Slope Angle Map – Maymorn Area

Figure E - 2: Slope Angle Map – Maymorn Area
Figure E - 3: Slope Angle Map – Kingsley Heights Extension
Figure E - 4: Slope Angle Map – Whitemans Valley Area
Figure E - 5: Slope Angle Map – Trentham / Prison Area
Figure E - 6: Slope Angle Map – St Patricks Estate
Figure E - 7: Slope Angle Map – Mangaroa Valley
Figure E - 8: Slope Angle Map – Cannon's Point Area
Figure E - 9: Slope Angle Map – Wider Upper Hutt Area

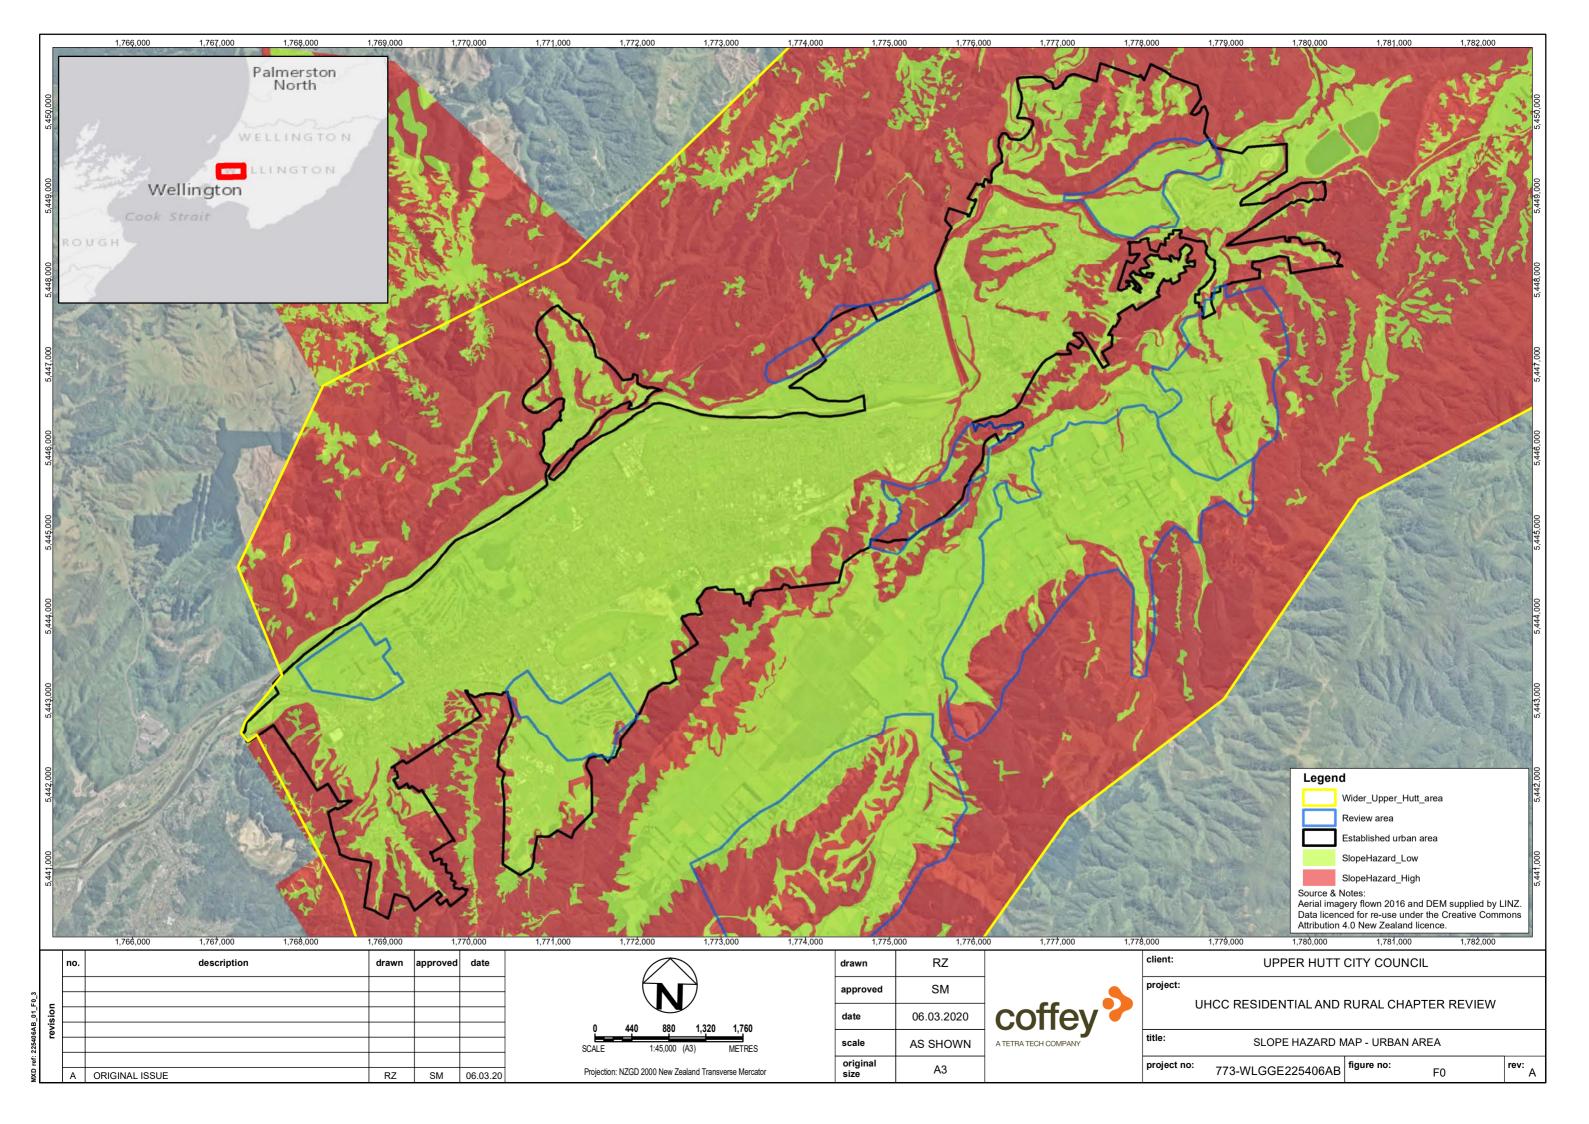
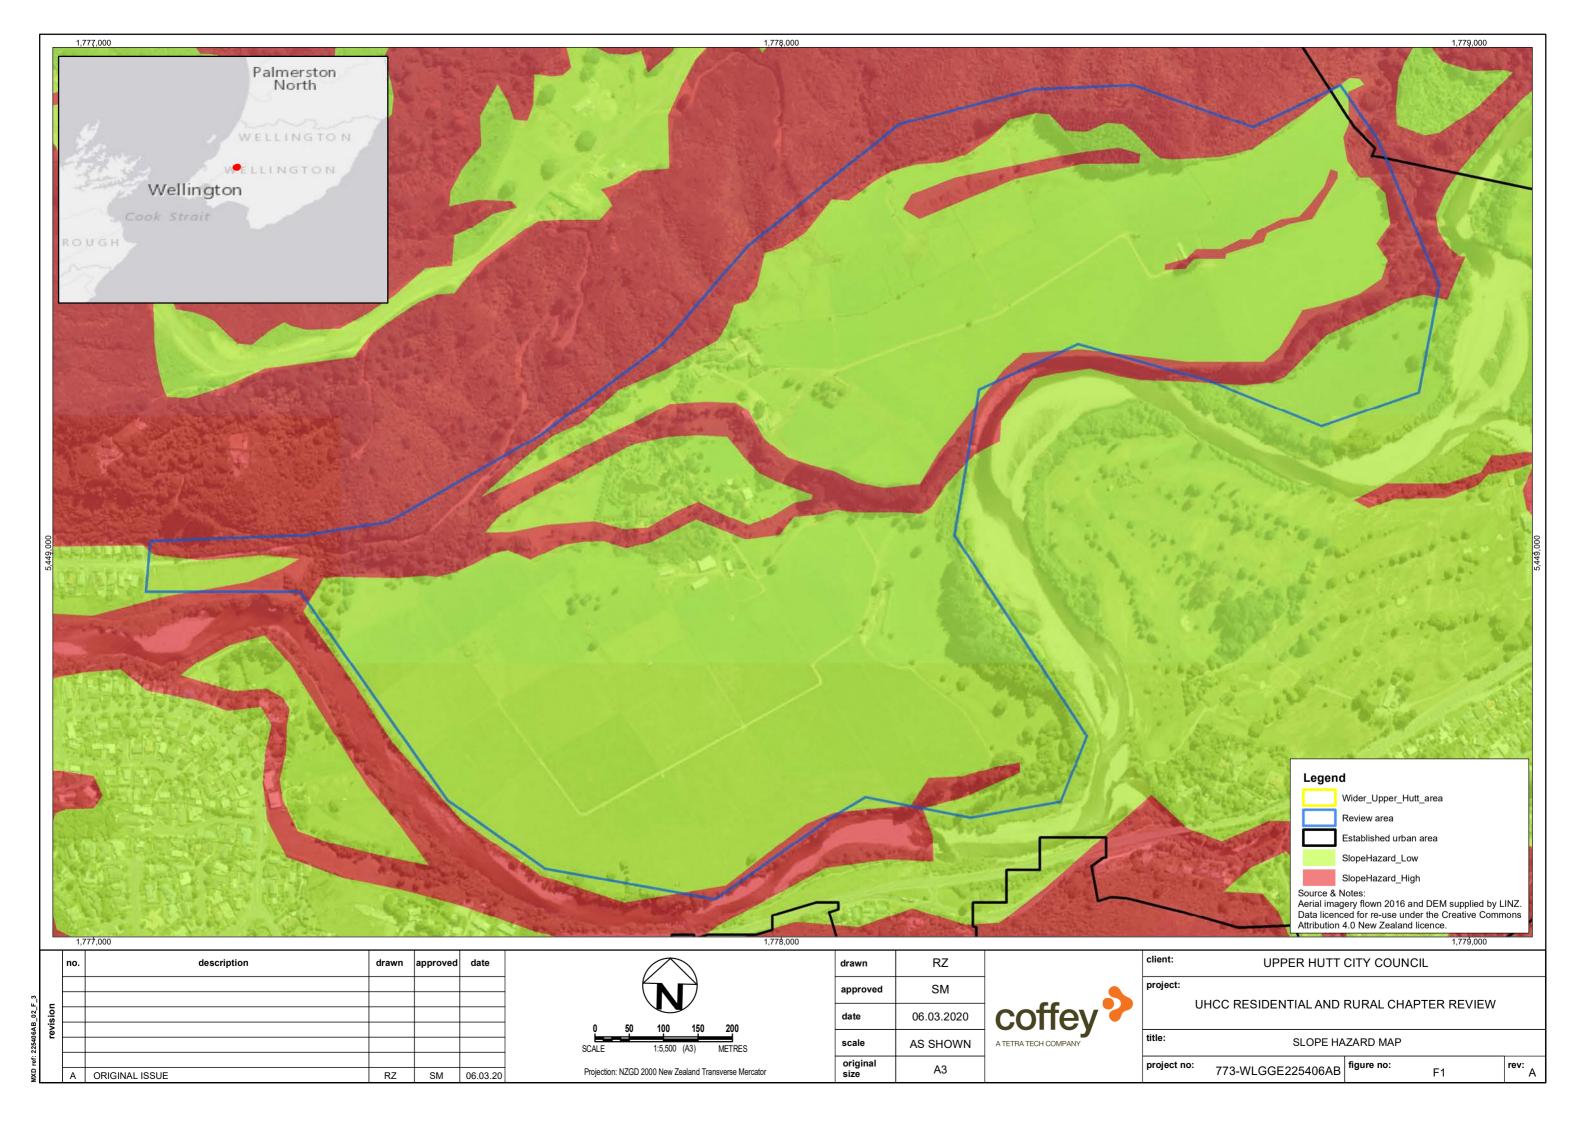
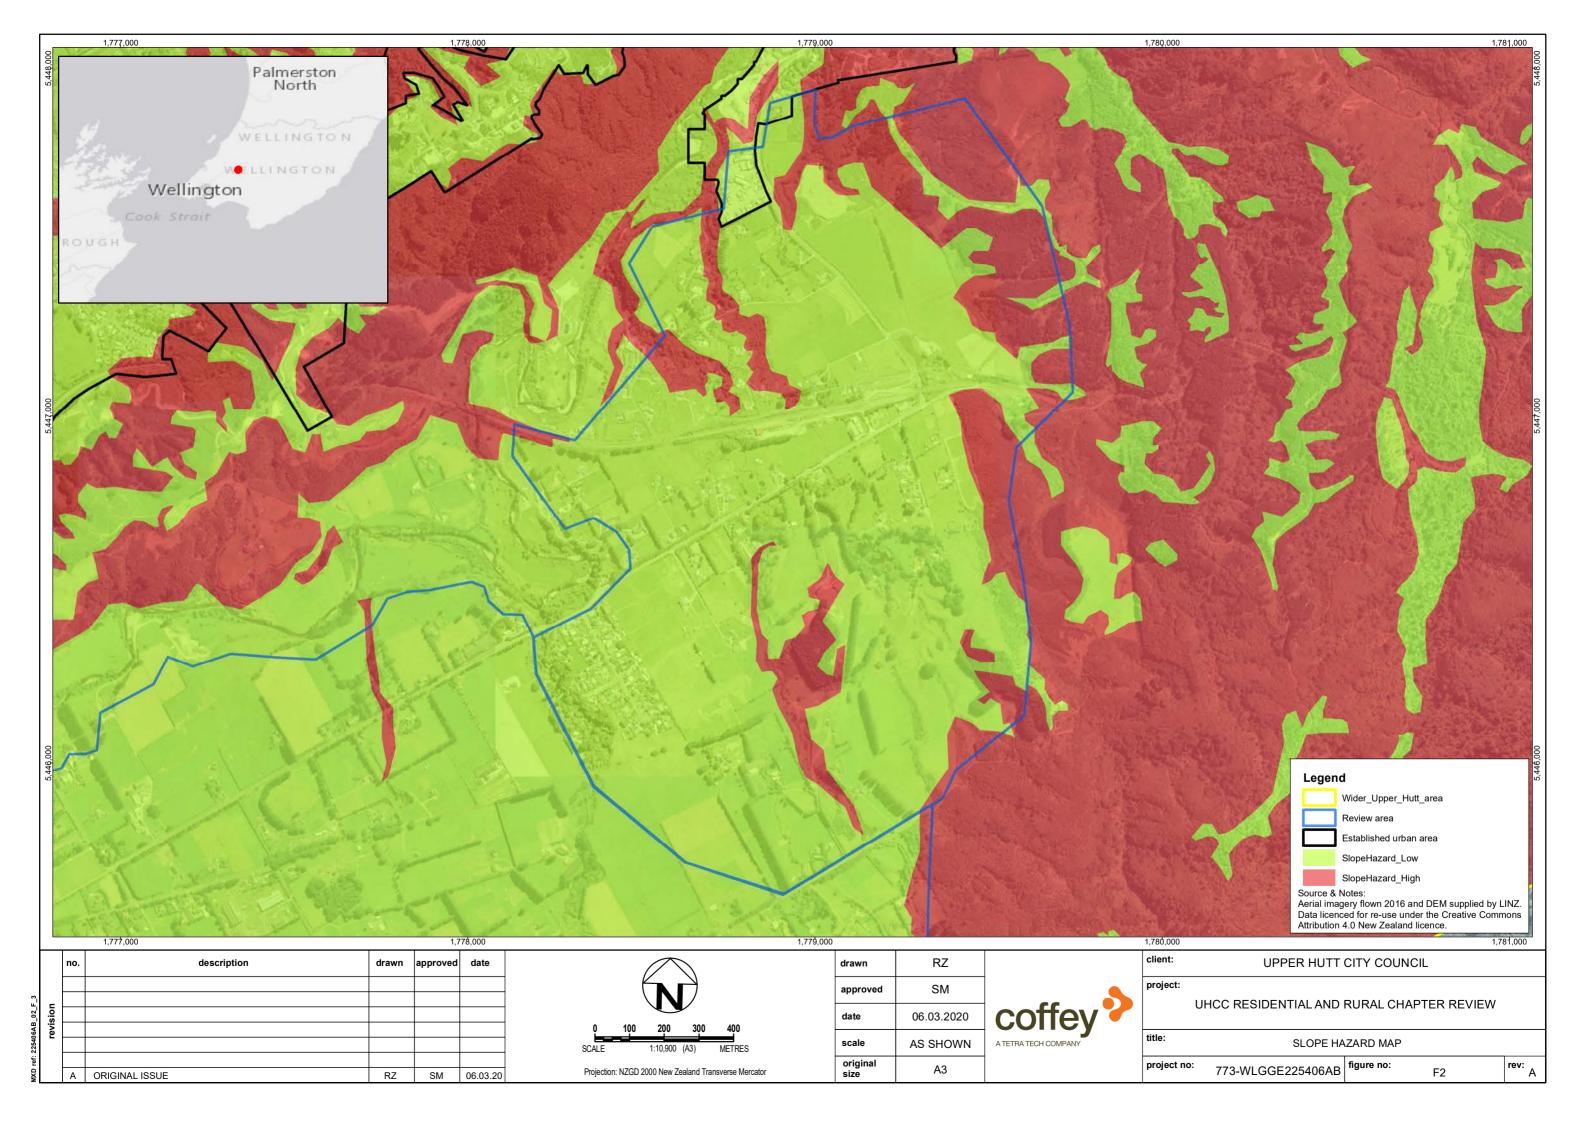
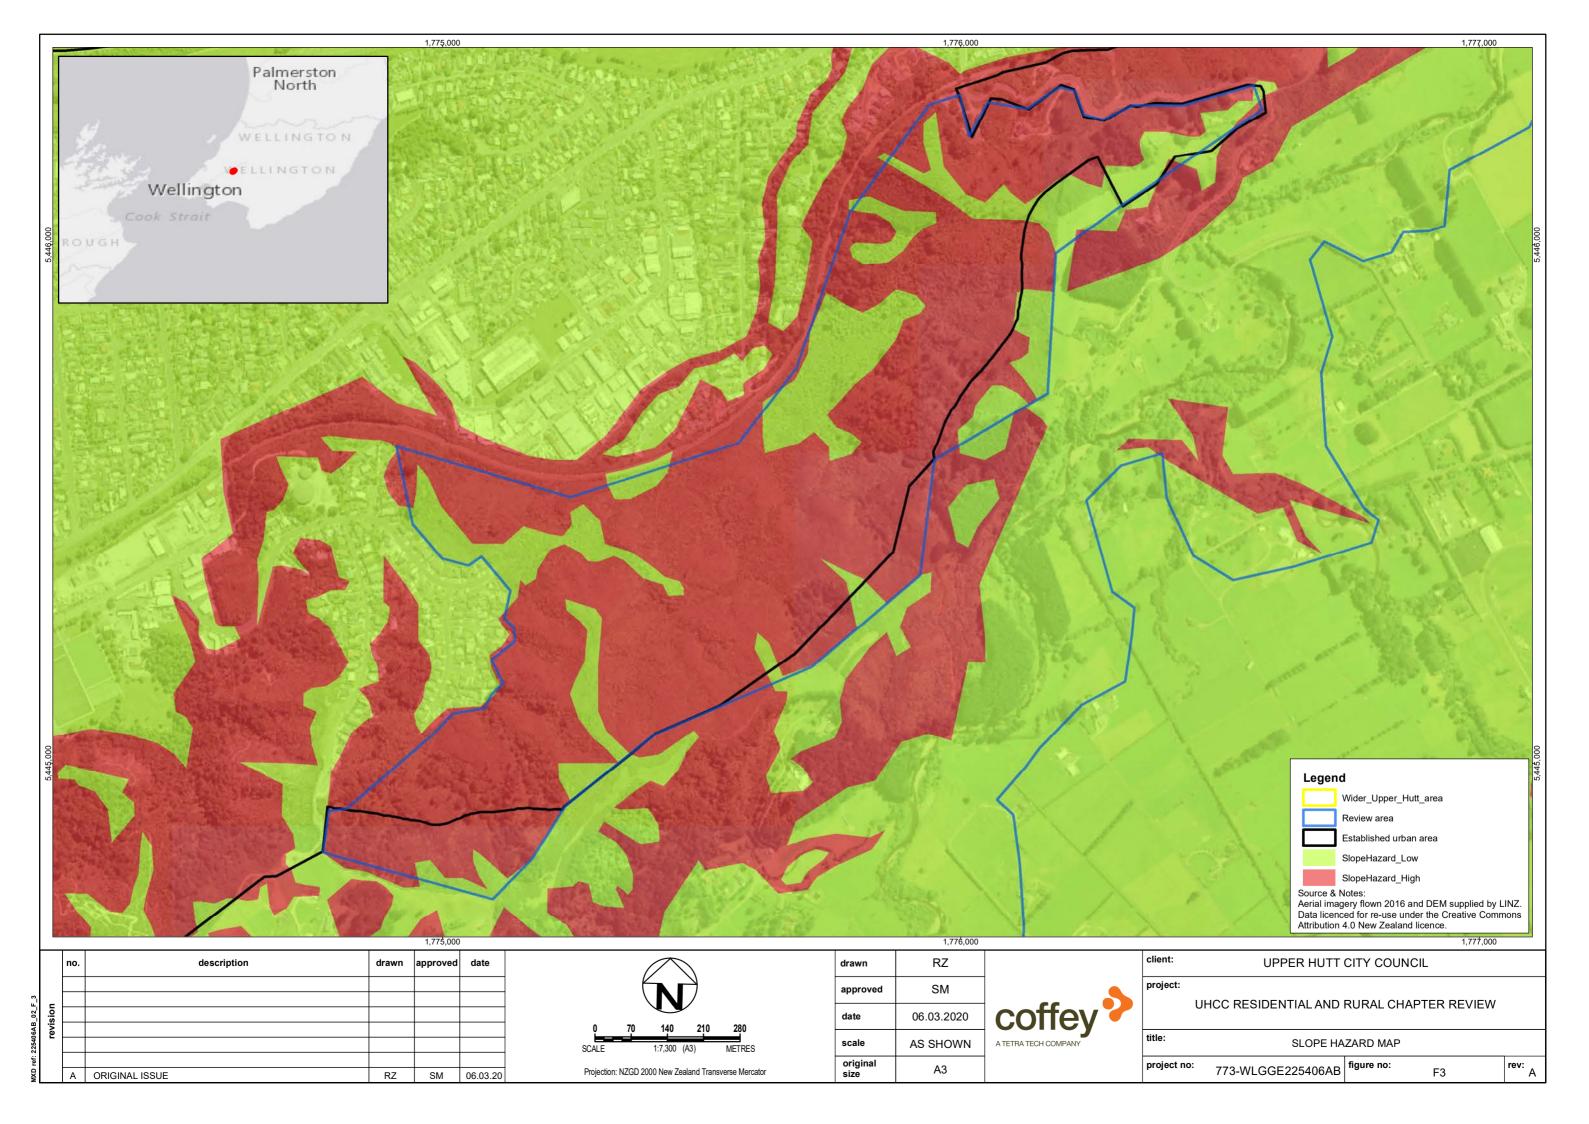
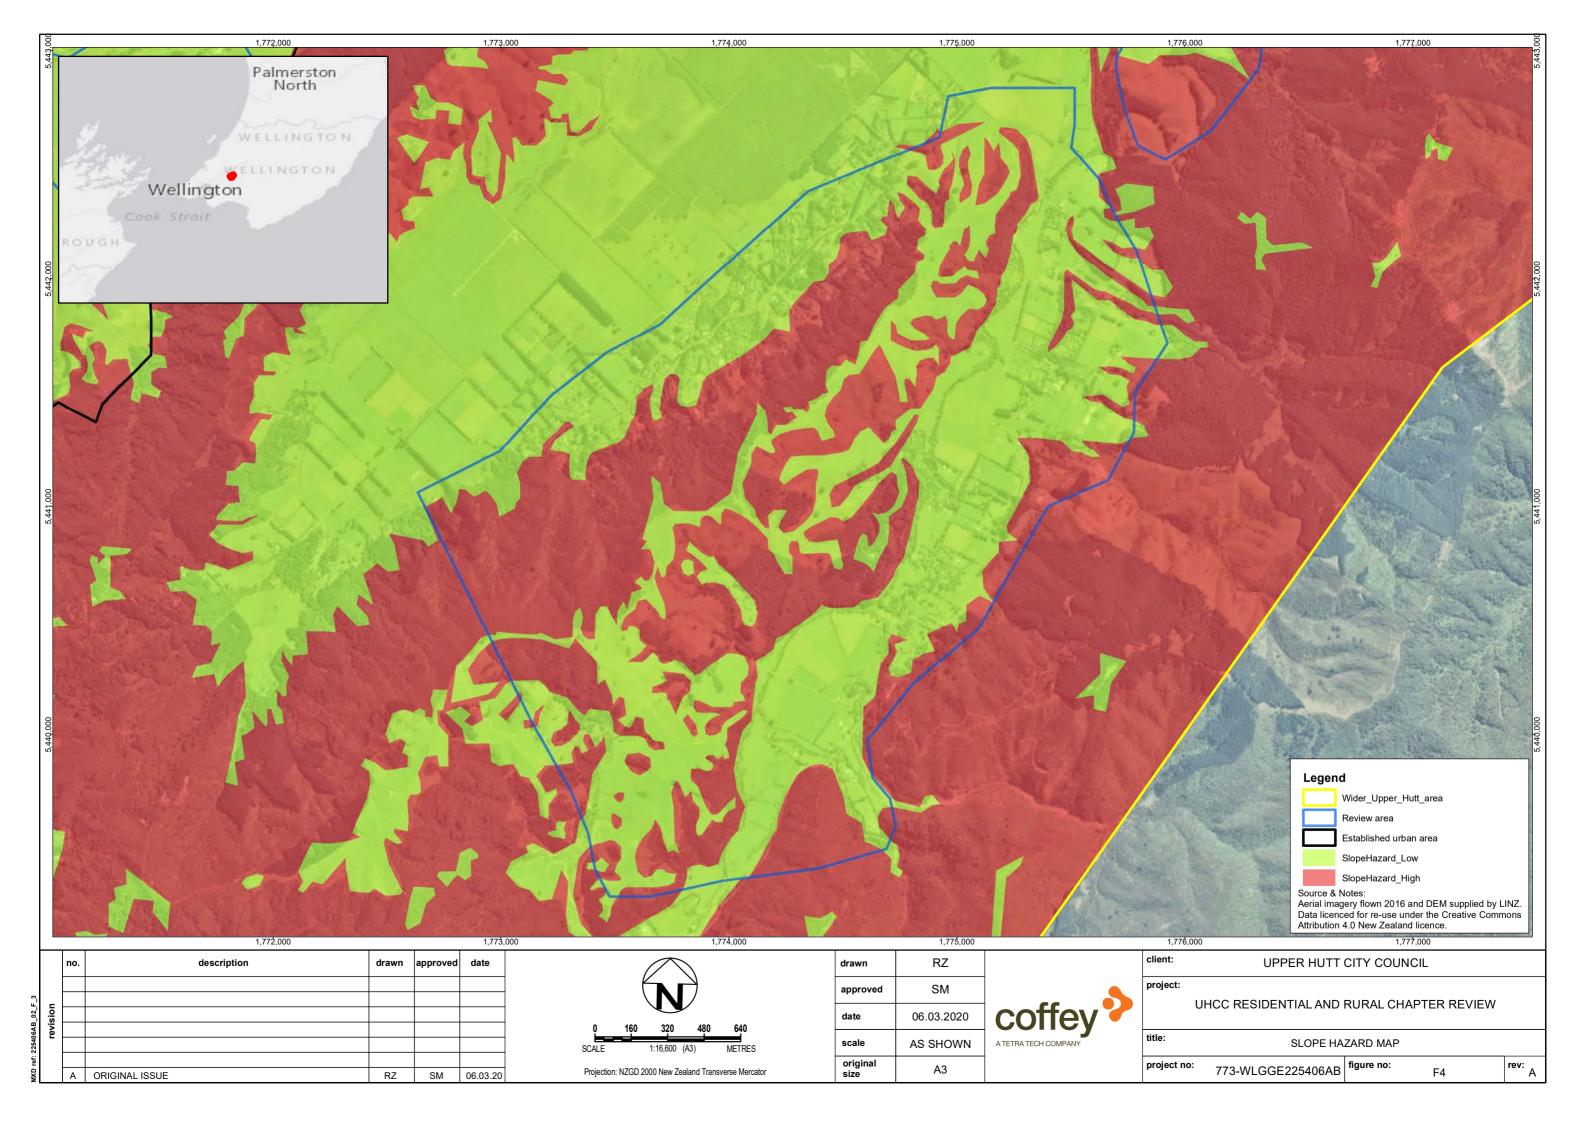
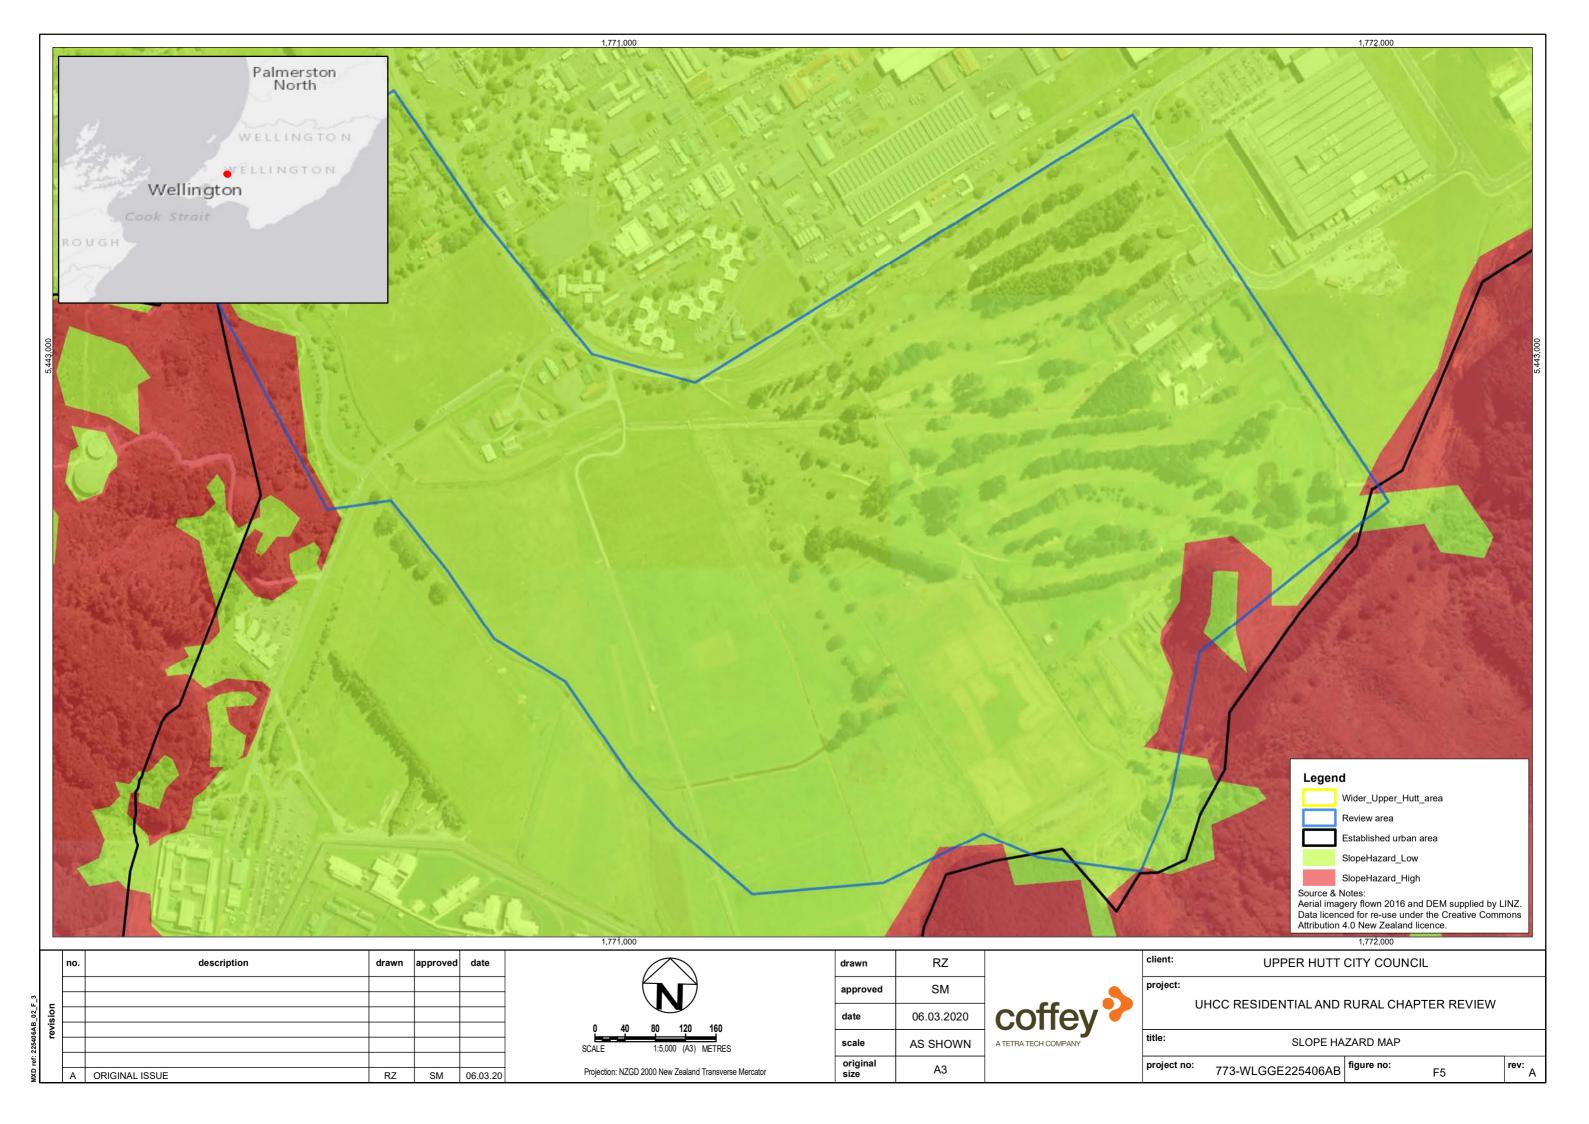
Figure F - 0: Slope Hazard Map — Urban Area Figure F - 2: Slope Hazard Map — Gillespies Road Area Figure F - 3: Slope Hazard Map — Maymorn Area

Figure F - 3: Slope Hazard Map — Maymorn Area
Figure F - 4: Slope Hazard Map — Kingsley Heights Extension
Figure F - 5: Slope Hazard Map — Whitemans Valley Area
Figure F - 6: Slope Hazard Map — Trentham / Prison Area
Figure F - 7: Slope Hazard Map — St Patricks Estate Area
Figure F - 8: Slope Hazard Map — Mangaroa Valley Area
Figure F - 9: Slope Hazard Map — Cannon's Point Area
Figure F - 10: Slope Hazard Map — Wider Upper Hutt Area
Figure F - 10 Slope Hazard Map — Upper Hutt

Site specific quantitative slope stability modelling for static, seismic and wet ground conditions will be required for sites identified as having a high slope hazard. We have provided general (conservative) setbacks from the crest and toe of steep slopes as follows, and as shown in Plate 4:

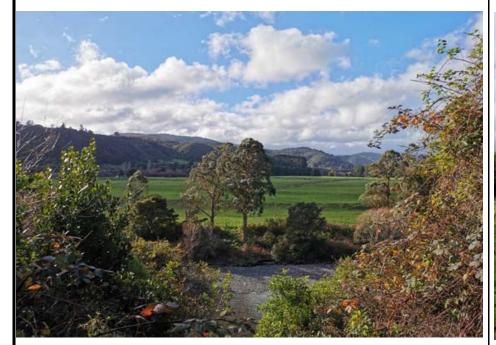
Photo 1: View across the Hutt River looking north onto Gillespies Road Area. Note the relatively flat grassed area with a series of terraces.

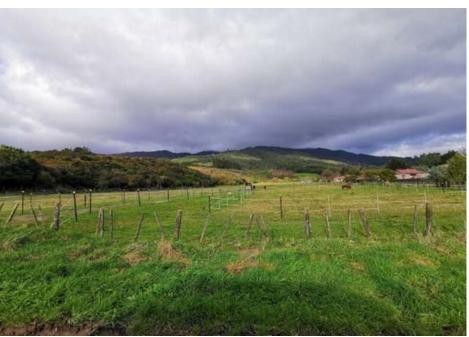
Photo 2: Looking south-east from Parkes Line Road across flat paddocks to the greywacke hills.

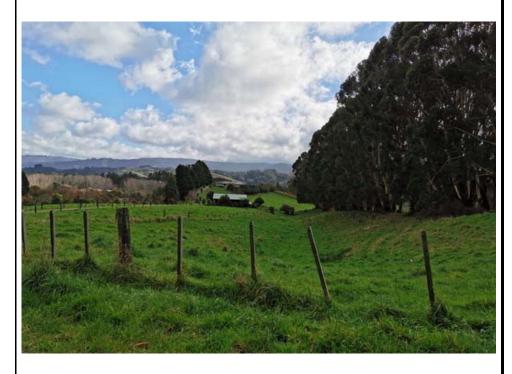
Photo 3: Photo of the sloping, gently undulating land on the southwestern side of the Mangaroa area

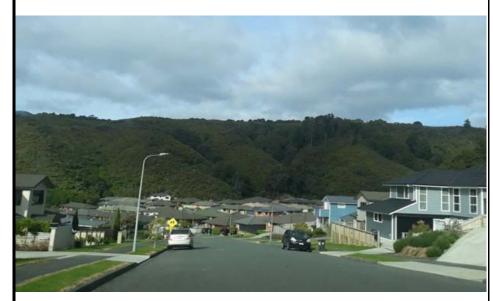
Photo 4: Photo of Kingsley Heights Extension taken from Kingsley Heights showing the ridges and valleys of the slopes with high to very high slope angles and a flatter ridgeline on top.

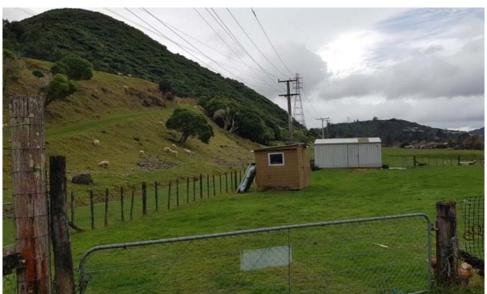
Photo 5: Photo looking north-east along the Lower Cannon's Point area. Note the lower terrace in the foreground and the steep terrace riser on the left. The greywacke hills are in the background.

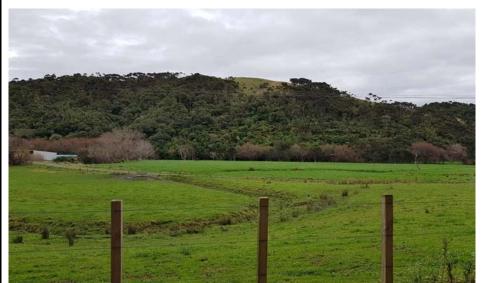
Photo 6: Photo of Whitemans Valley showing incised streams and gently undulating valley floor with bush-clad steep hills behind.

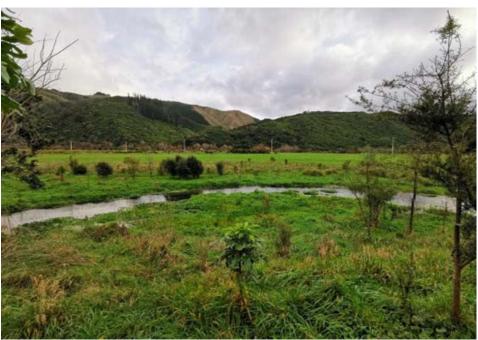
Photo 8: Looking across the St Pats Development Block. Area is typically flat, grassed with streams crossing it.
