Upper Hutt City Council Residential & Rural Chapter Review

This page has been left intentionally blank

Residential & Rural Chapter Review

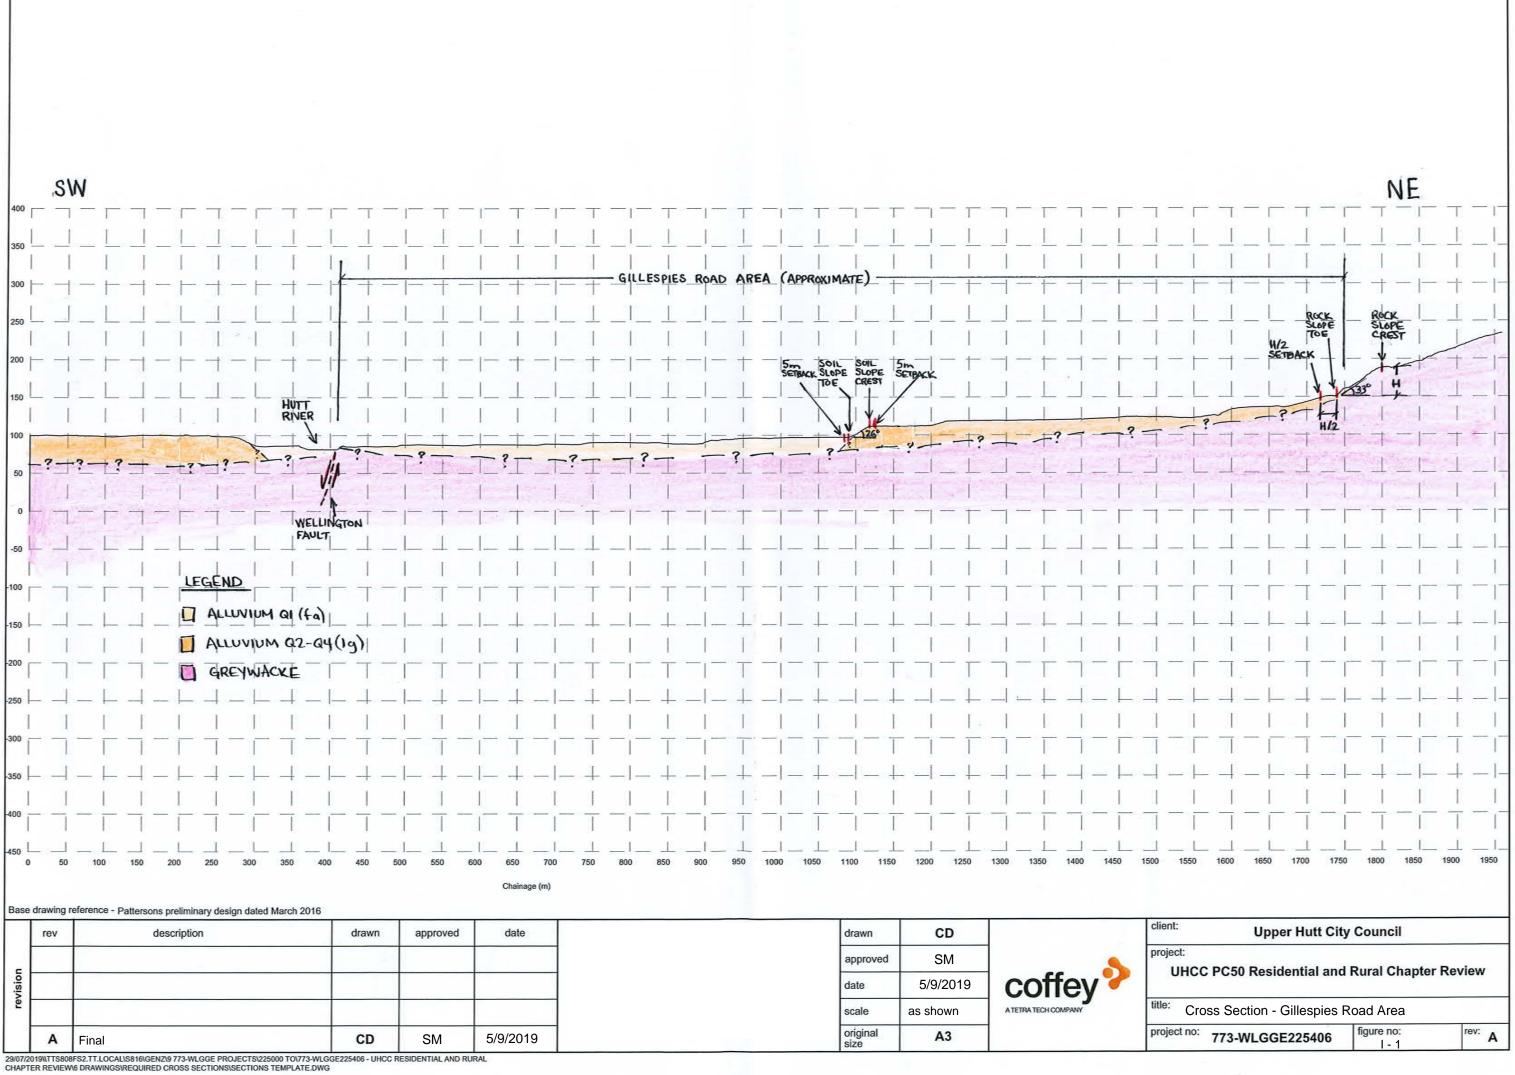
Figure I - 1: Cross Section – Gillespies Road Area Figure I - 2: Cross Section – Lower Cannon's Point Area

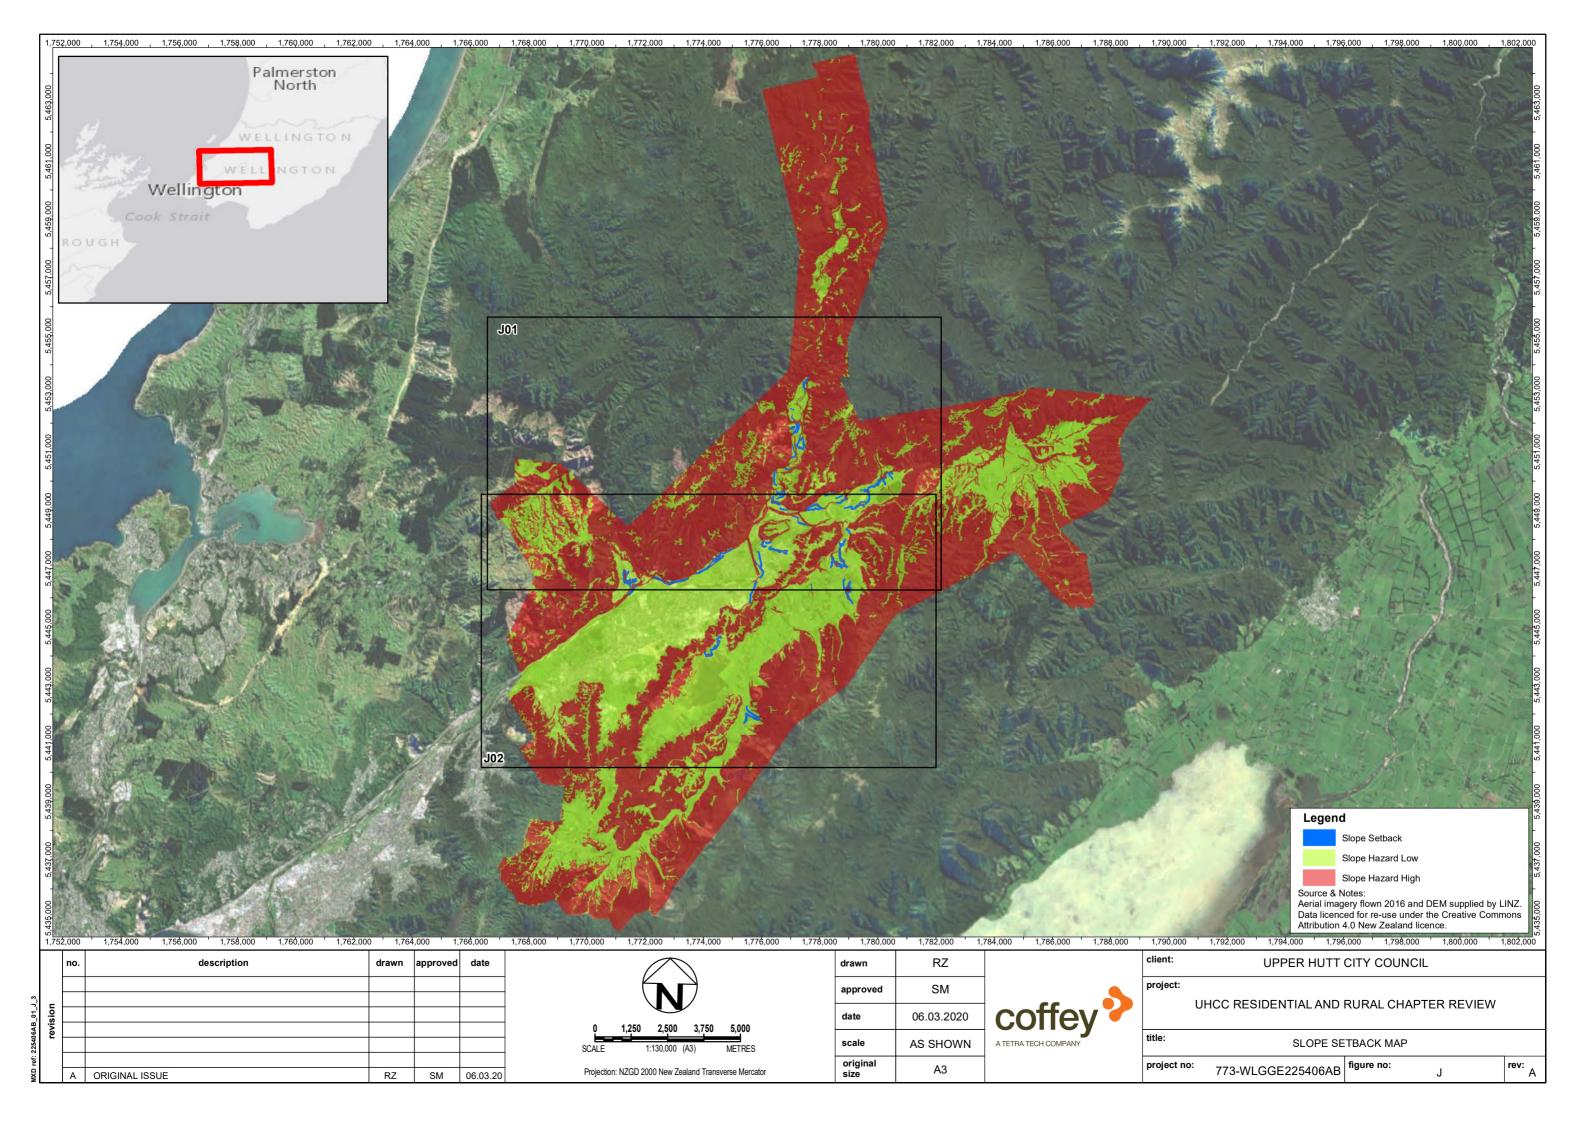
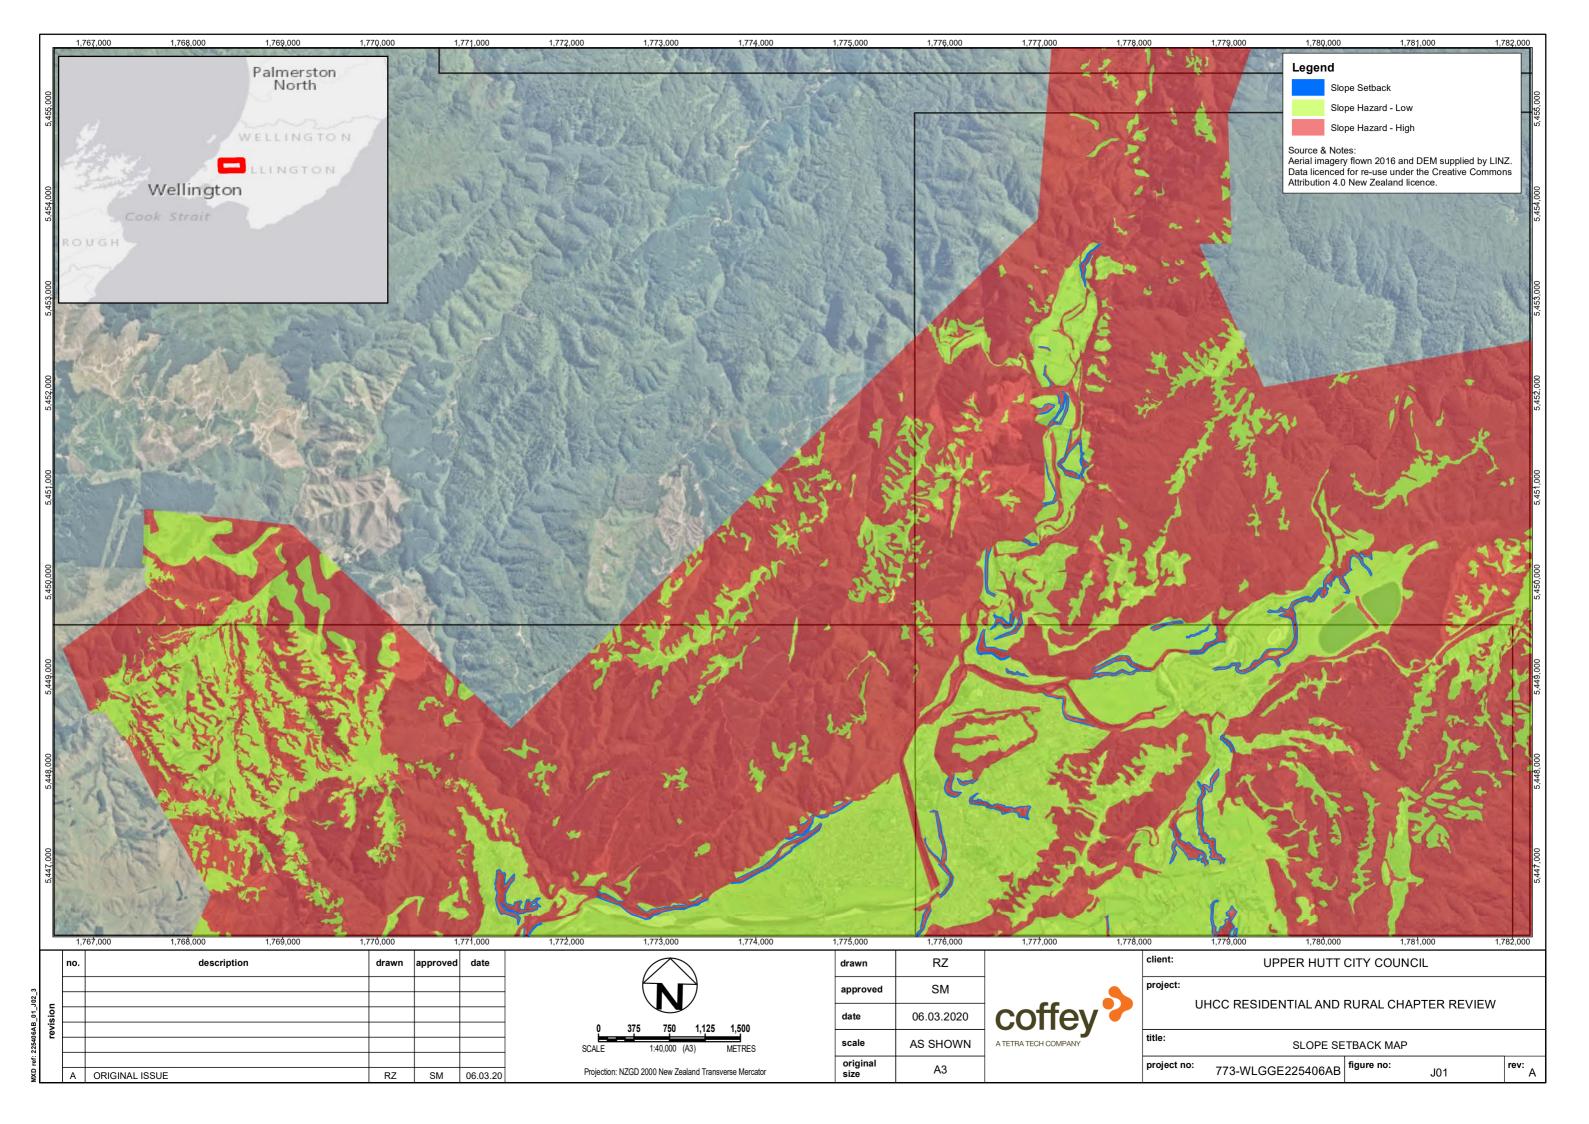
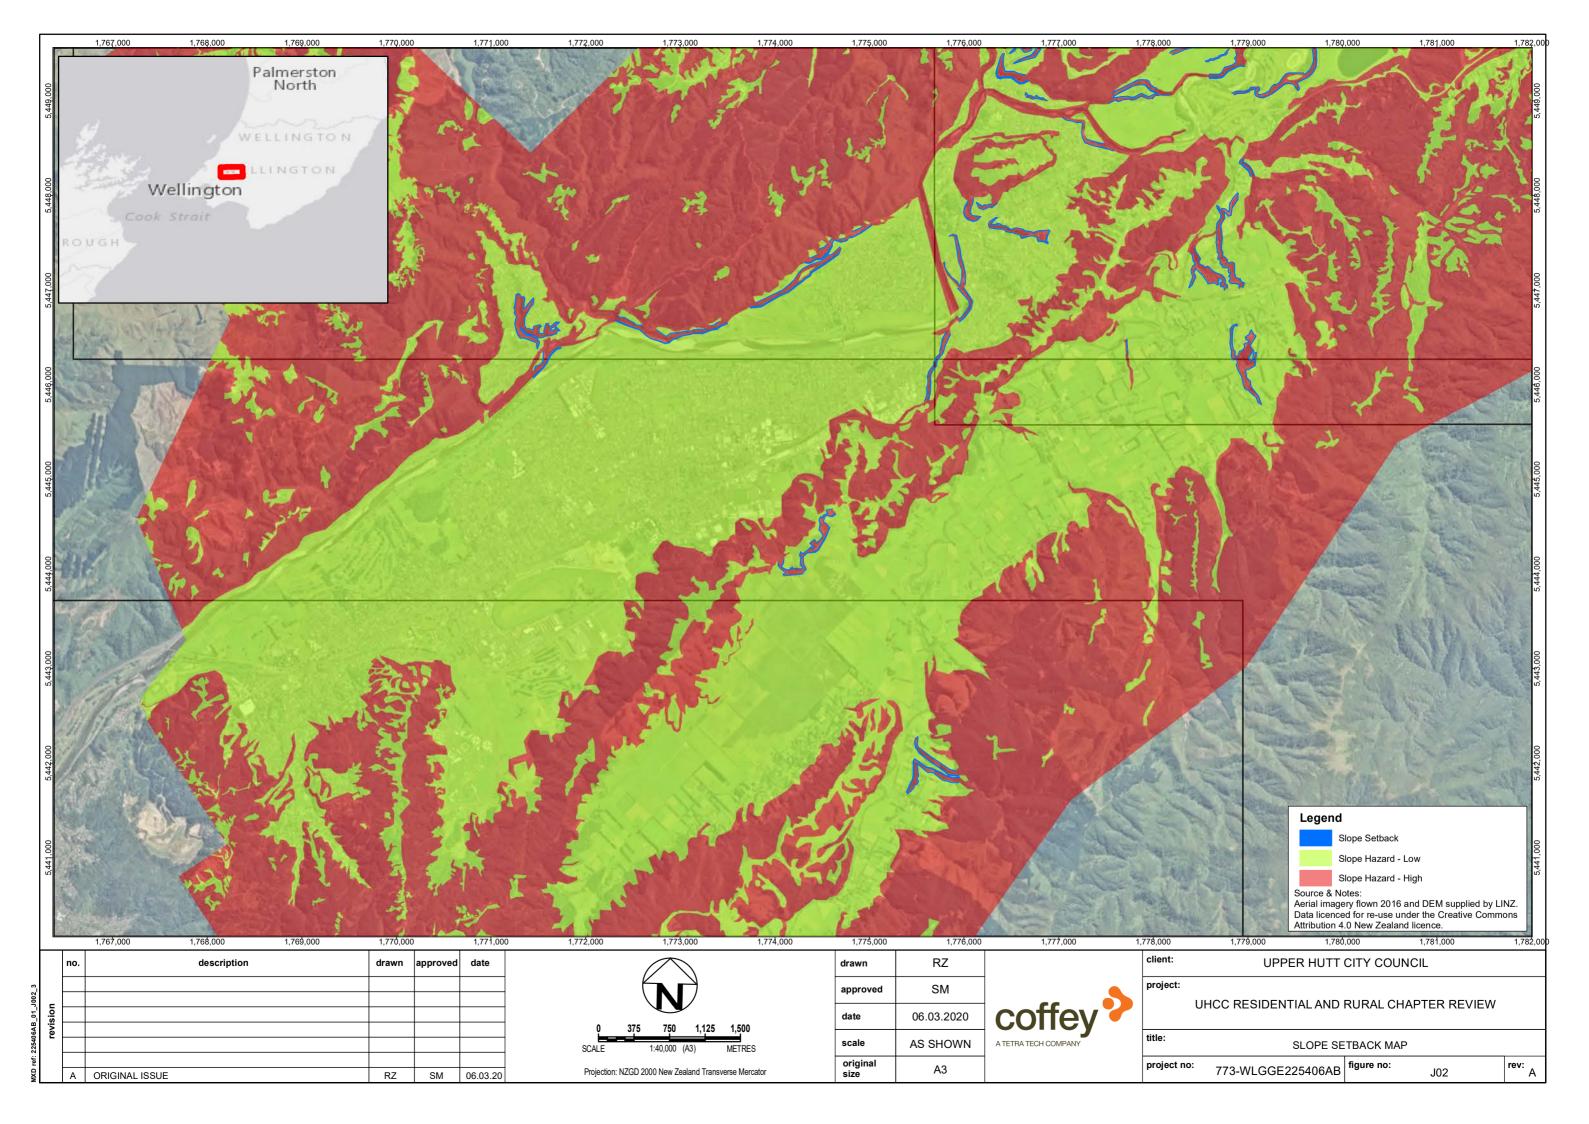
Appendix J – Slope Setback Maps

Figure J : Slope Setback Map – Upper Hutt Figure J01: Slope Setback Map -Northern Upper Hutt Figure J02: Slope Setback Map – Urban Upper Hutt
